AN INNOVATIVE UPGRADE AND PERFORMANCE RERATE OF LARGE, HIGH SPEED, HIGH TEMPERATURE, MULTISTAGE BARREL PUMPS

Flowserve Corporation

BP Oil, Oil Technology Network

BP Oil Grangemouth Refinery Limited

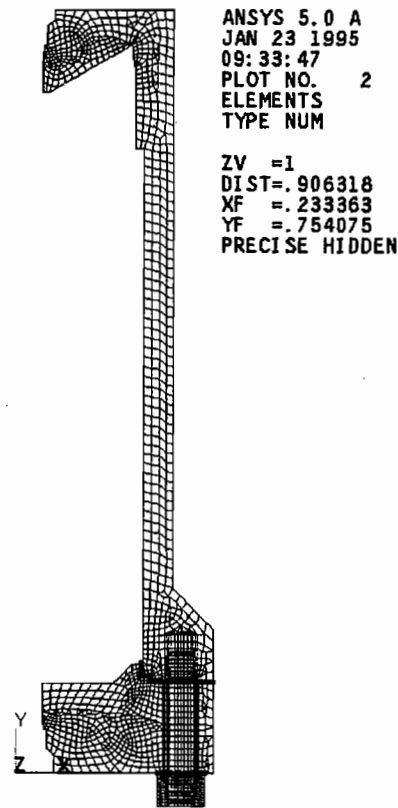
Figure 3. Barrel Stress Analysis for Pump P-301—Gasket Seating.

Assessment of the existing barrels for the increased pressure recommended using ASME VIII Division 1 sizing calculations, but they revealed that the thickness of the existing pressure boundary was inadequate. Since the cost of three complete new barrels/covers with subsequent extra installation cost was very high, it was decided to perform an indepth ASME VIII, Division 2 stress analysis. This was done in two steps:

From all these detailed stress evaluations, it was decided to manufacture a new barrel for pump P-302, while for pump P-301 and P-303 the existing components were used. The existing components (barrel/cover) were still slightly modified as a result of the vibration survey to change the pump feet stiffness and the bearing bracket stiffnesses. This is described in detail in the next

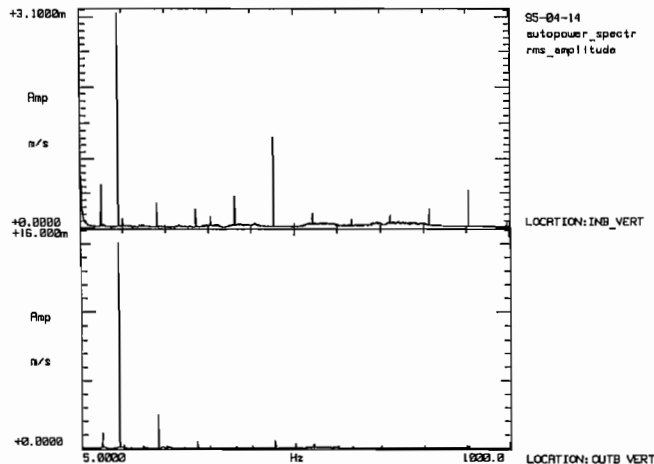
Figure 6. Operational Spectra—Pump P-302.

The root cause survey first started with vibration levels and spectrograms of the existing units operating with either fresh feed or recycle feed or, for P-303, both fresh and recycle feed product. Figure 6 shows a typical measured bearing housing spectrogram on P-302, operating with recycle feed.

- When pumping recycle feed, overall vibrations at the inboard bearing housing are high in horizontal and axial direction. These elevated vibrations are due to higher vibrations at the vane passing frequency, the 1× speed vibrations are not affected.
- At the outboard bearing of P-302, a very high 1× speed vibration is measured in vertical direction.

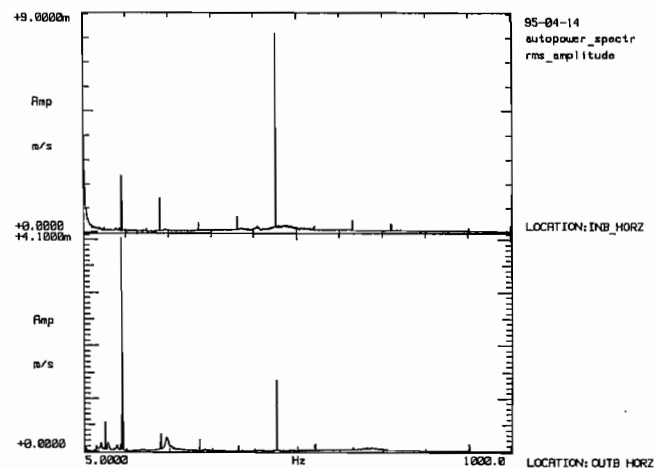
Figure 7. Operational Spectra—Pump P-303.

Figure 7 shows a typical measured bearing housing spectrogram on P-303 with recycle feed. In summary, the vibrations show dominating peaks at 1× speed and 5× speed, the impeller vane passing frequency (Table 5).

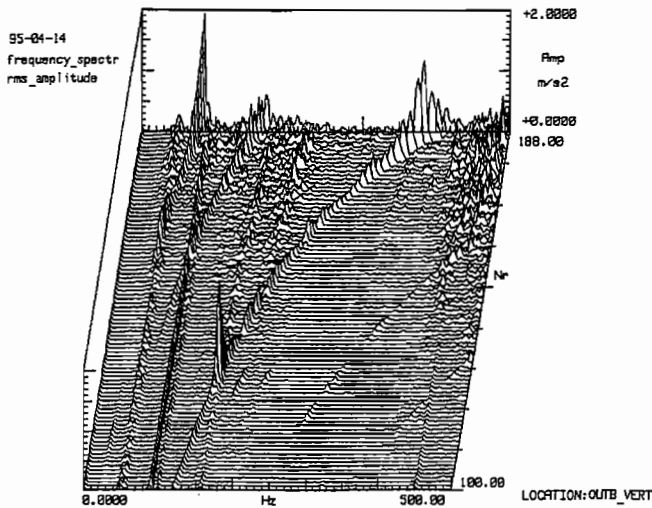
Figure 8. Campbell Diagram for Pump P-302.

Figure 8 shows the Campbell diagram of pump P-302, the outboard bearing housing vertical direction.

On this unit, several resonances are directly observed at almost 50 Hz and 90 Hz. The magnification of the 1× speed at 90 Hz is clearly observed, and also magnification of the 1× speed vibrations at 50 Hz, the motor operating speed.

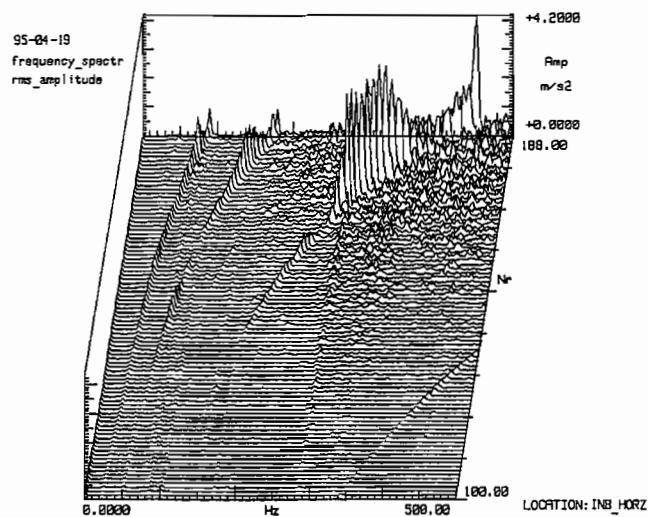
Figure 9. Campbell Diagram for Pump P-303.

Figure 9 shows the Campbell diagram for pump P-303 at the inboard horizontal plane for fresh feed and recycle feed. The large values at vane passing frequency on recycle feed show up as a forced vibration problem. At a speed just below operating speed, there are some indications of resonances.

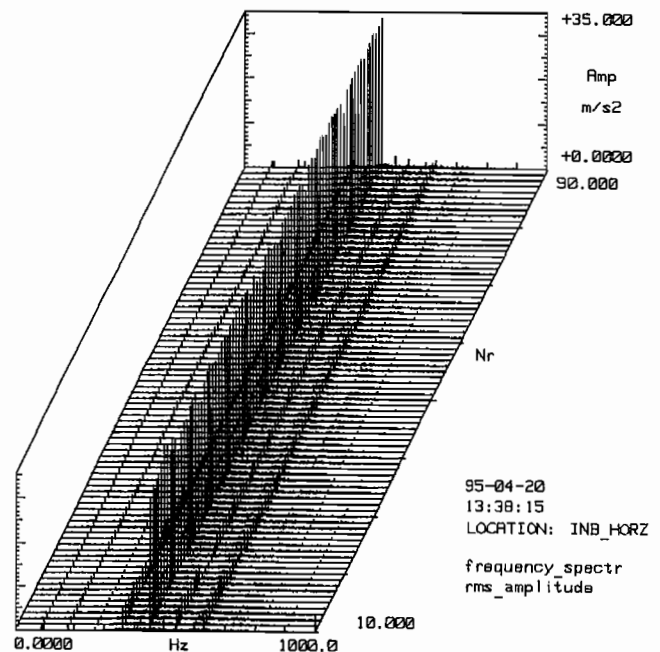
Figure 10. Bearing Housing Vibrations of Pump P-302 Versus Flowrate.

flow dependent. Figure 10 shows the vibration spectrograms while operating pump P-302 from minimum flow to full rated flow. No influence is observed.

Since the difference in vibration between fresh feed and recycle feed was large but not flow dependent, the elimination method for finding the root cause necessitated the following root causes to be verified by analysis, measurement, etc.

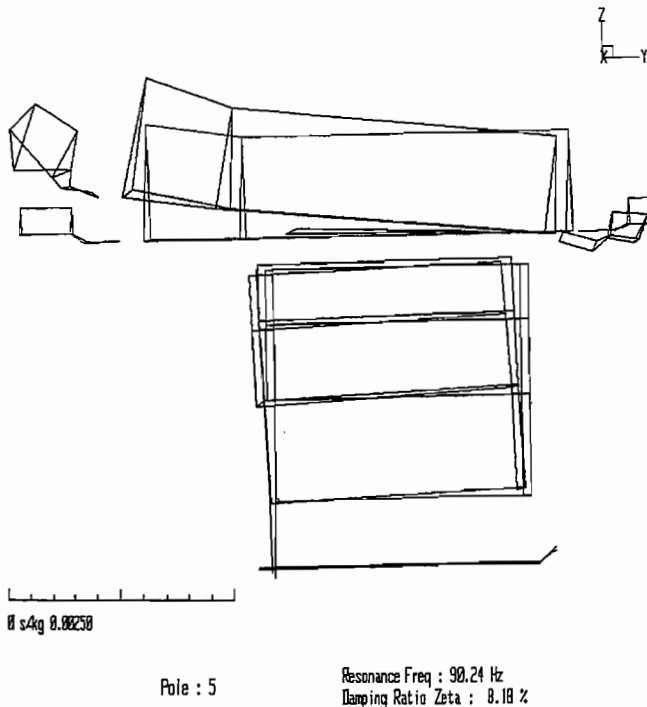
Figure 12. Modal Analysis of Pump P-302.

Figure 12 gives the mode shape of the 90.25 Hz mode, which shows large deformation of the inboard housing out of phase with the pedestal deformation.

Furthermore, a local bearing bracket resonance was found at 482 Hz. This resonance will be excited by vane passing forces if pump speeds are in the range of 5300 to 6300 rpm. By stiffening the brackets, a sufficient separation margin can be realized, avoiding an excitation of the resonance. Since all pumps are identical, the structural resonances of the pumps will occur at the same frequencies, with certain tolerances (bolting torque, material differences, temperature changes). Modifications to cope with resonance problems were proposed on all units as follows:

- Replacement of the five vane impellers by seven vane impellers for fourth and fifth stage of pumps P-301, P-302, and P-303 (recycle feedpumps)
- Geometry change of center bushing and balance bushing on all pumps to allow for interchangeability
- Replacement of pump support construction by pedestals mounted on a thick, rigid plate welded to the baseplate; implementation on all pumps, to eliminate pedestal resonances
- The barrel feet and bearing brackets will be replaced by new designs with increased stiffness on all pumps.

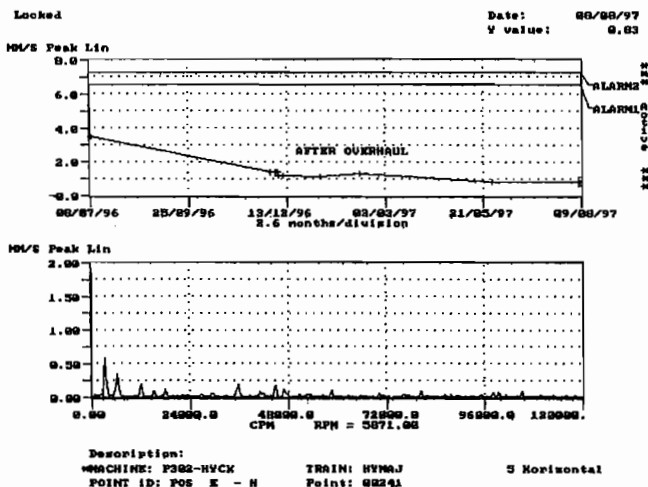
Figure 13. Pump P-302 Inboard Horizontal Vibrations after Overhaul.

All three pumps were commissioned satisfactorily, with minimal delay, and have operated completely trouble free. Vibration levels remain within the agreed limits (Figures 13 and 14) as has seal oil consumption. At the time of writing, P-301 has been in operation for approximately 2500 hours, P-302 for approximately 5000 hours, and P-303 approximately 90 hours.
