BOILER FEED WATER PUMPS PERFORMANCE LOSS

AMR MOHAMED GAD- RASGAS

29TH INTERNATIONAL PUMP USERS SYMPOSIUM

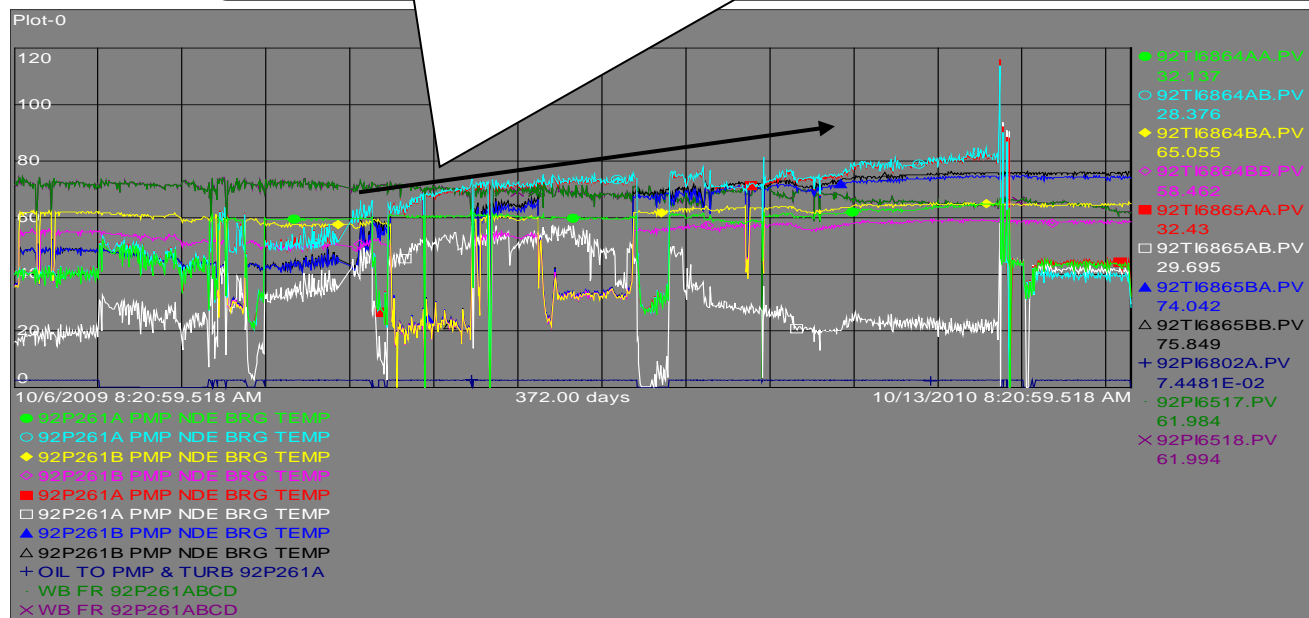
pump's thrust bearing temperature increase due to bearing degradation over one year – alarm level reached (85 deg C)

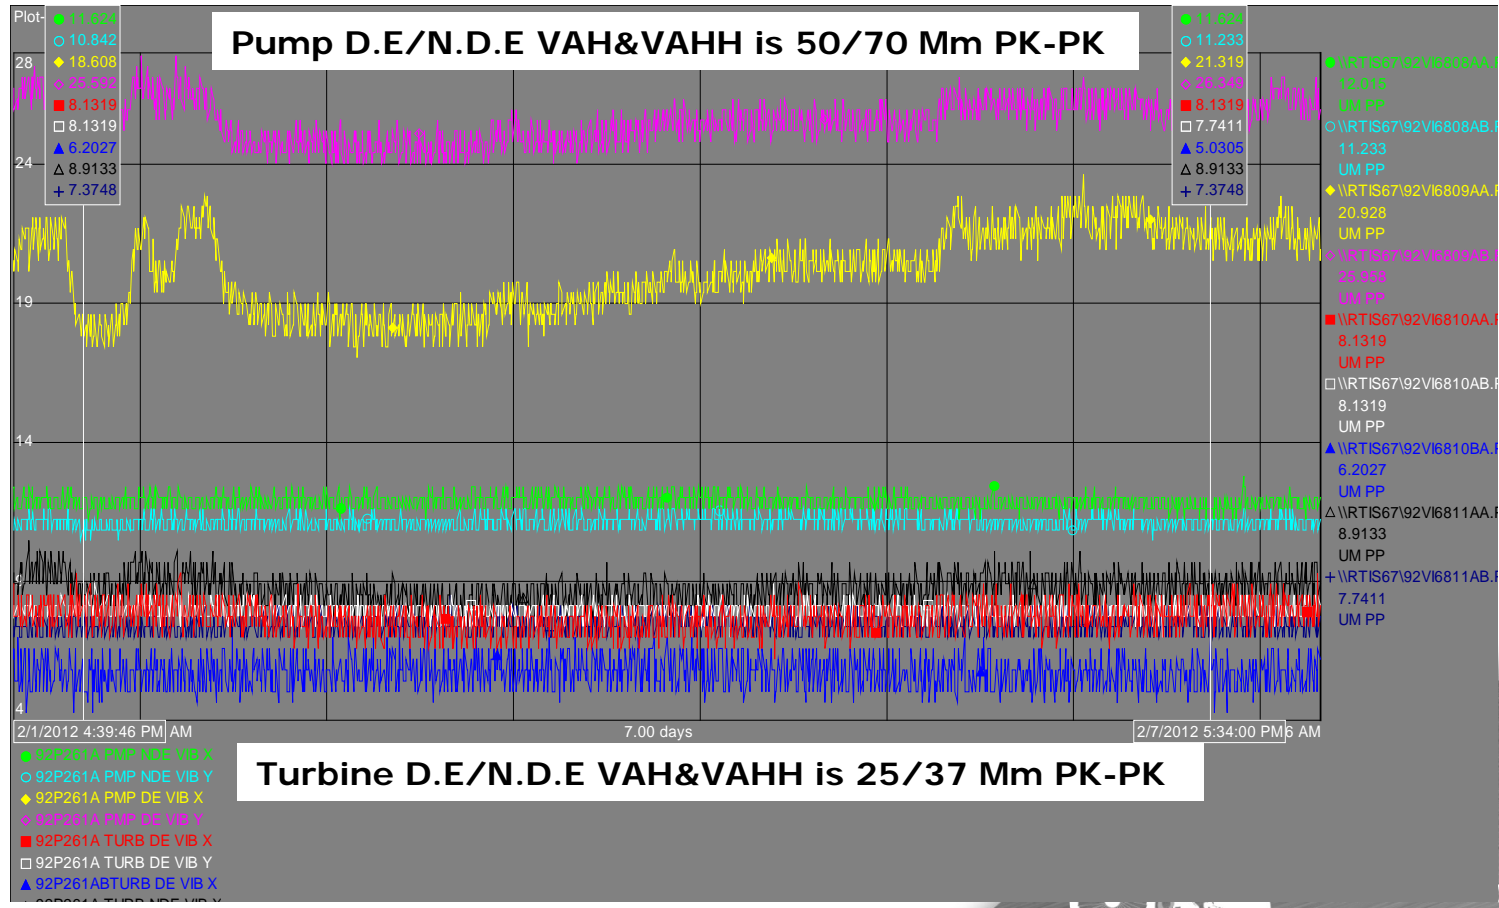
Pump D.E
radial vibration

Pump N.D.E
radial vibration

Turbine
D.E & N.D.E
radial vibration

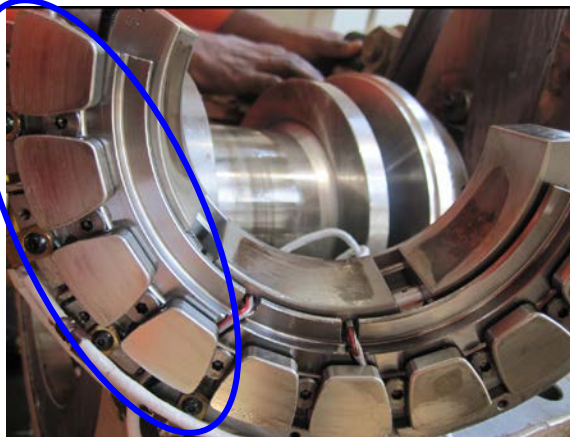
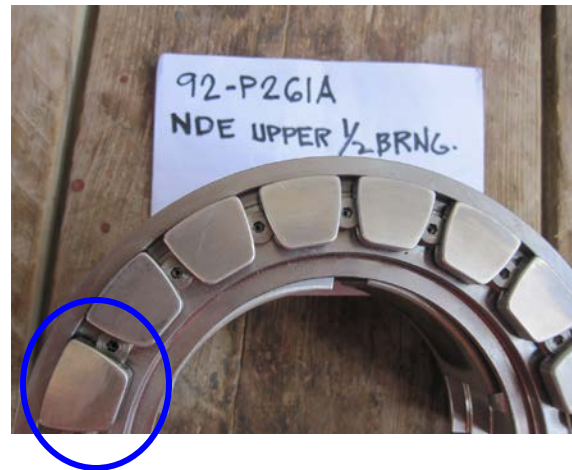
Thrust Bearing failure signs:

Scored and smeared thrust pads

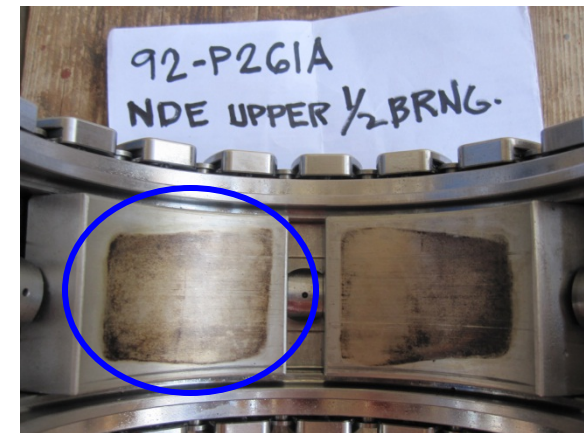
Smeared Journal pads

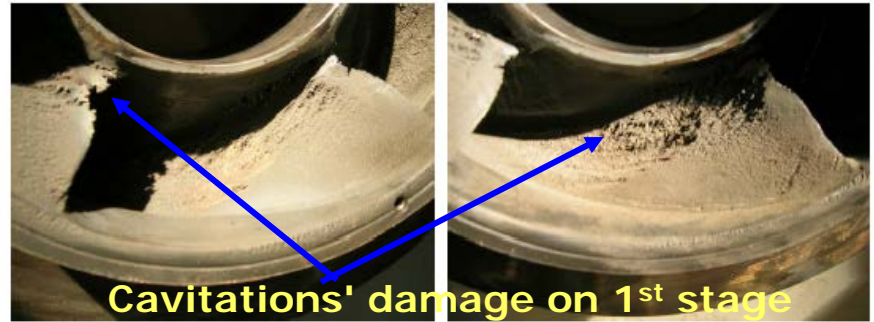
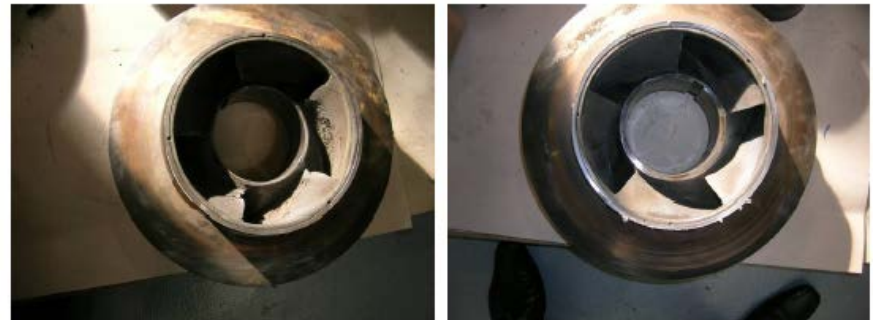
Casing erosion

- Root Cause (Human) - Incorrect material specification of the pump casing for boiler feed water service led to major damage of casing inner walls and rotor parts
- Contributing Factor 1 (Latent) – Insufficient online monitoring of pump performance due to inadequate instrumentation prevented effective pump health monitoring
- Contributing Factor 2 (Latent) – Inadequate surveillance program for boiler feed water conditions led to a possible corrosive environment within pump flow path

- Immediate action: Purchase x6 new BFWPs with 12%Cr Stainless Steel casings (A487CA6NM) and replace the existing pumps with carbon steel casing (A216 WCB)
- Medium action: Revise Equipment Strategy to perform bi-monthly online performance monitoring task including steam condensate dissolved oxygen and PH levels to ensure remaining within specification
- Long term action: Improve online monitoring:
 - Digital discharge pressure transmitter
 - Install flow measurement devices on the discharge and recirculation line

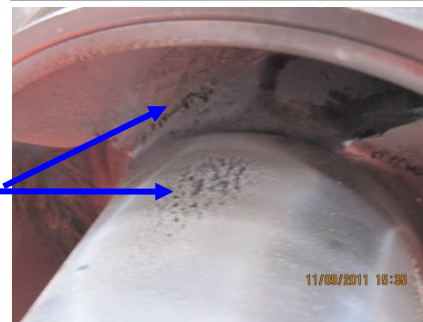
Cavitations' damage

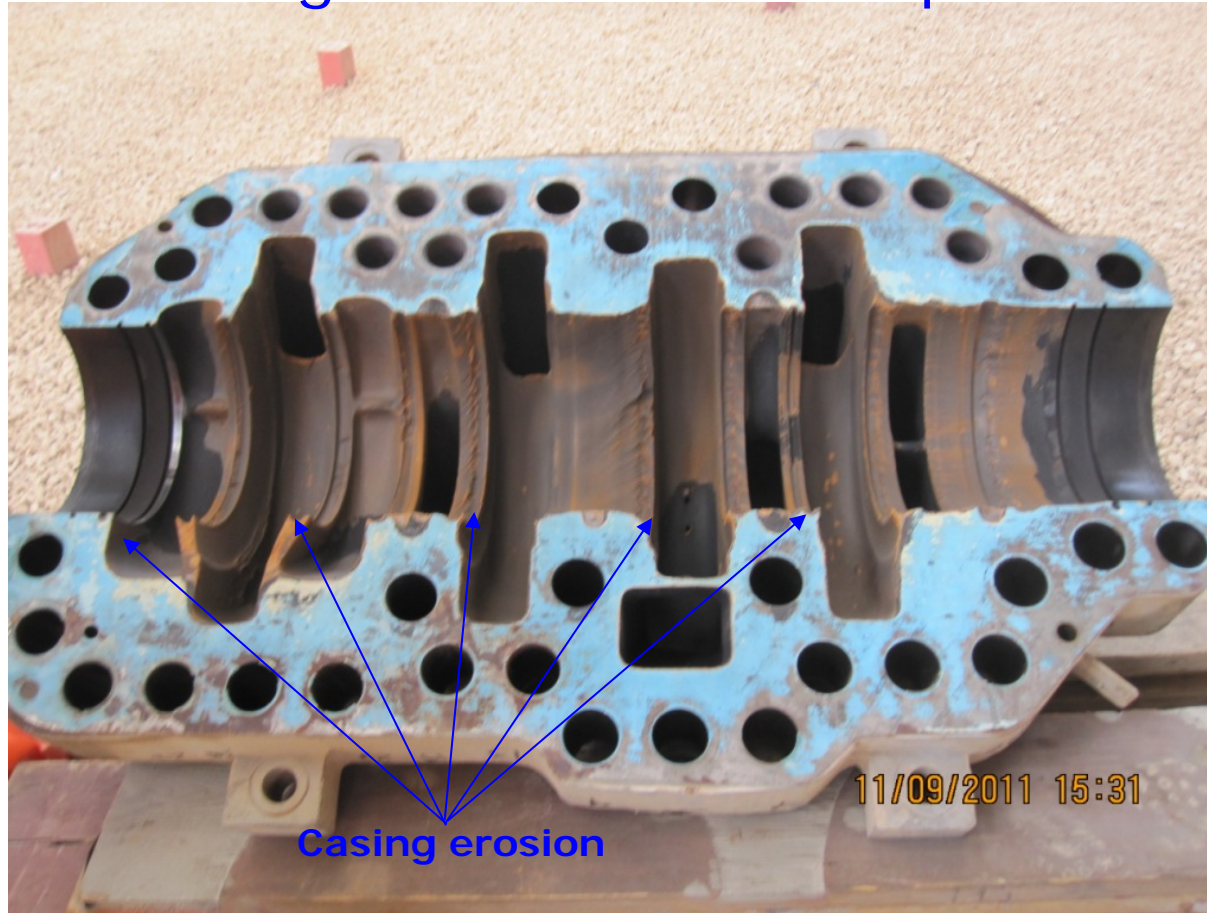
Casing erosion

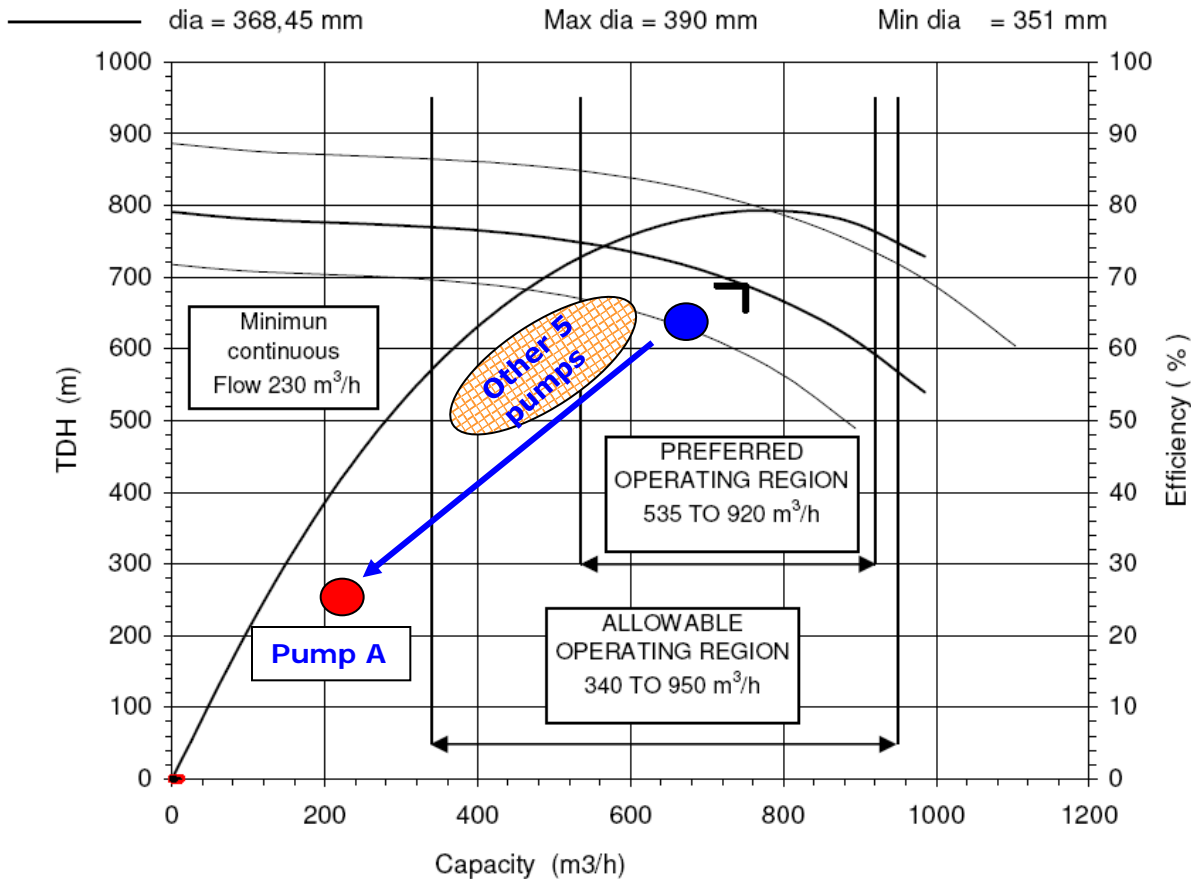
Optimum performance ● Deteriorated performance ● Other pumps performance ●

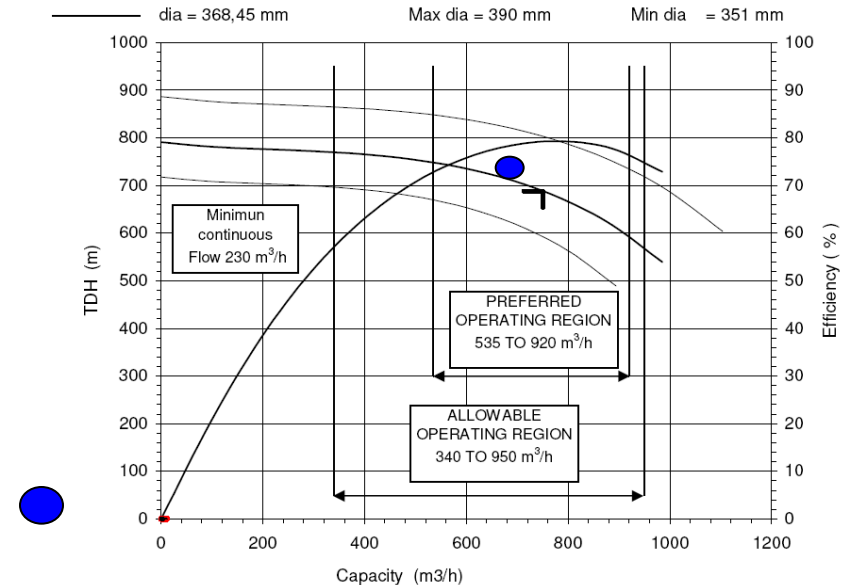
- Performance for the repaired 3 units as interim solution was similar to OEM design.
- Ultimate replacement of all pumps by new stainless steel casing's units results in operating the BFW system with reliable units as per OEM design.

Optimum performance
