Canned Motor Pump Failure

A Case History of Canned Motor Pump Failures – Demystifying the Thrust force

Vineet Jindal

Rotating Equipment Engineer – Shell Chemicals Seraya Pte Ltd , Singapore

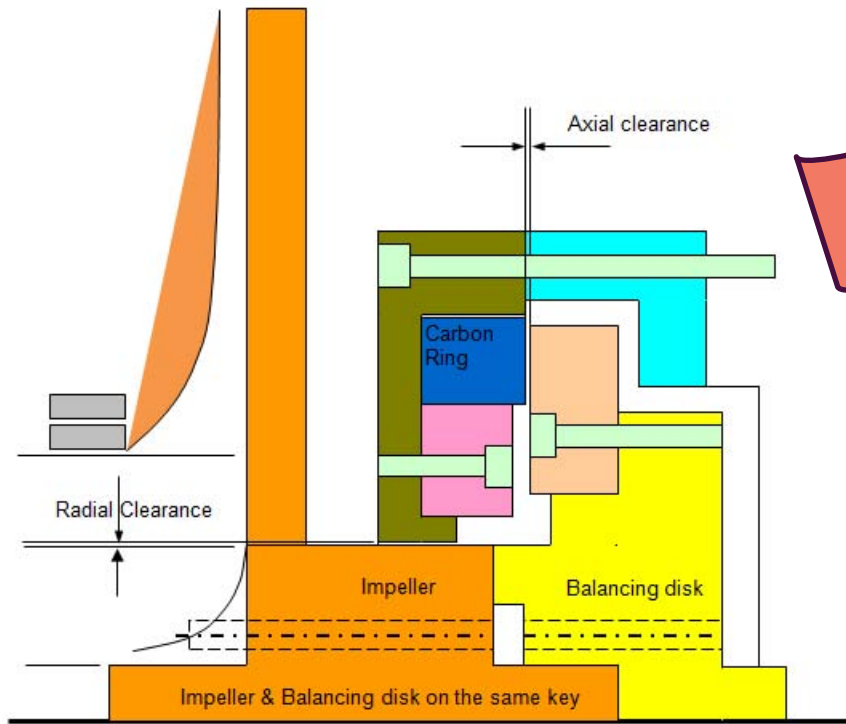
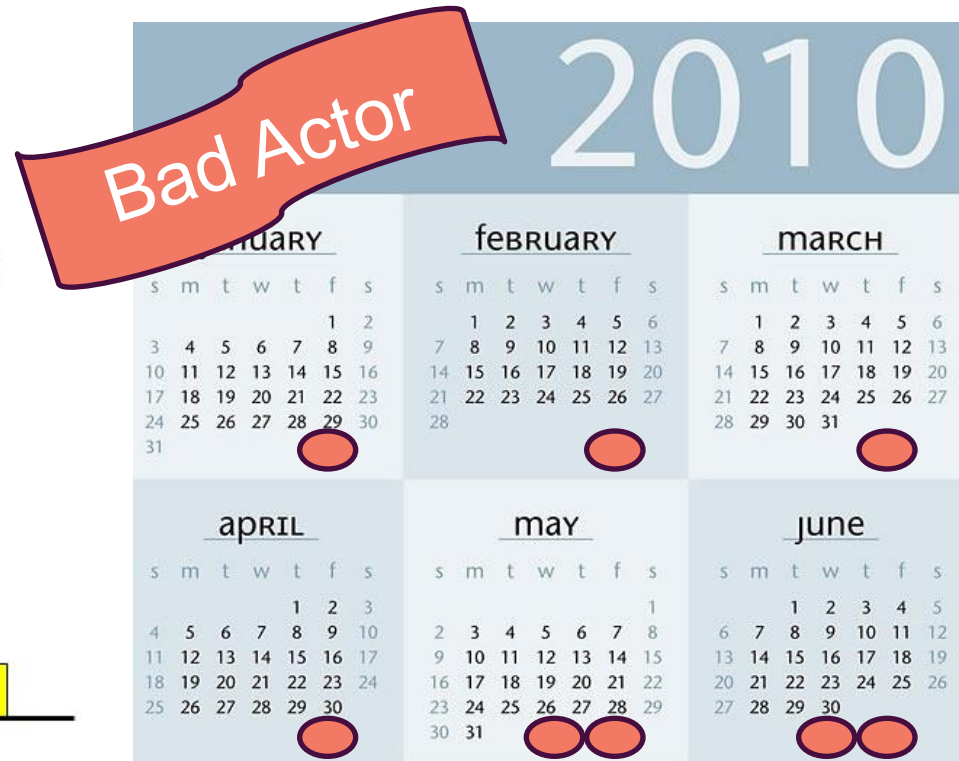
Problem Statement – Failure Mode

- In a typical failure mode, axial position will change and motor current will increase.
- The carbon ring would be found heavily rubbed & damaged

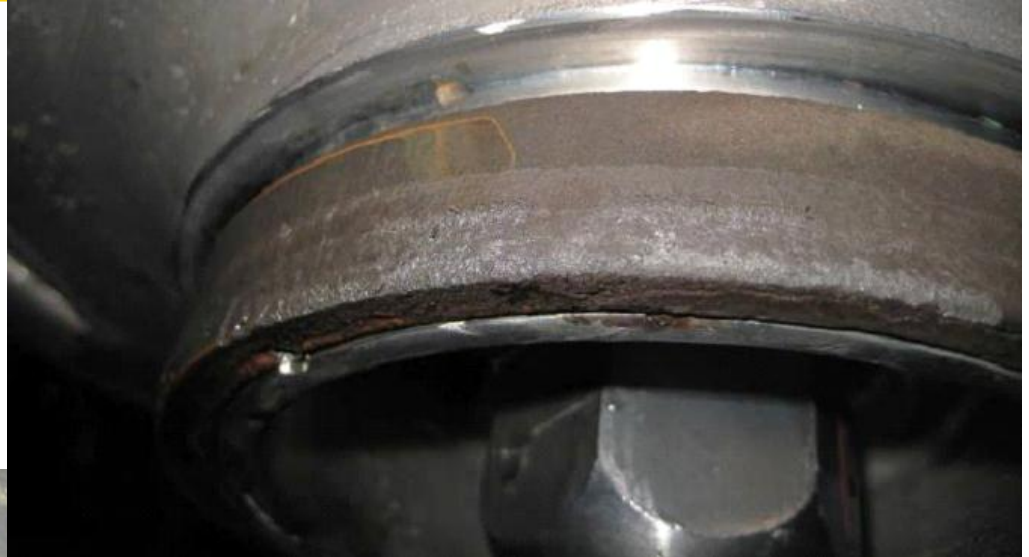
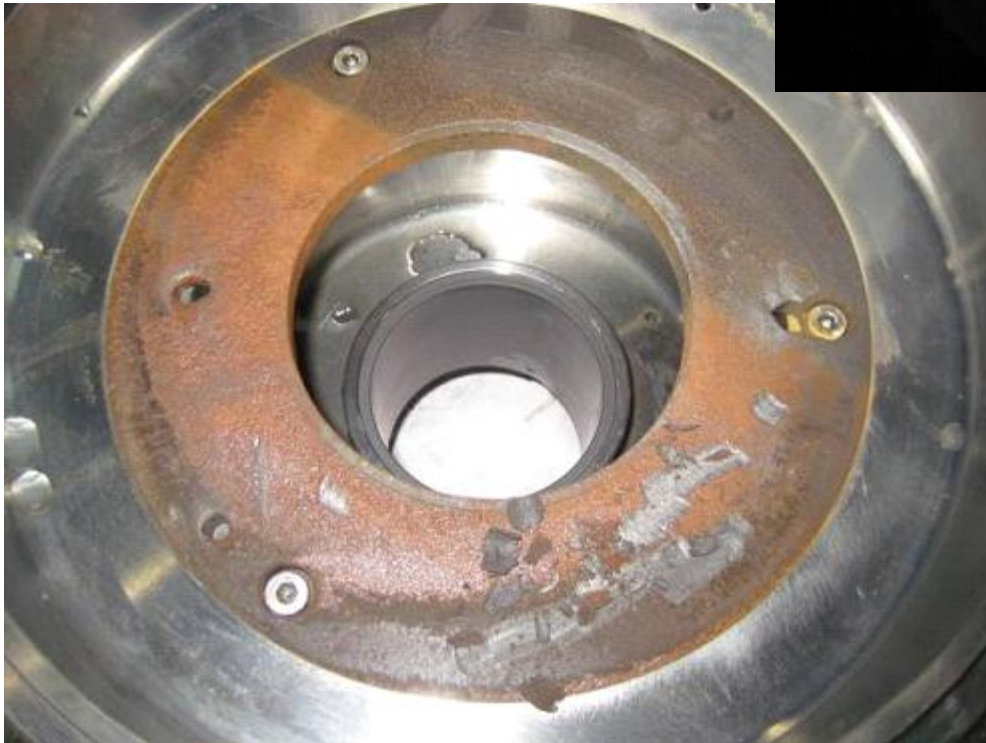
In July 2010 , a close look at the cast iron parts revealed a clue to the Mystery

- The wear rings on primary impeller were found soft as carbon.
- The secondary impeller back and front shrouds were found soft as a chalk!

A relook at the pumping medium revealed the following :
 The pump contains more than 85% of water by volume.
 Water being an excellent electrolyte , caused the “Galvanic Corrosion”

All cast iron components were replaced with SS 316 to prevent Galvanic Corrosion.
