# FINDING AND ELIMINATING CHRONIC PUMP FAILURES

**Clay Crook**

**Mechanical Supervisor**

**Motiva Enterprises LLC**

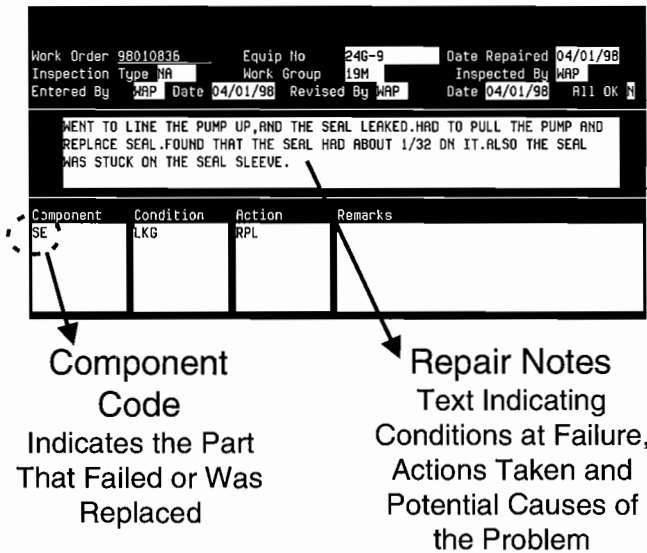
Figure 1. A Condition Report, Showing Component Codes and Repair Notes.

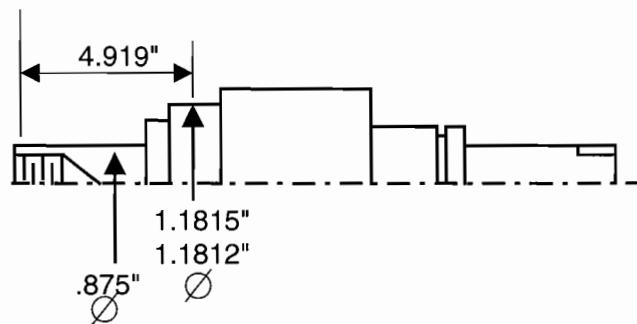
First on the list was excessive movement of the pump shaft. To get an idea of the amount of shaft movement, the  $L^3/D^4$  ratio was calculated for the pump (Figure 2).  $L$  in this shaft was 4.919 inches, the distance from the end of the shaft to the center of the radial bearing.  $D$ , the diameter of the shaft under the packing sleeve, was 0.875 inches. The  $L^3/D^4$  ratio was 203, indicating a very flimsy shaft. In a perfect world, the  $L^3/D^4$  ratio will be under 30. The bottom line is that  $L^3/D^4$  should be as small as possible. A flimsy shaft on a pump will cause a great deal (more than 0.002 inch) of shaft movement at the seal. If the pump is run off its best efficiency point, there will be even more movement for the seal to contend with.

Figure 2. Diagram of the Water Wash Circulation Pump Shaft, Showing the Dimensions Used in the  $L^3/D^4$  Ratio.

The pump has now run for two years without failure. For the years 1997 and 1998 there were no maintenance dollars spent on pump repairs. The root cause of the problem on the seal was excessive movement of the shaft under the seal, a faulty design. Even with little historical information to start with, classifying the available notes by the agents of failure put the troubleshooter in the right place to solve the chronic seal problems.

Corrective action meant redesigning the shaft to get rid of the packing sleeve. Stated another way, the shaft diameter in the seal area had to be increased. The new diameter was 1.125 inches, bringing the  $L^3/D^4$  ratio down to 74, meaning the stiffness of the shaft increased by a factor of three. A new shaft was built, costing 100\$/hp. Total expenditure on the pump so far was 580\$/hp, short of the 960\$/hp justified by the life cycle cost to upgrade this pump. The redesigned shaft was installed when the upgraded seal failed after a six month run time.

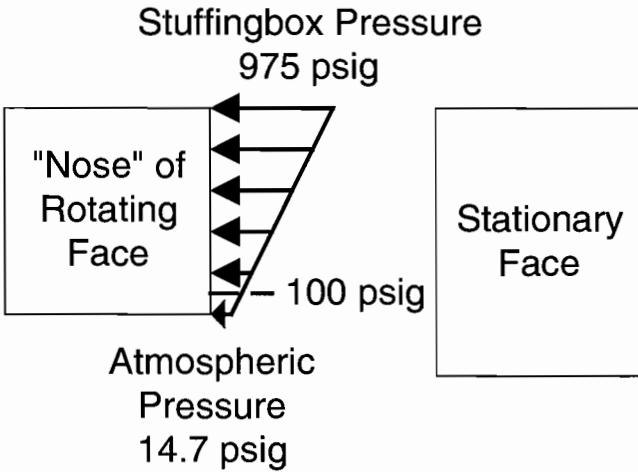
Excessive temperature can cause the liquid needed for seal lubrication to evaporate. Like any other wear parts, lack of lubrication of seal faces will cause wear and rapid failure. Repair notes mentioned melted and brittle O-rings, implying that excessive temperature was present. Field temperature measurements of the outside of the stuffing box and of the gland typically were over 300°F. Estimating that the pressure of the fluid declined linearly between the stuffing box side and the atmospheric side of the seal face (Figure 3), at least 10 percent of the seal face could be expected to have steam in between the faces. In other words, every place on the seal face below 100 psig and at

temperature of 300°F would have steam as the lubricant. In addition, as the fluid makes the phase change, the gas will expand and further reduce the contact area that is being lubricated. Since the pump had an API Plan 32 seal flush system, high temperature indicated a faulty design or the unintended operation of a seal flush system. Testing this idea required taking a temperature profile of the inlets and outlets of the seal flush cooler.

Figure 3. Sketch of the Estimated Pressure Drop Across the Seal Contact Area.

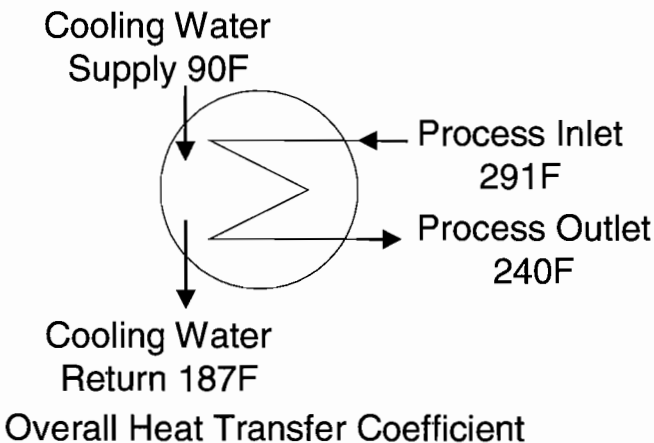
Using the standard Fourier equation for heat exchangers ( $Q = U \cdot A \cdot \text{LMTD}$ ), and the temperatures shown in Figure 4, the calculated overall heat transfer coefficient ( $U$ ) of the seal flush cooler was 99 Btu/(hr-ft<sup>2</sup>-°F). The exchanger supplier confirmed that the cooler was fouled, because  $U$  should be 250 Btu/(hr-ft<sup>2</sup>-°F) for an unplugged cooler in a water-to-water service. In perfect operation, the cooling water outlet temperature would still be well above the 140°F that the supplier recommended for the flush cooler used on the scrubber bottoms pump. Even with treated cooling water, water side temperatures above 140°F cause fouling of the coils of most off-the-shelf seal flush coolers. The higher the temperature above 140°F, the faster the fouling occurs.

Figure 4. Process and Cooling Water Temperatures Used to Calculate the Overall Heat Transfer Coefficient.

The root cause of the pump failures was faulty design. In this case, faulty design of the seal flush system. Extensive condition reporting made it possible to quickly converge on the root cause of the chronic failures.

To correct this design of the seal flush system, a finned tube exchanger with a much larger surface area for cooling the Plan 32 flush was selected and installed. Nearly the entire life cycle cost of 229\$/hp would be needed to install the larger exchanger. With the extensive failure history and life cycle costs, management approved capital money to correct the root cause of the failures.

After installation of the larger exchanger, flush temperature reaching the gland was less than 90°F. Gland temperature fell to 100°F. A lowered gland temperature allowed for improved operator surveillance. If the flush is working, the operator can touch the seal gland without gloves and not fear a burn. In the three years since the larger cooler was implemented, the yearly cost per horsepower has fallen to zero in 1998. The same pump that failed nine seals in 1994 has failed only once since 6/96.
