Pipe Strain - *Pump Case Distortion*

Case Study:

Induced pump case distortion due to excessive misalignment of the suction piping flange connection.

Chuck Lyons – IMI Technologist

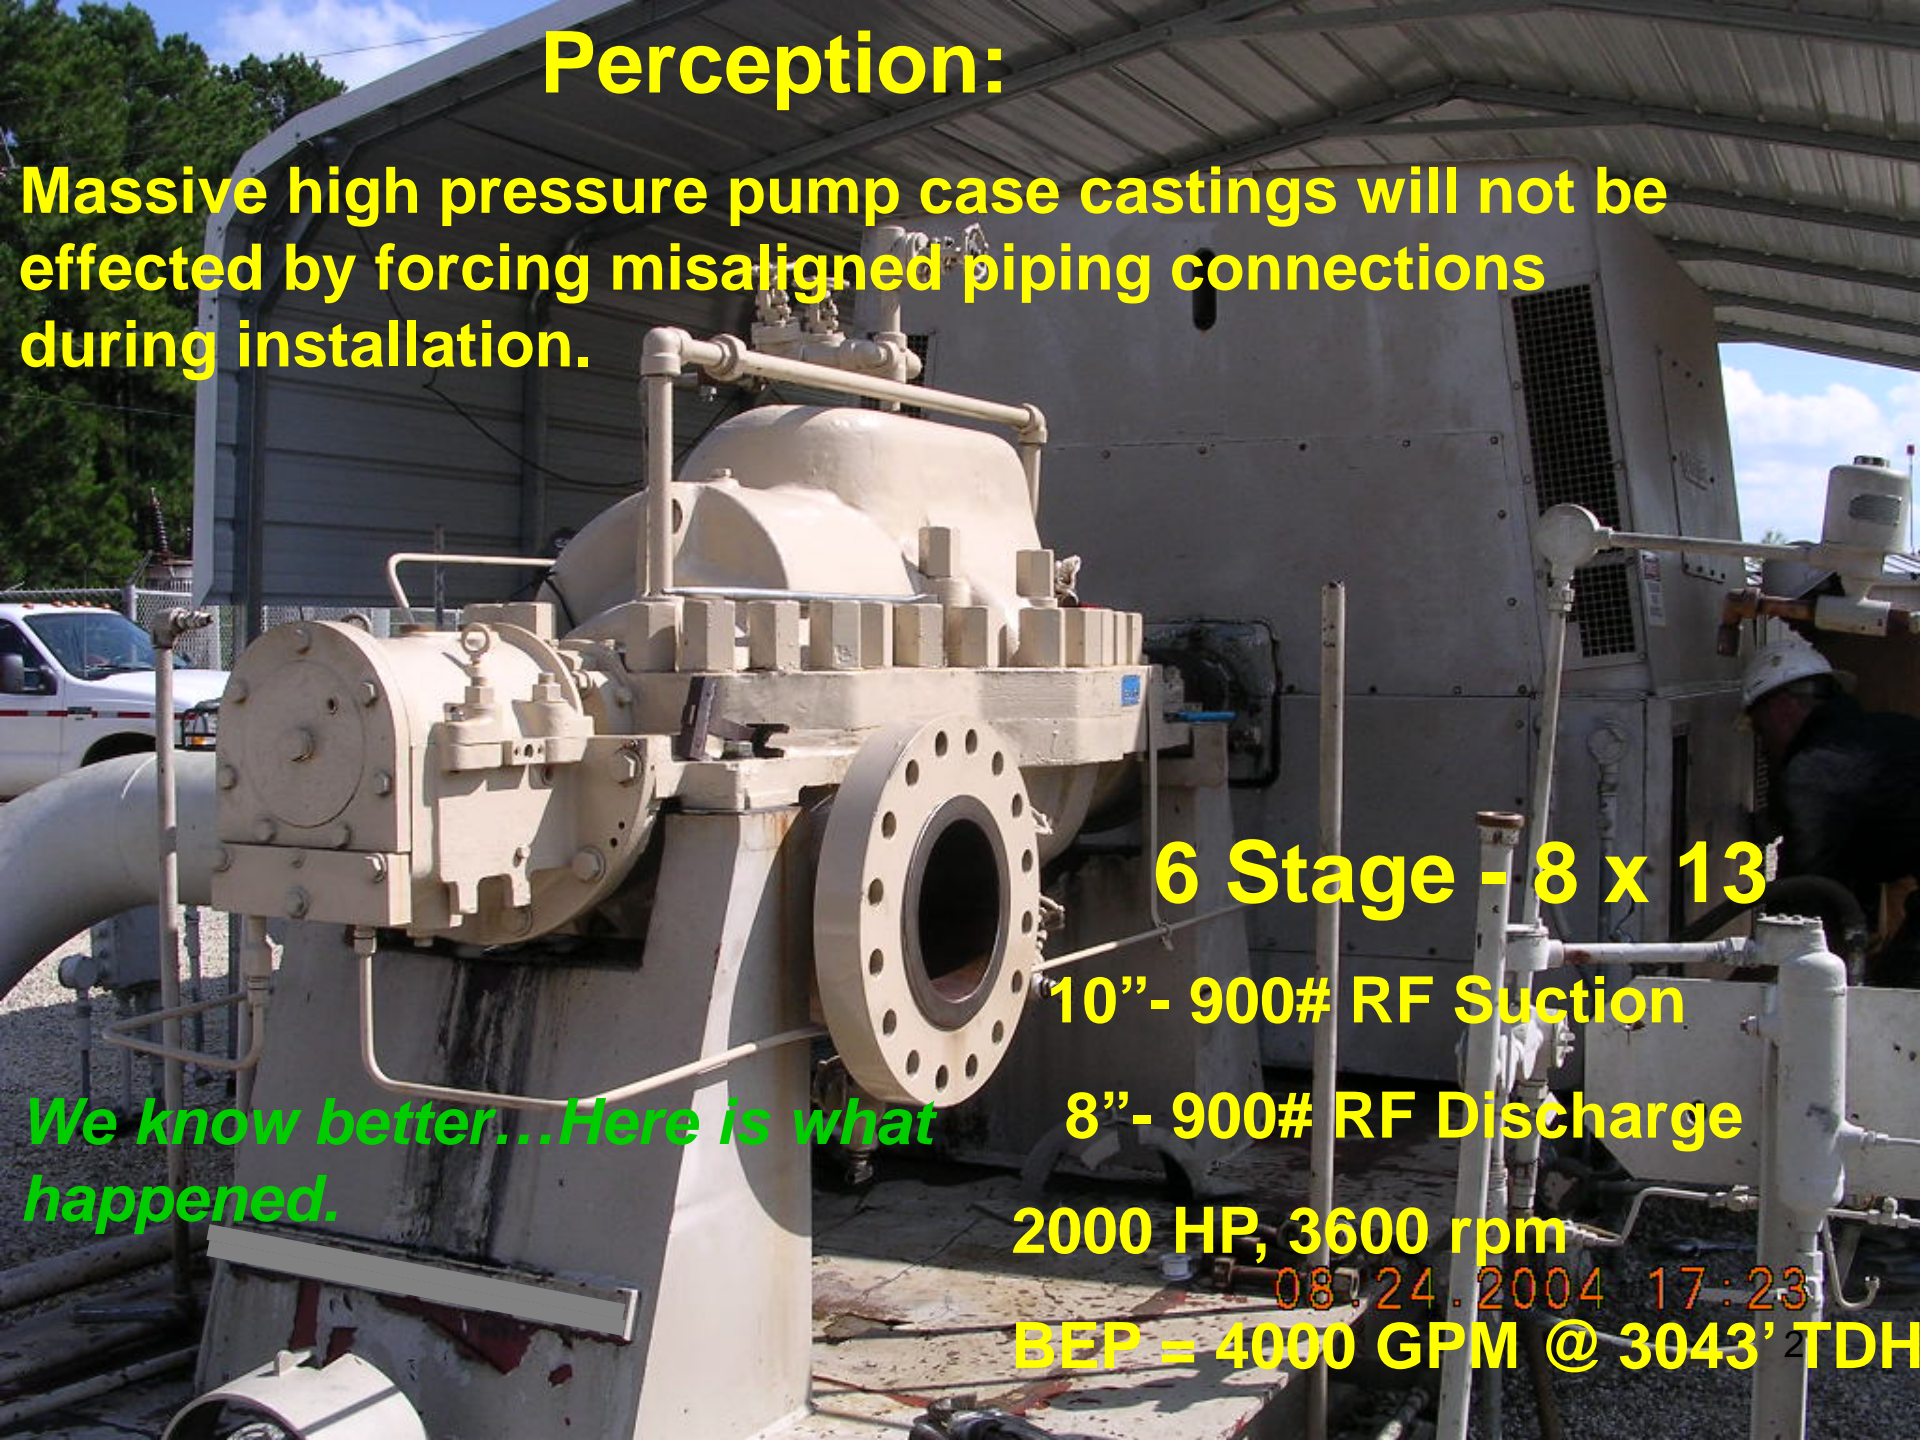
6 Stage - 8 x 13

10"- 900# RF Suction

8"- 900# RF Discharge

2000 HP, 3600 rpm

BEP = 4000 GPM @ 3043' TDH

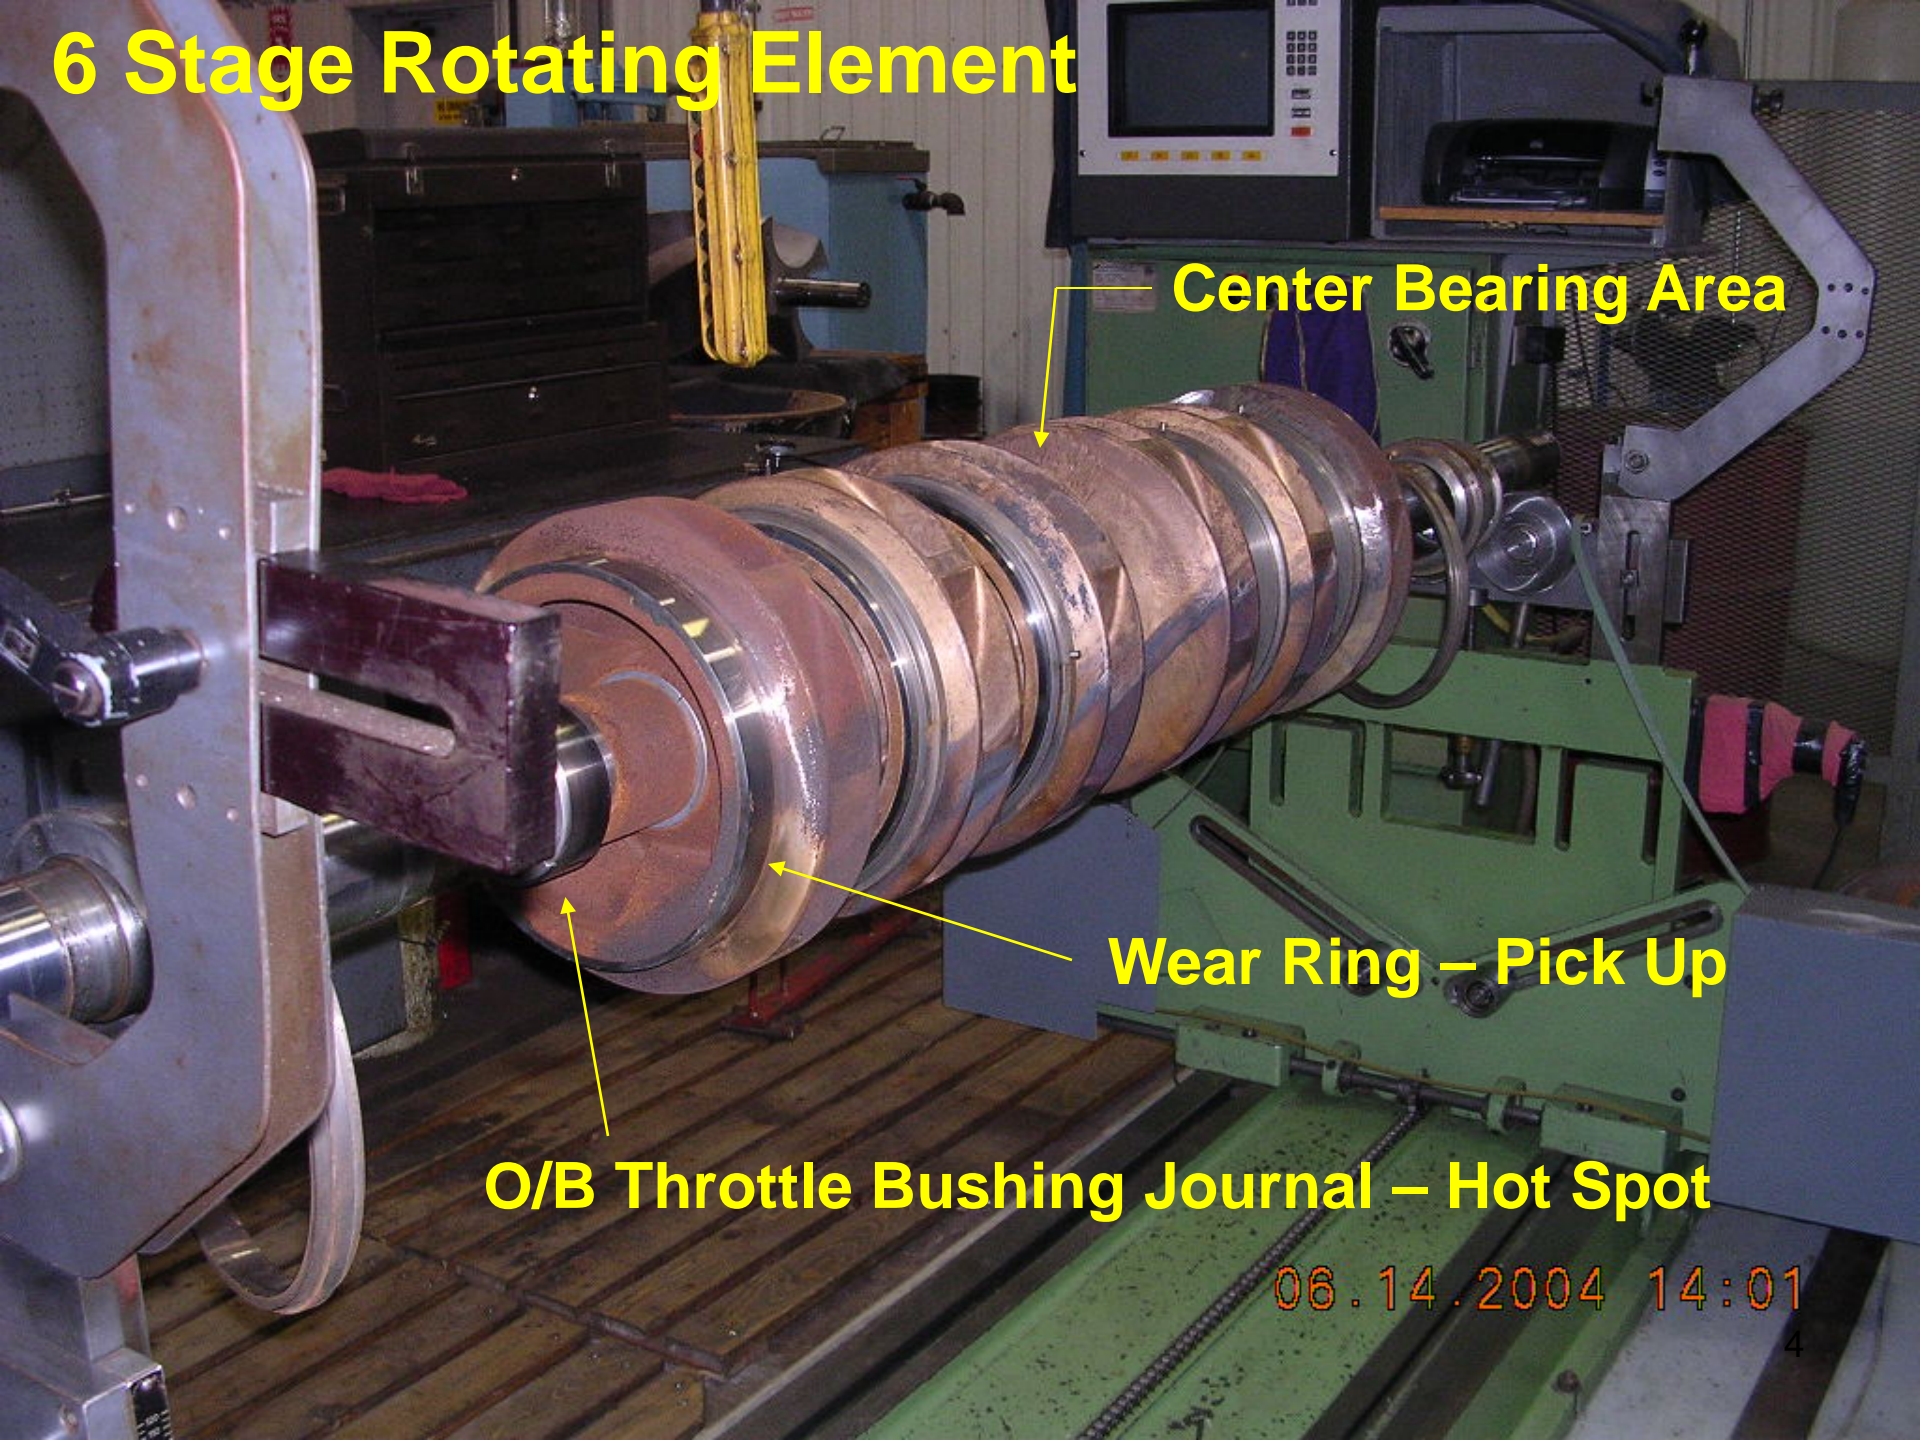
6 Stage Rotating Element

- **Case distortion / rotor damage limited from the O/B suction end of pump to center bearing area. I/B bearing had a small shiny area.**
- **Rotor checked OK for run out and straightness.**
- **Case / bearing housings assembled and boring mill checked. All surfaces concentric and perpendicular to shaft centerline.**

- Pump case required no repairs.
- Center bearing bushing skim cut to remove high spots – reused.
- Rotor – Center bearing journal and throttle bushing journal skim cut and polished. Radial bearing journals and wear rings polished – Rotor reused.
- O/B radial bearing, thrust bearings and O/B throttle bushing replaced. I/B radial bearing and throttle bushing reused.
- Mechanical seals were replaced.

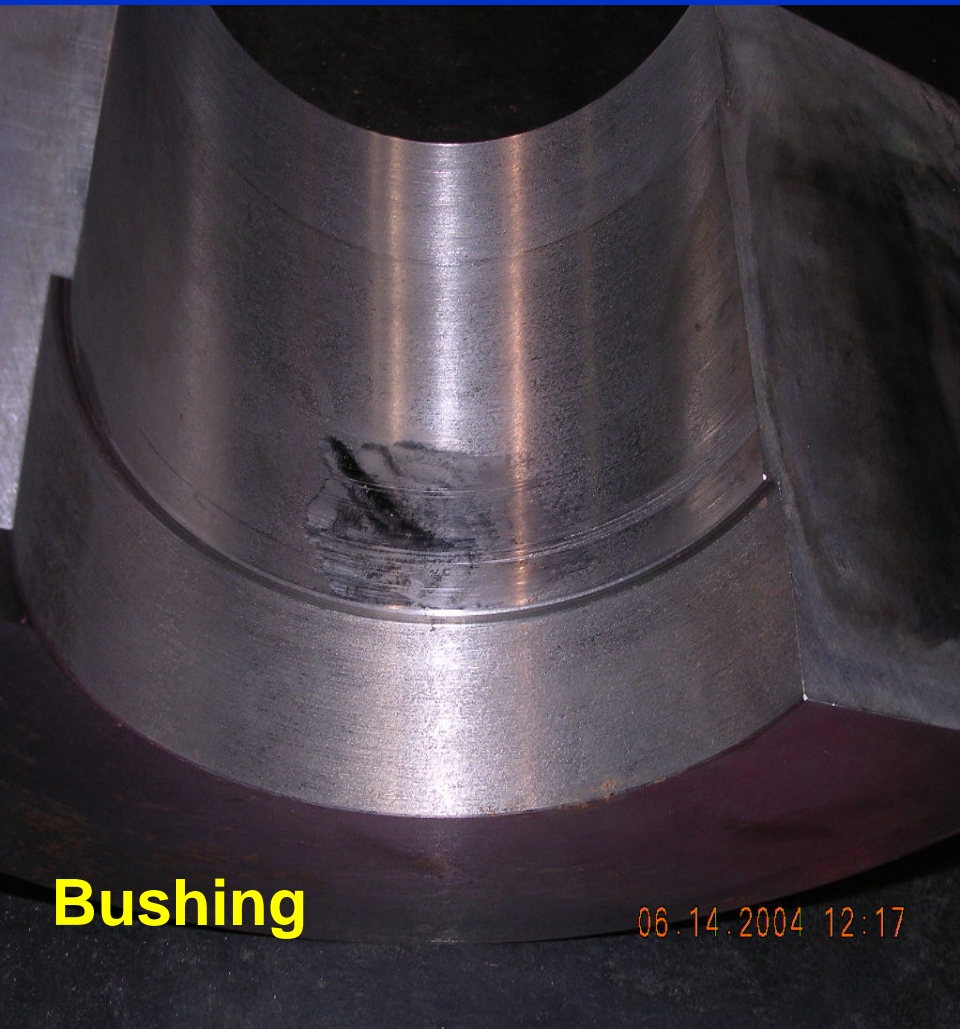
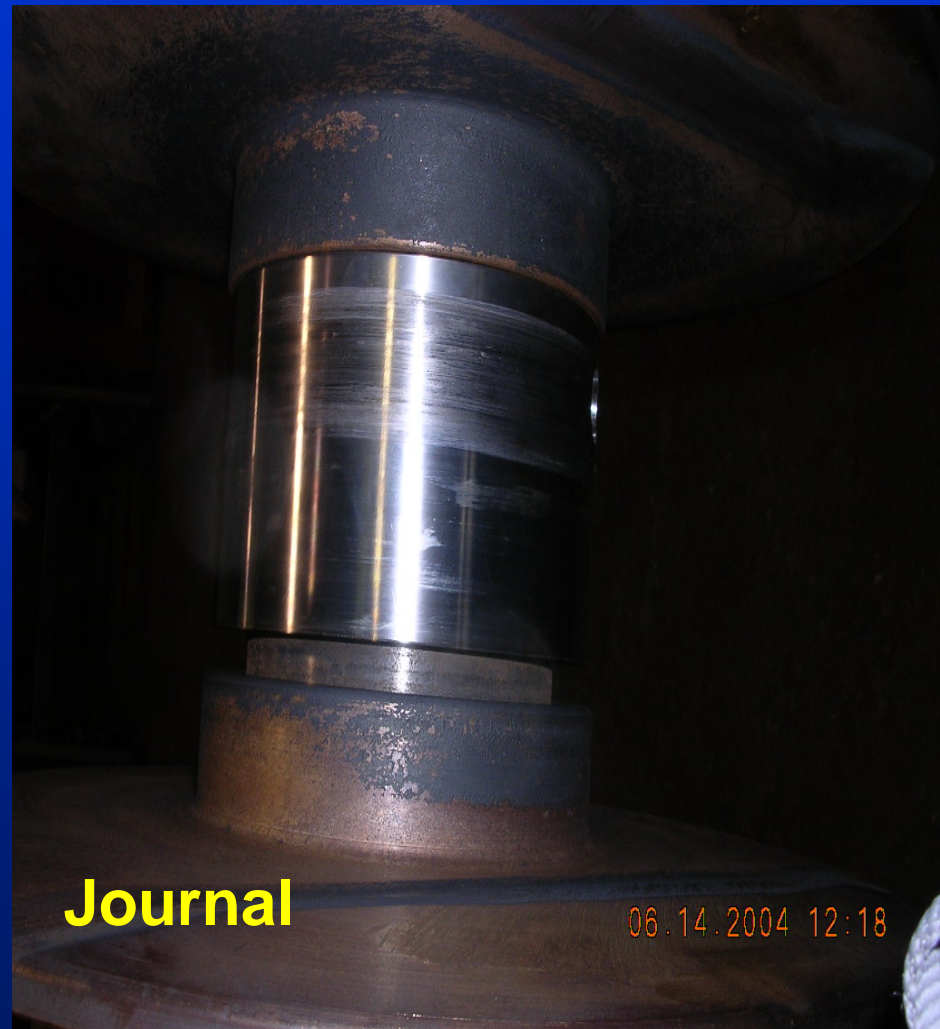
Center Bearing

Pump Case – O/B End

2 Minutes of Run Time

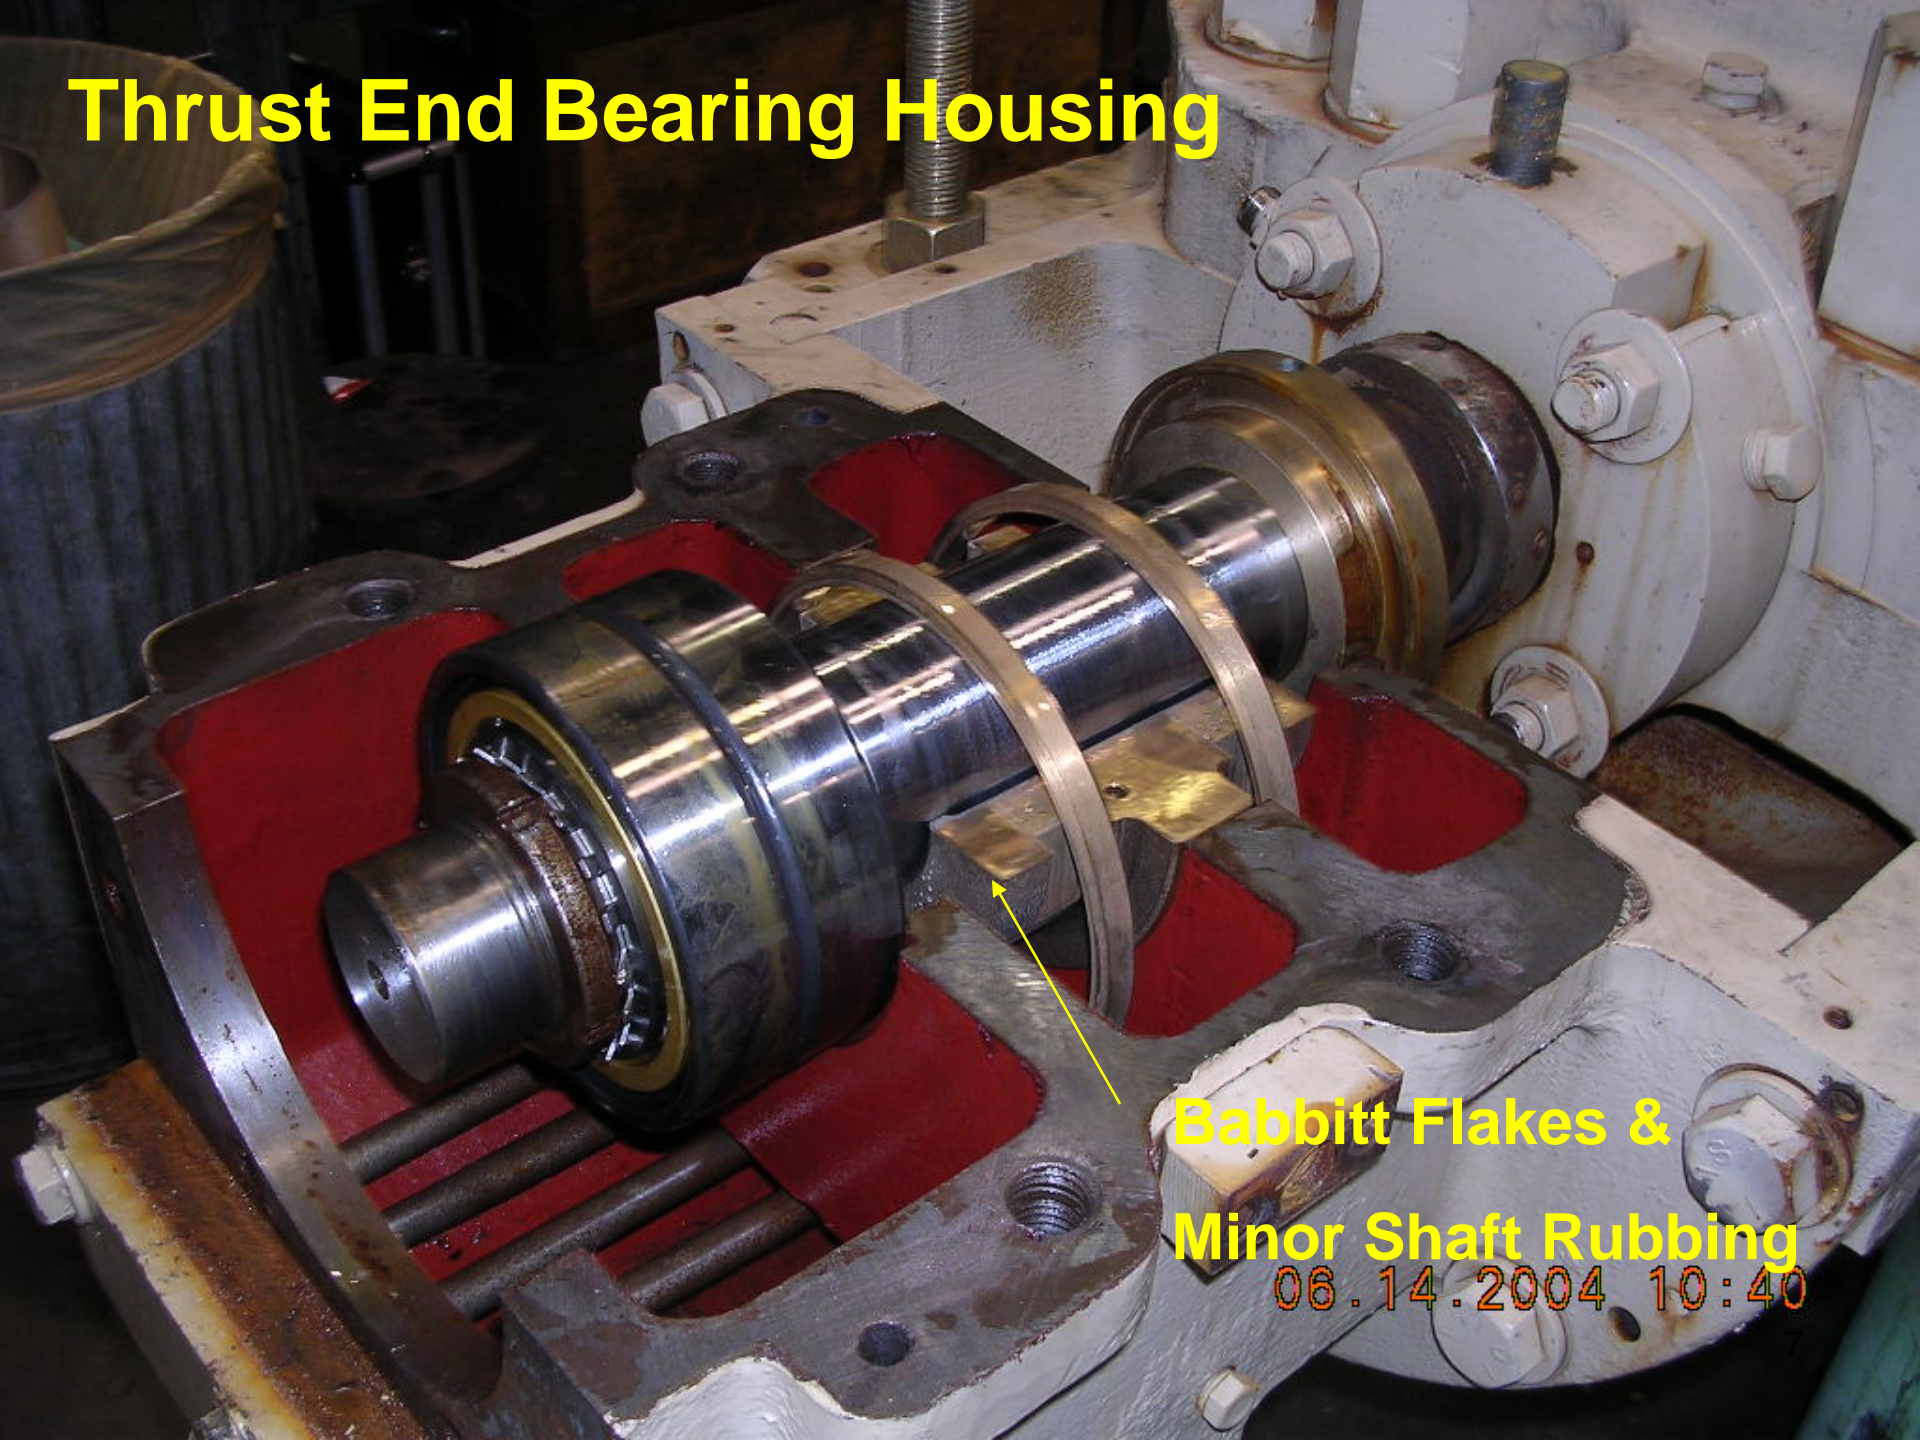
Thrust End Bearing Housing

Babbitt Flakes &
Minor Shaft Rubbing

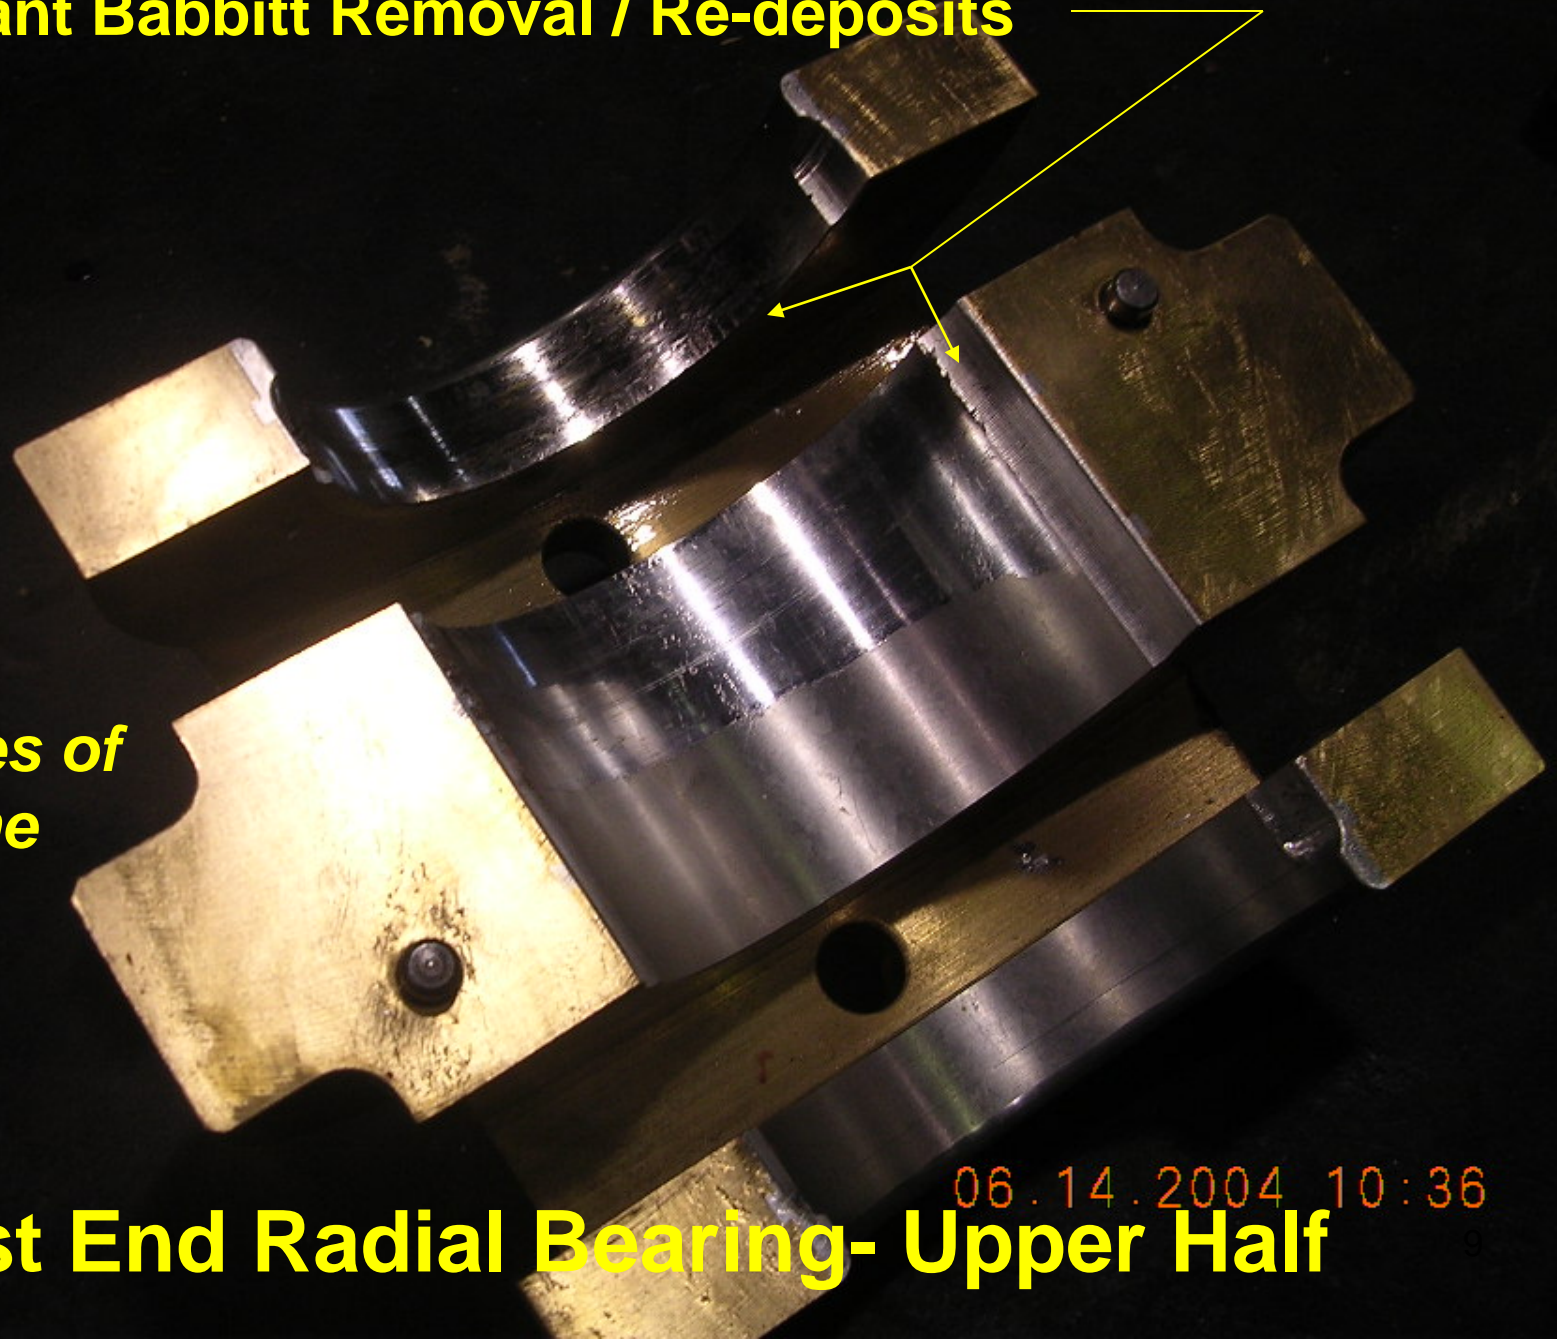
Thrust End Radial Bearing- Upper Half

Significant Babbitt Removal / Re-deposits

***2 Minutes of
Run Time***

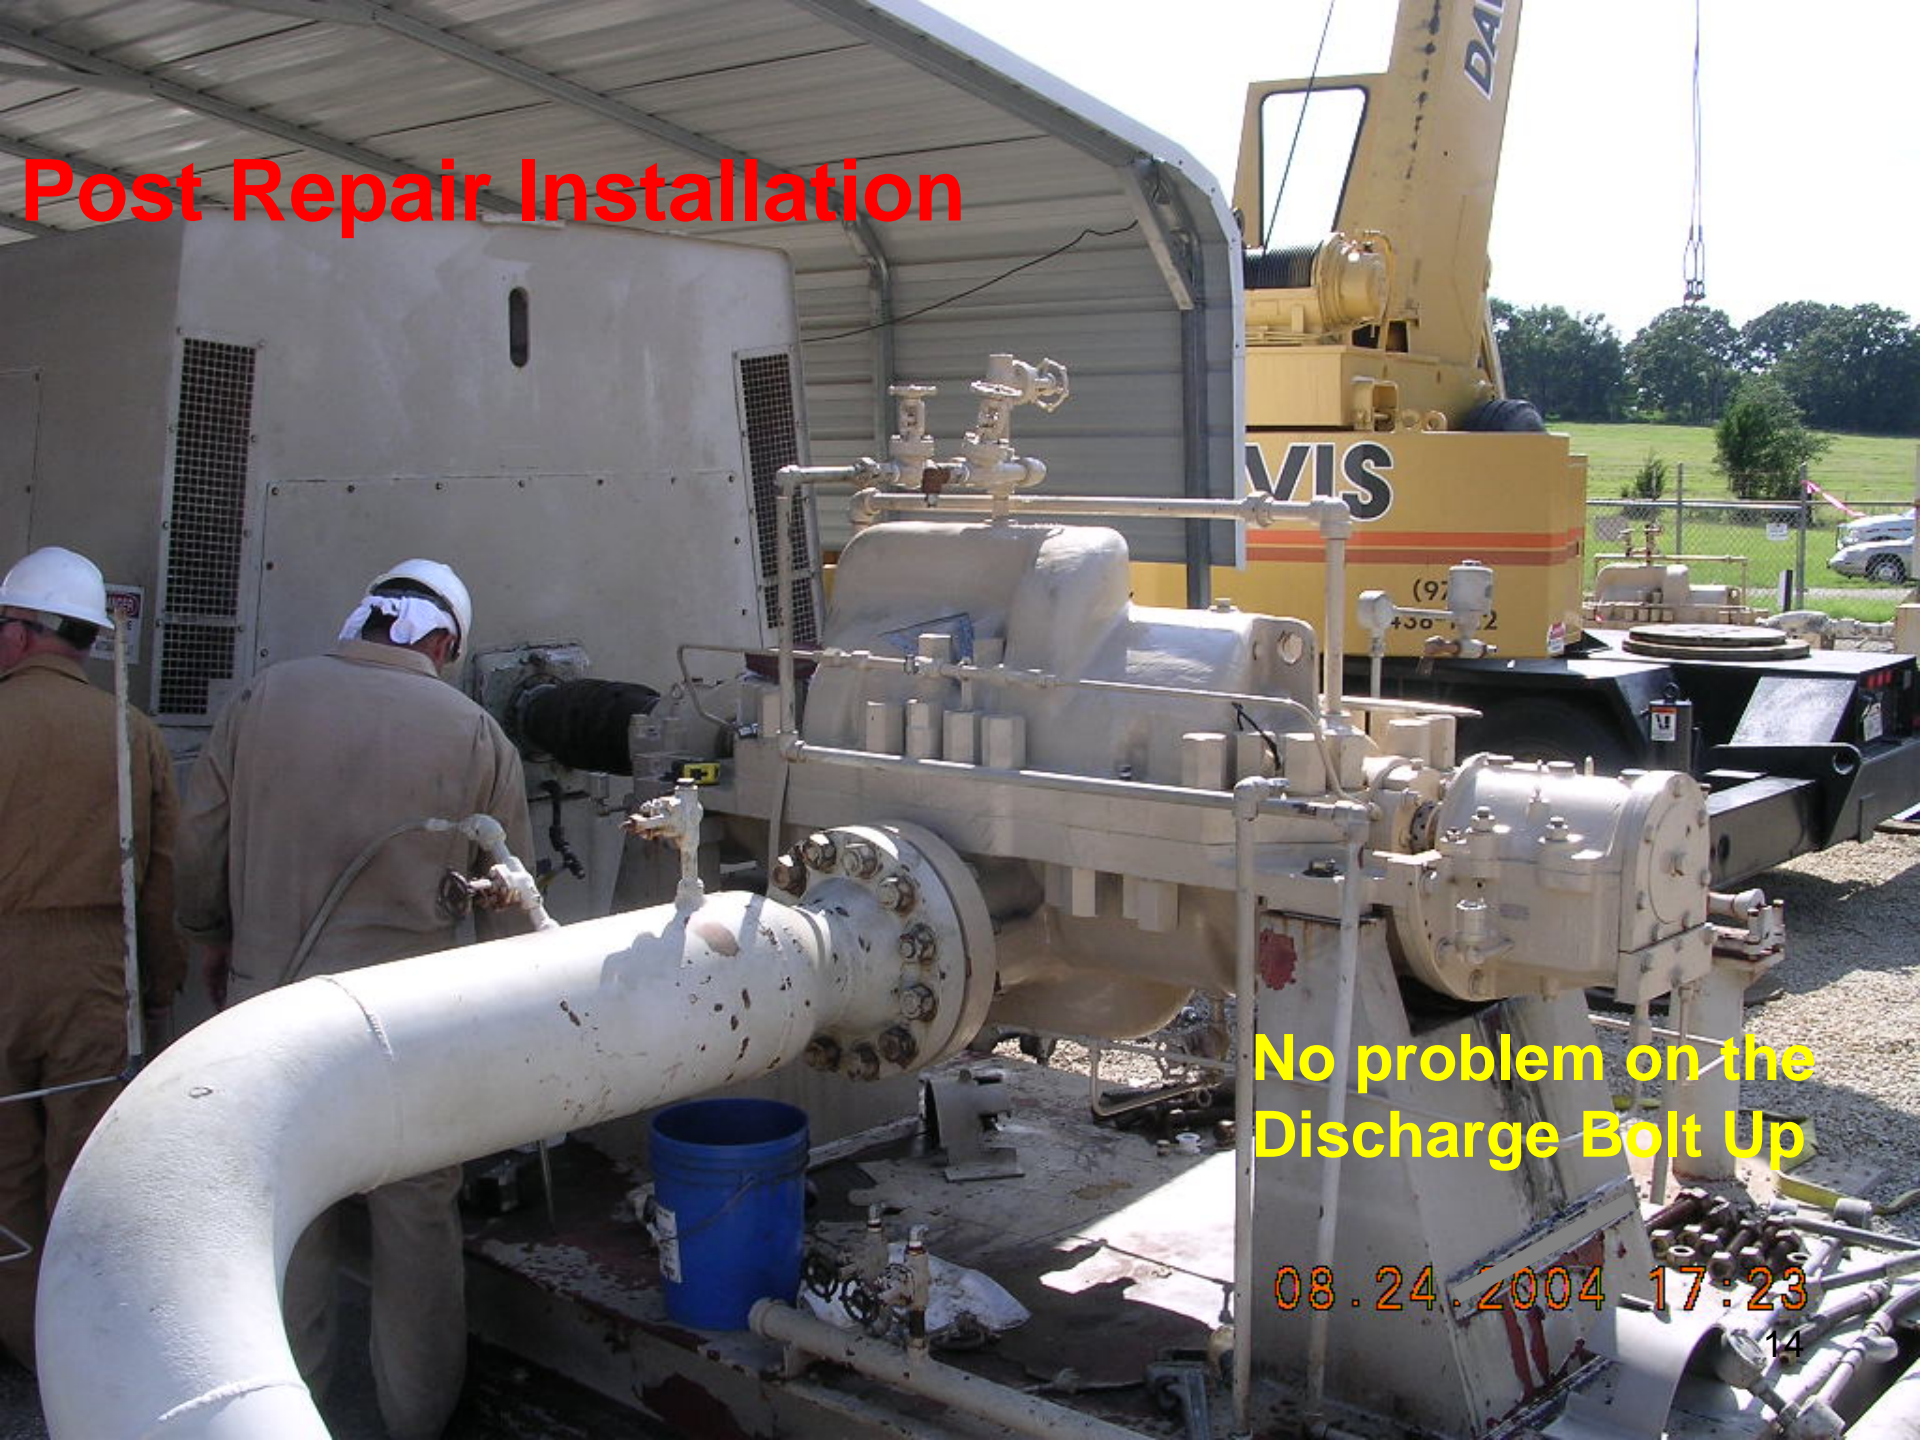
Post Repair Installation

No problem on the
Discharge Bolt Up

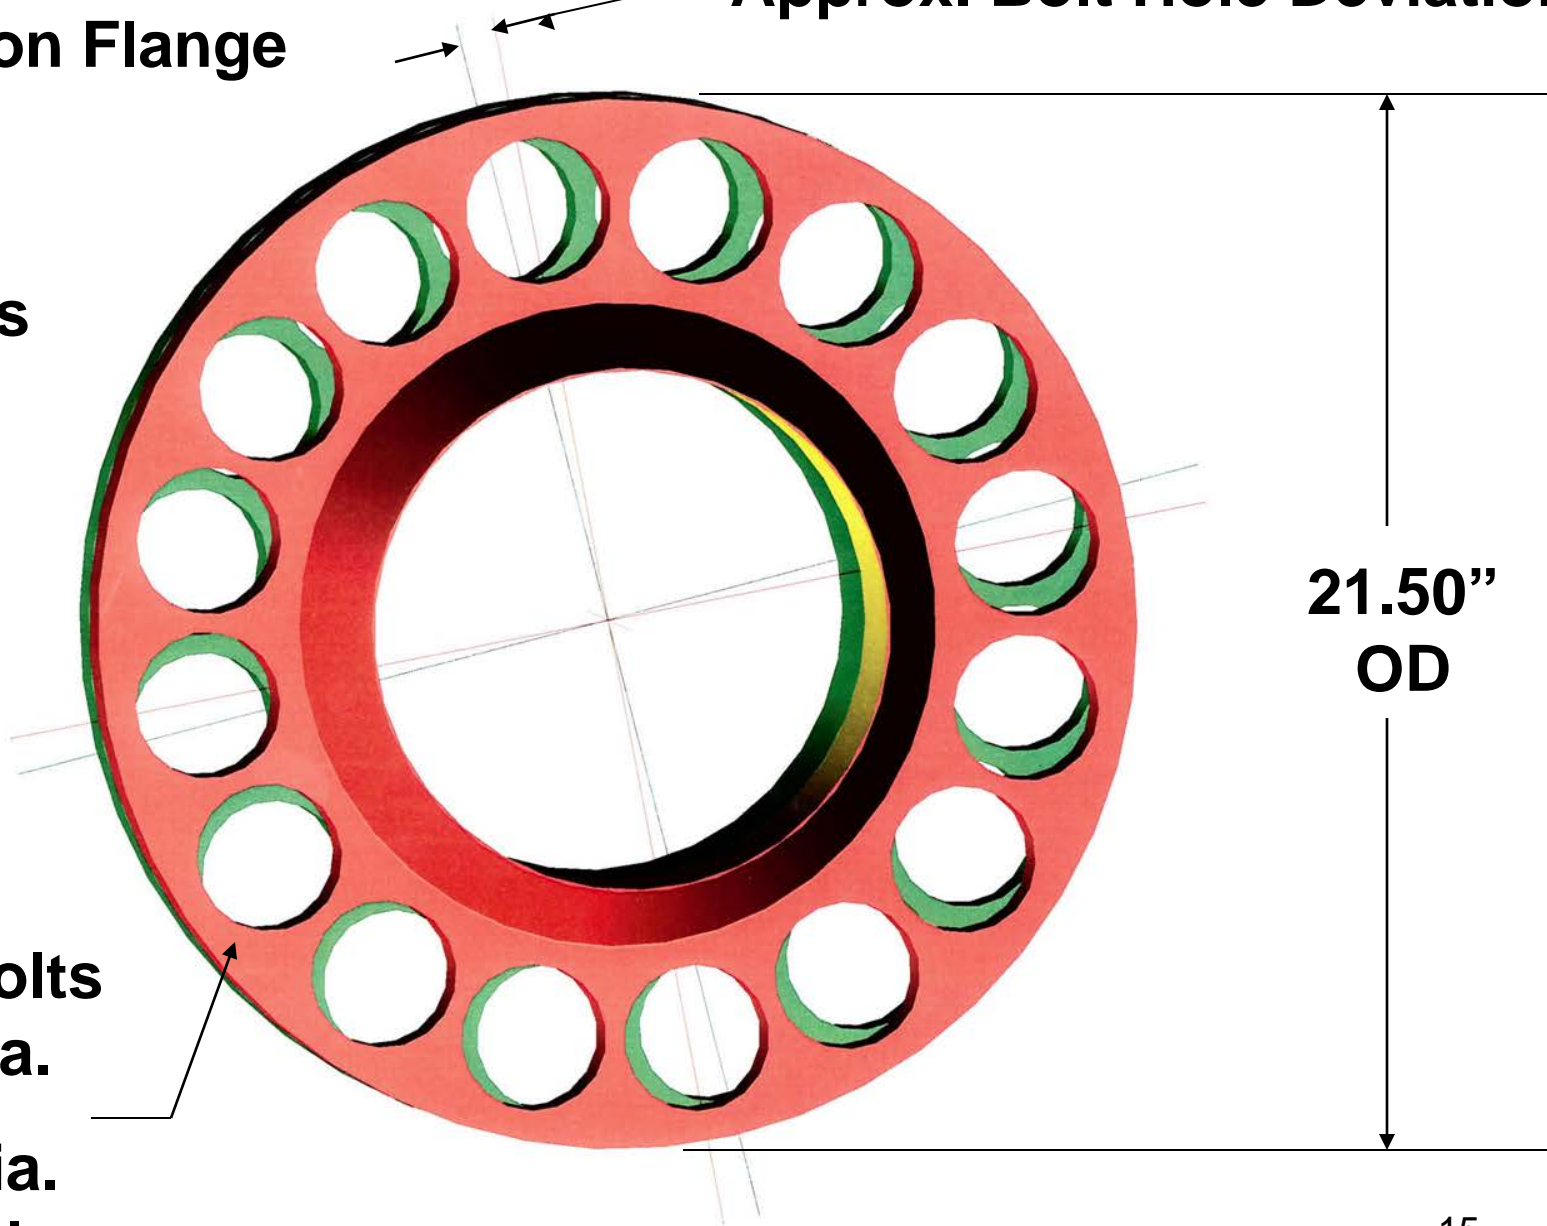
**10" - 900#
RF Suction Flange**

Approx. Bolt Hole Deviation

- **Failure to maintain dimensional uniformity when the suction flange was changed on the pump case was a key contributing factor.**
- **Discussions indicated that bolt hole timing may have been more of an issue than flange center line deviation.**
- **A prompt decision to shut down the unit limited damage to minor machining, polishing and replacement of wear parts.**
- **Continued operation would have resulted in a more severe wreck up to a rotor lock up or worse.**
- **Pump has been in service since re-installation in August, 2004.**

- Pump drive coupling hub was monitored for movement with dial indicators, top and side, during piping bolt up – 0.002” allowable.
- Decision made to fabricate a new suction spool to correct center line and bolt hole timing misalignment before attempting a bolt up.
- New suction spool was fitted and reworked until no coupling hub movement was present during flange bolt up.
- Unique suction spools are identified and stored at the facility for use with individual pumps.
- Soft Foot and Pipe Strain checks are understood to be key elements in the machinery shaft alignment procedure.

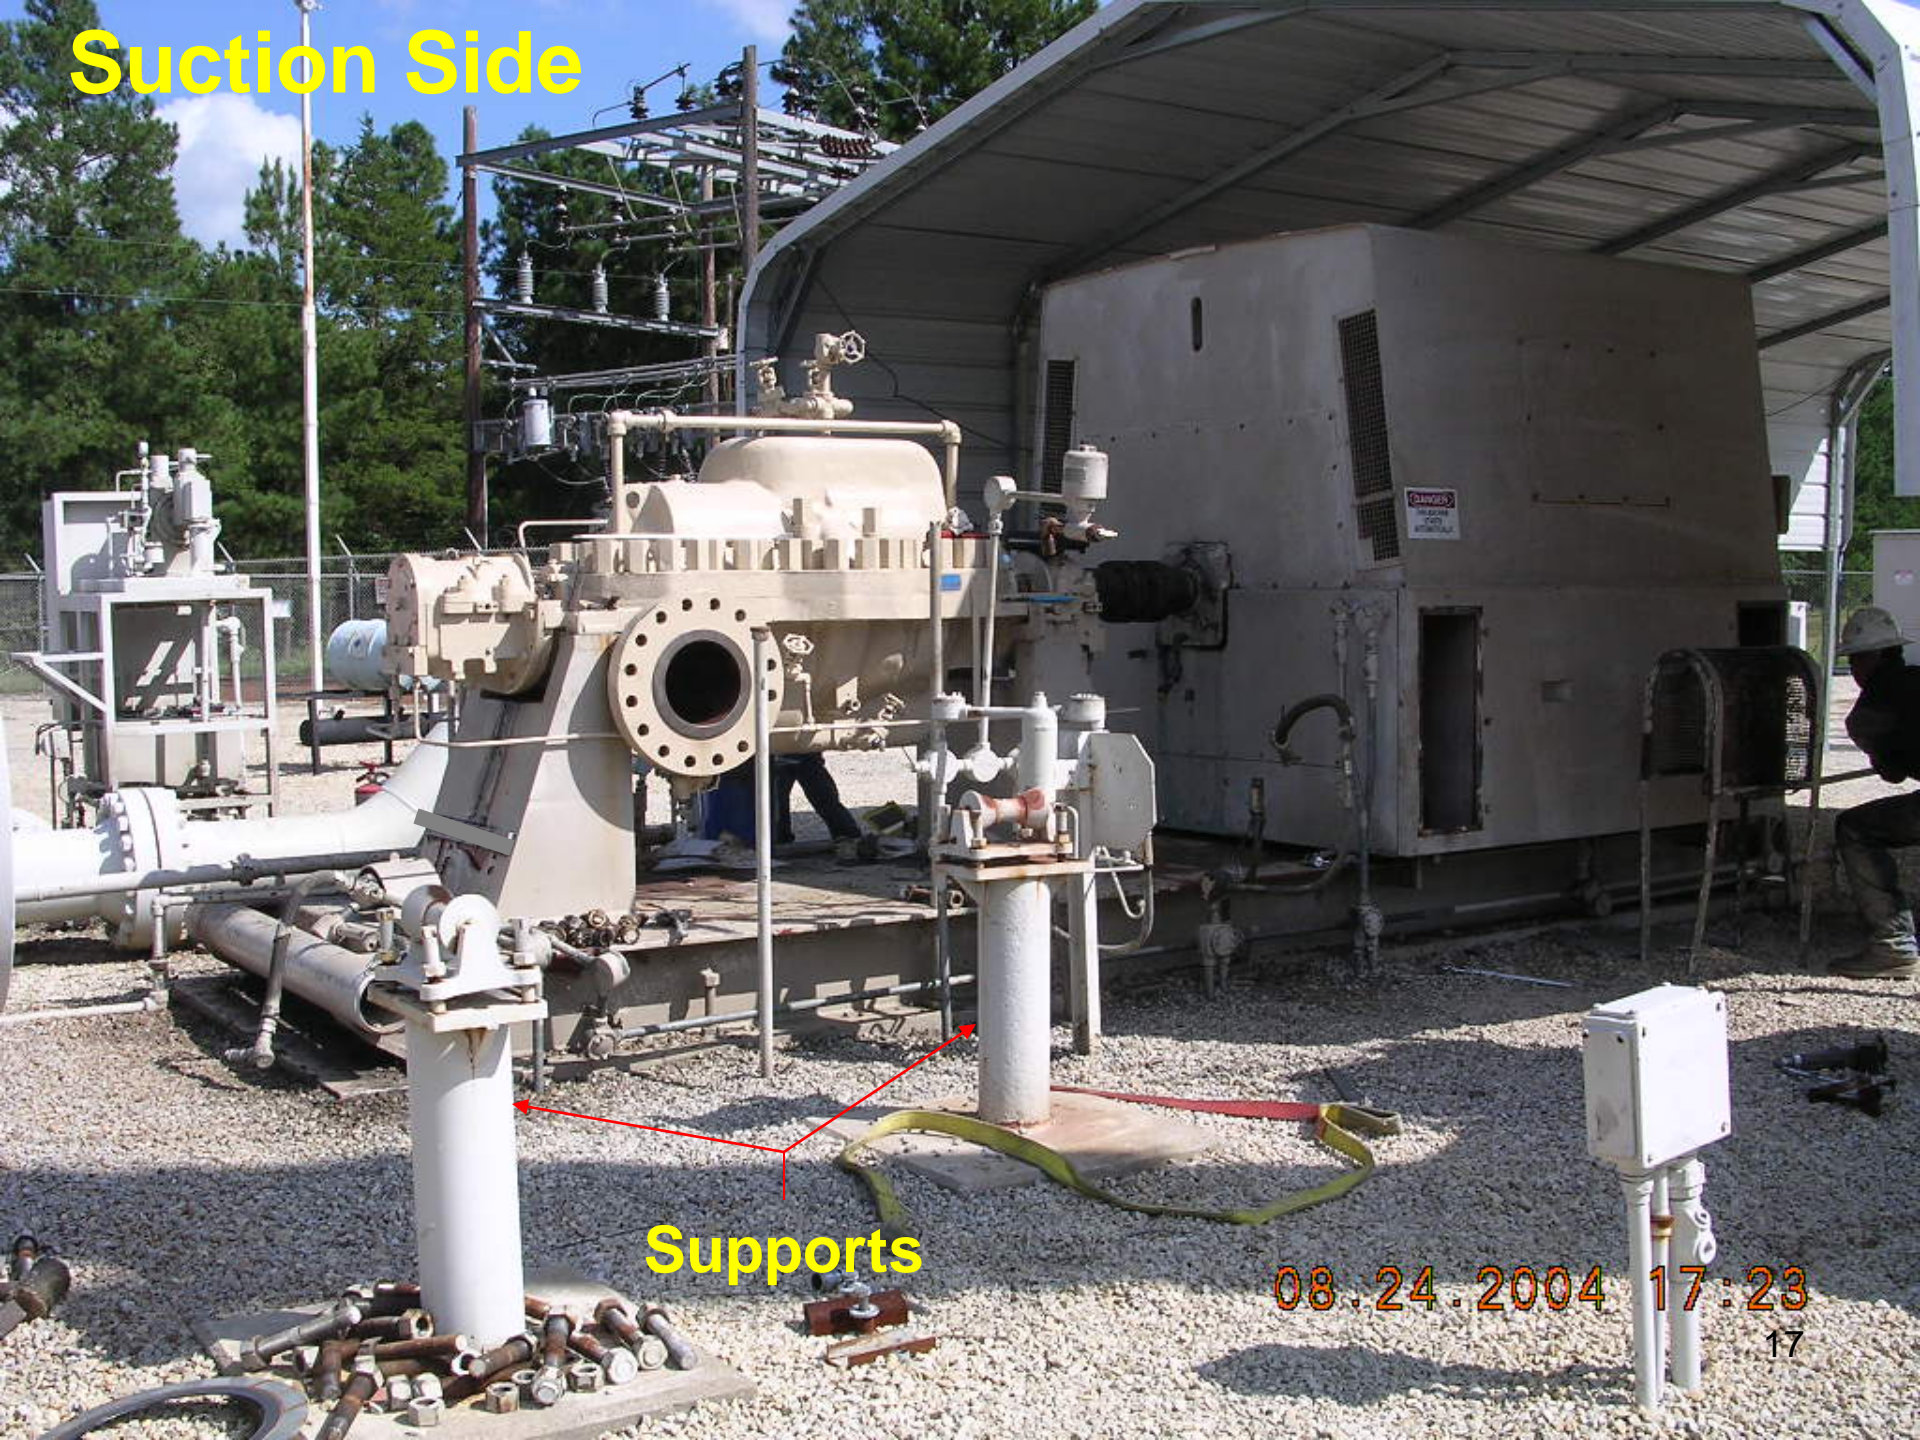
Suction Side

Supports

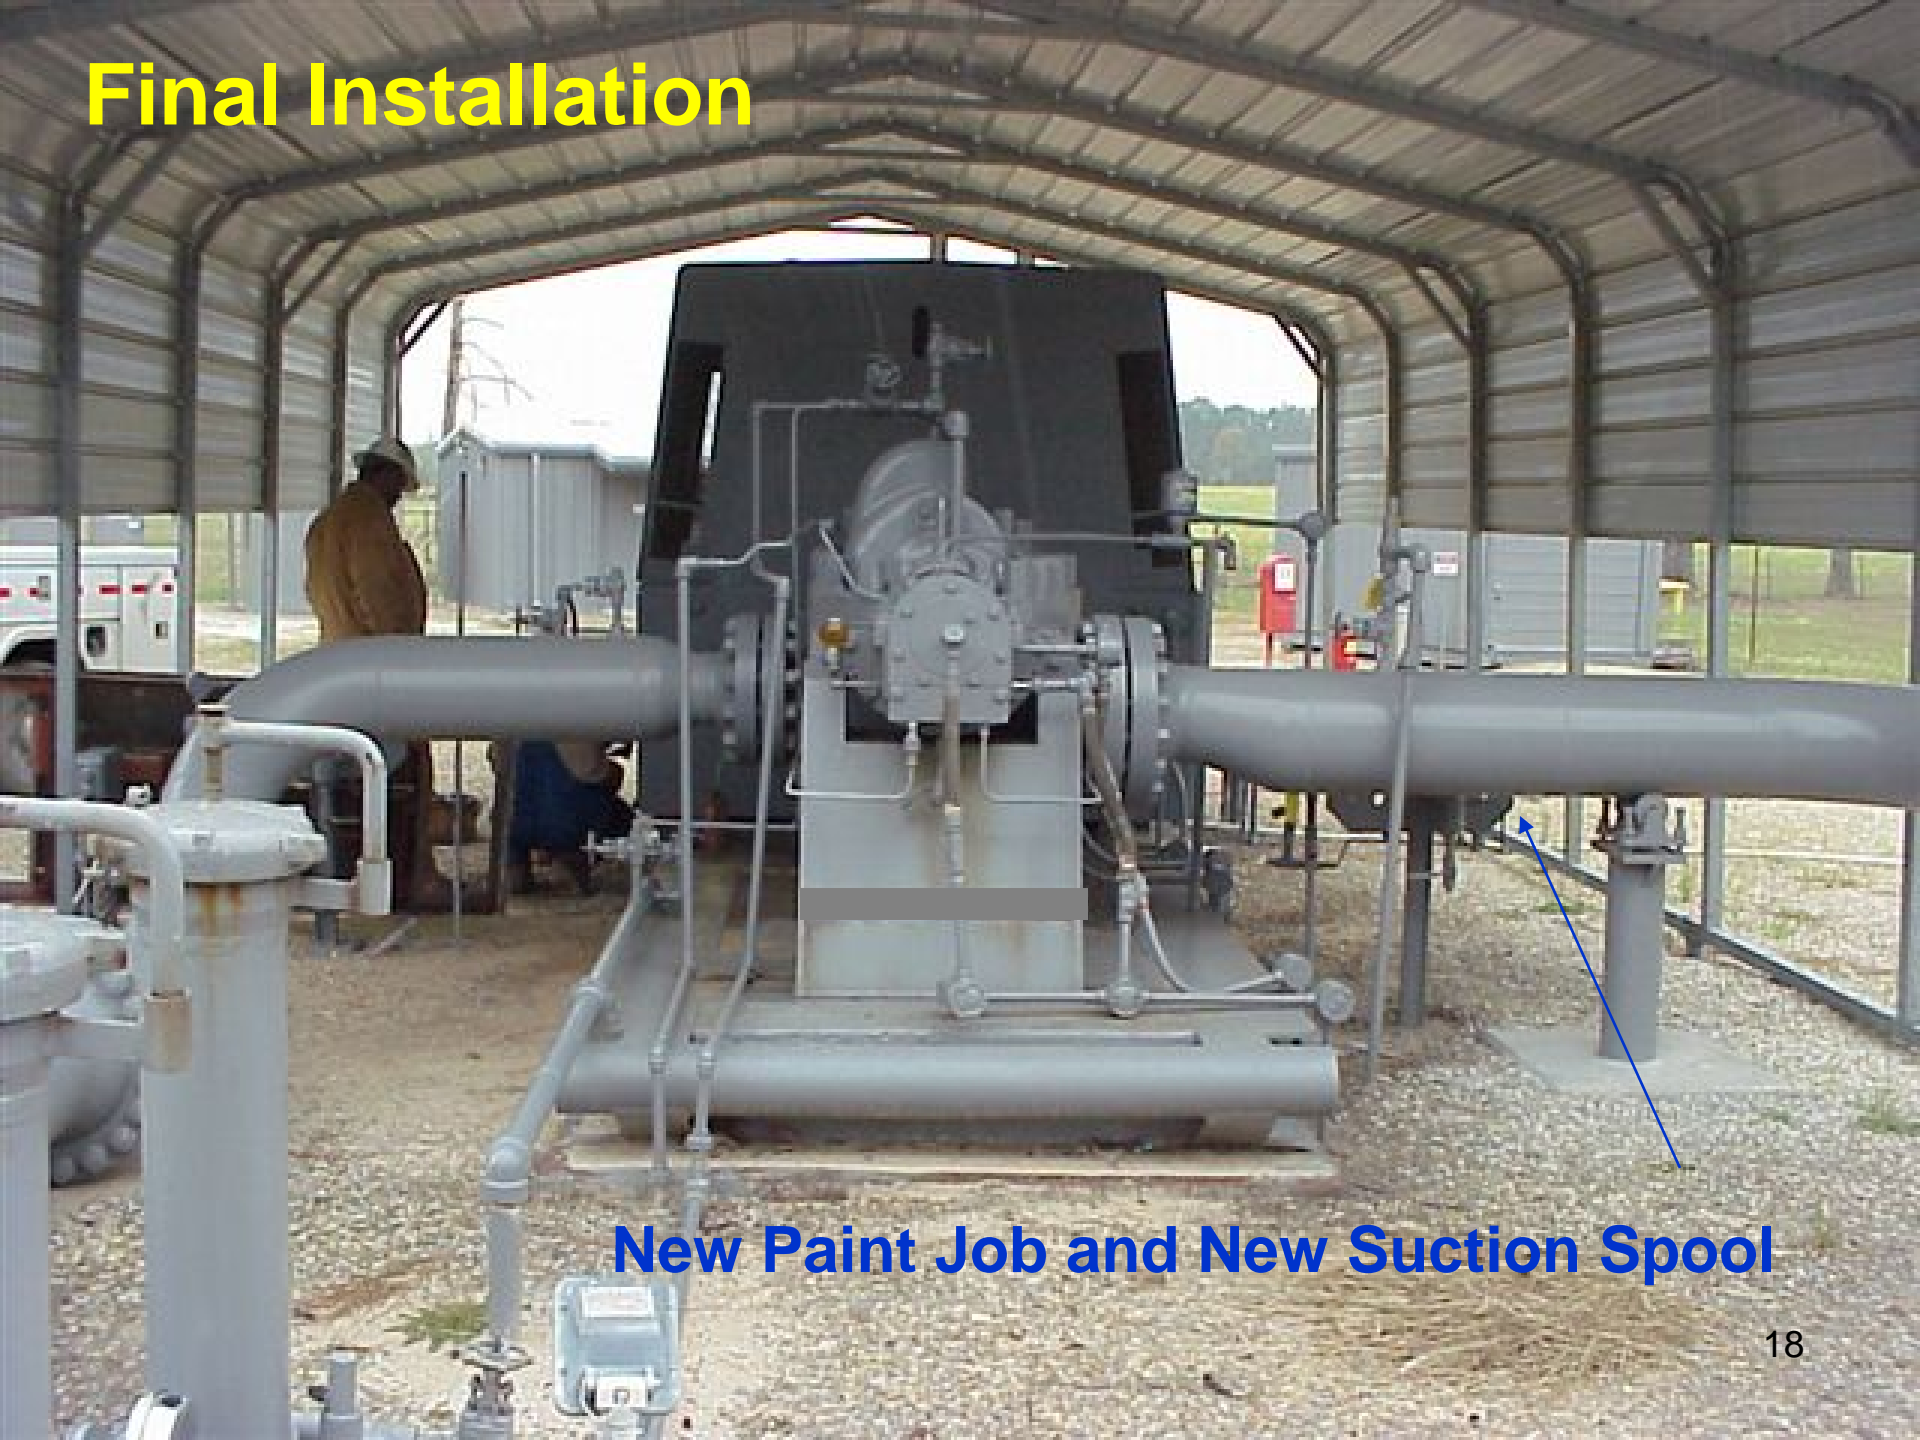
Final Installation

New Paint Job and New Suction Spool
