**43rd Turbomachinery
30th Pump SYMPOSIA**

RELIABILITY IMPROVEMENT OF MAGNETIC DRIVE PUMP FOR SPECIAL SERVICES

Presentation Overview

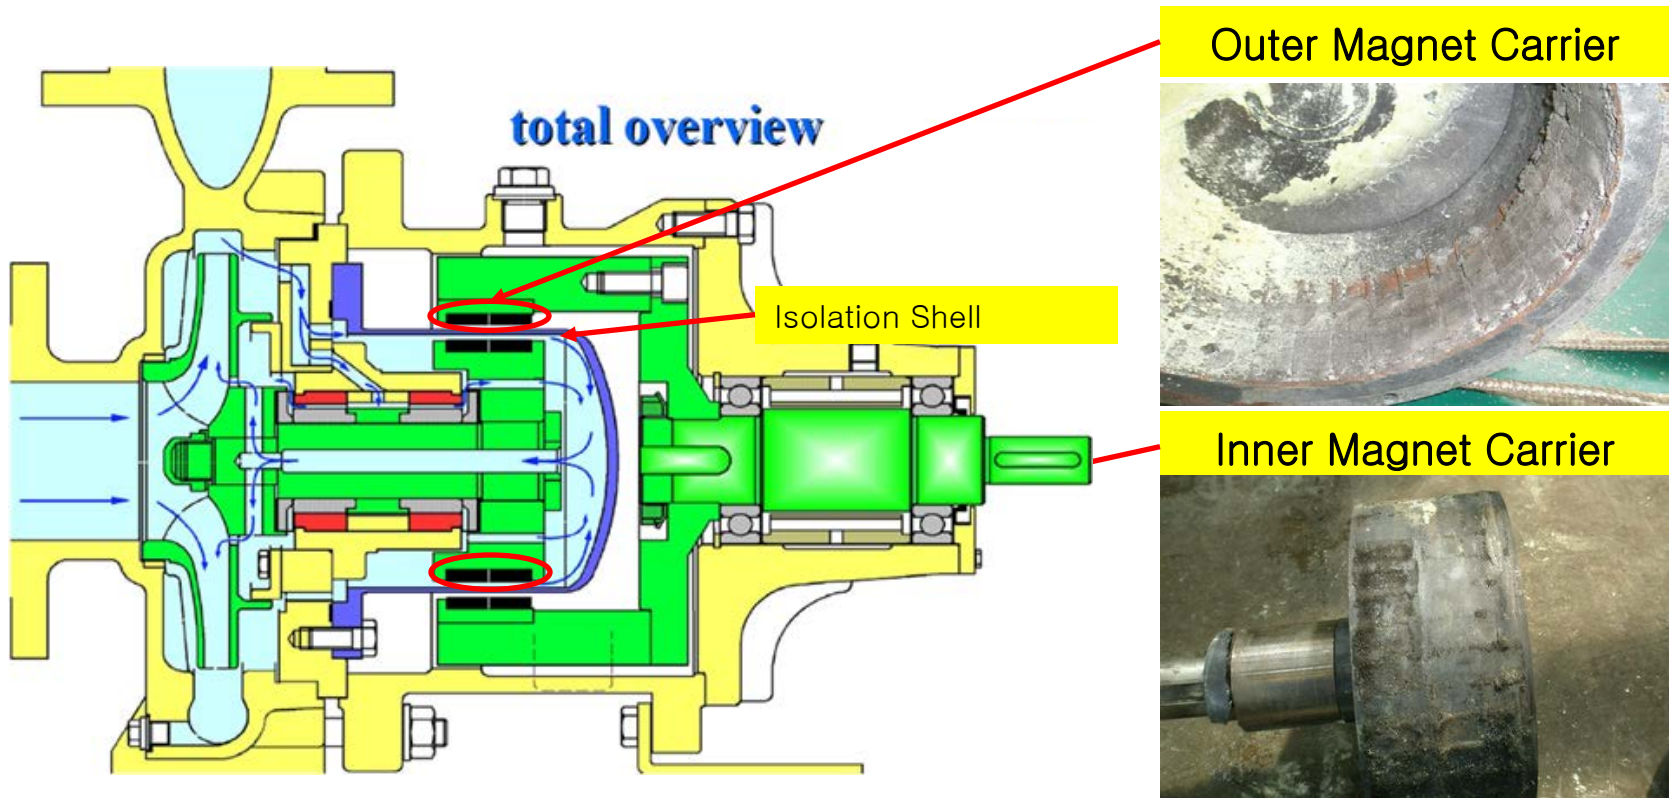
- Pump shaft could not be turned by hand since pump had been operated on Aug. 14, 2010.
- Internal Parts were damaged ; Isolation Shell, Sleeve Bearing, Inner/Outer Magnet

Root Causes	Solutions Provided	Aspect
Ⓐ Parallel Operation	▪ Prohibit the parallel operation of pumps	Operation
Ⓑ Insufficient Magnetic coupling torque	▪ Increase torque rating of magnetic coupling higher than motor's	Design
Ⓒ Pump didn't stop as soon as magnetic coupling was slipped	▪ Implement proper protection system - Shell Temperature Monitoring & High Trip - Motor Amp. Low Trip for slip of Magnetic Coupling	Protection System
Ⓓ Additional remedy	▪ Enlarge the size of min. flow orifice to increase min. by-pass flow	Design

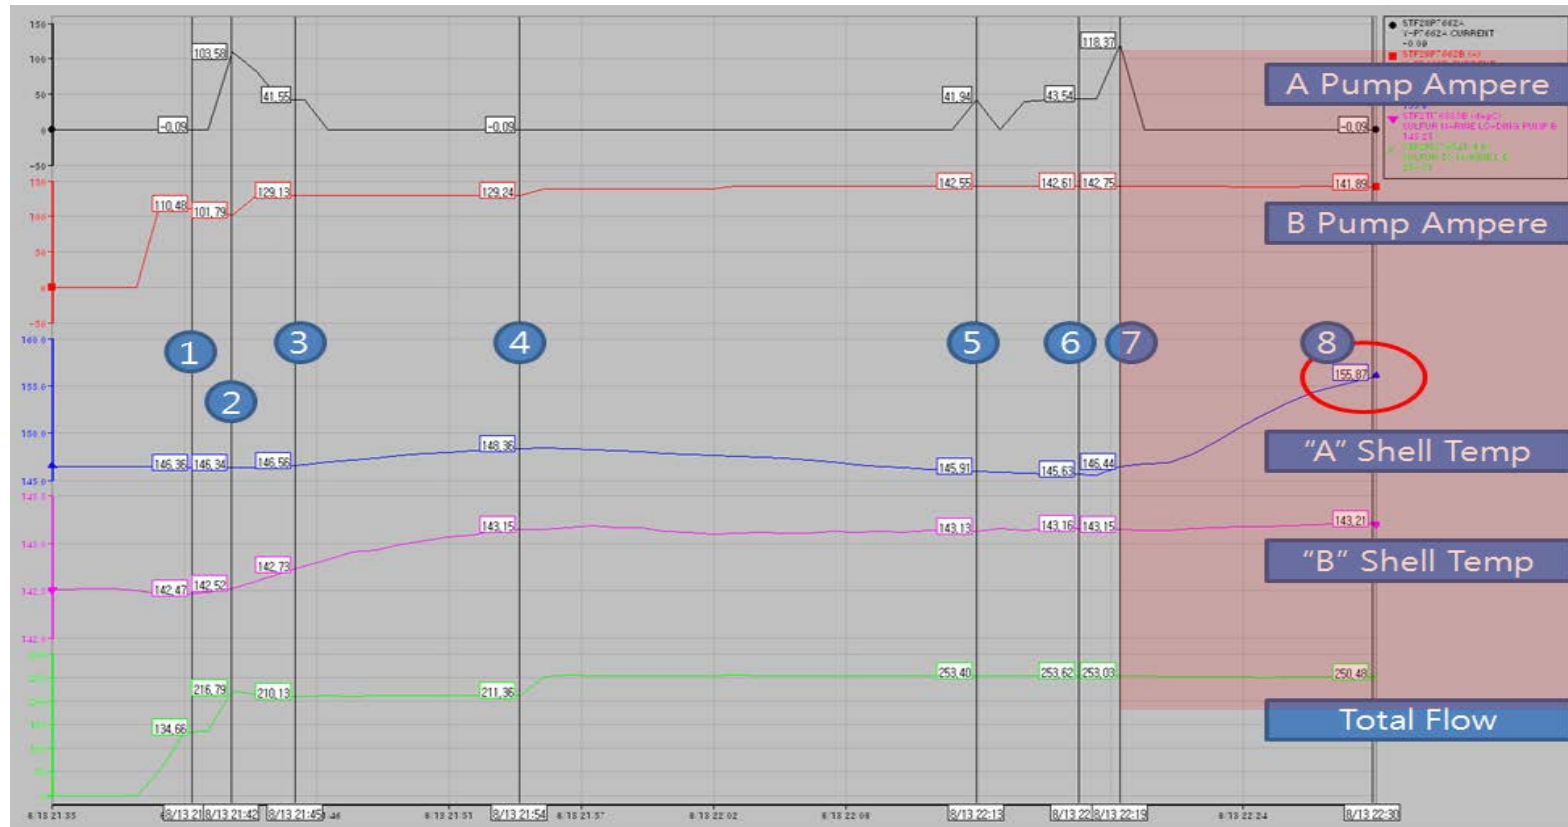
Operator wanted to shorten loading time, then run two pumps in parallel. Parallel operation had been tried several times but one motor current was near no load.

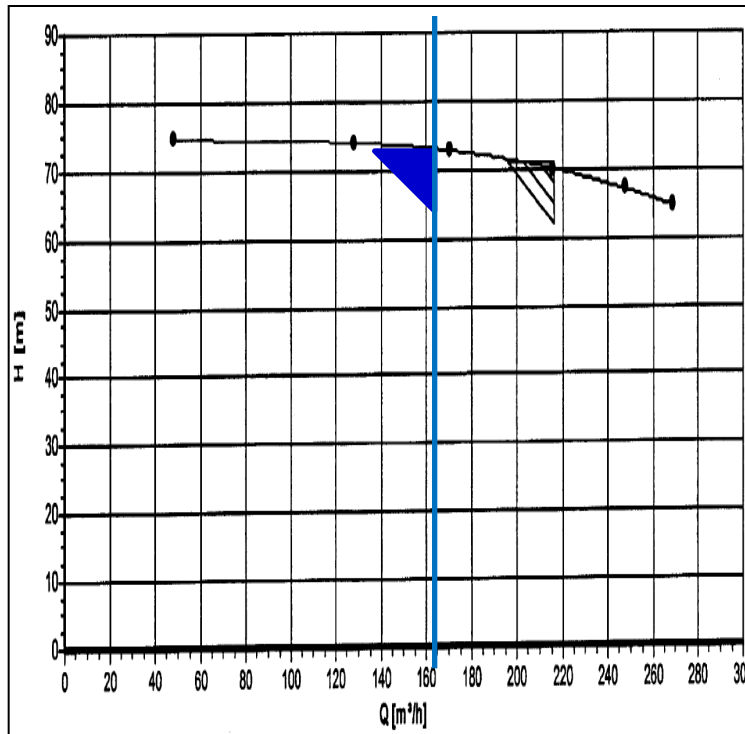
"B" Pump Operating Point

The parallel operation could cause unbalanced flow for each pump with flat performance curve.

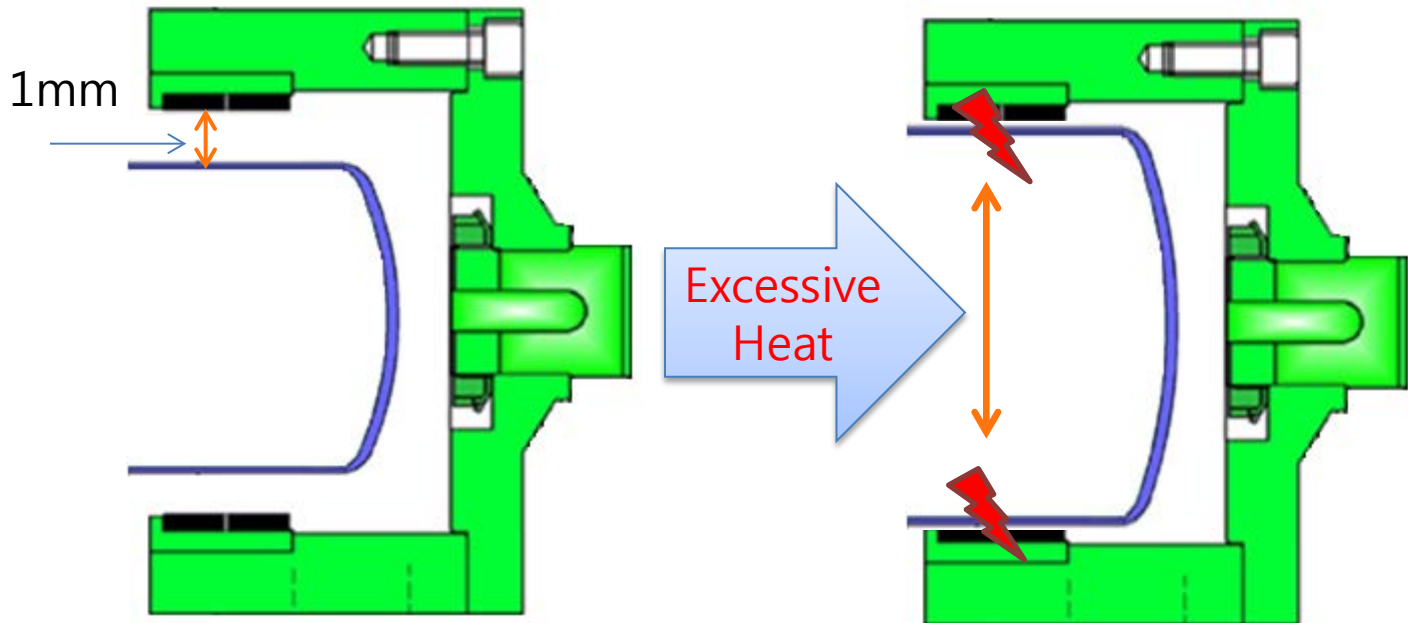
Thermal expansion of isolation shell by excessive heat cause contact with outer magnet carrier

Clearance between outer magnet carrier and isolation shell is very small to prevent magnetic loss. Excessive heat can make isolation shell easy to contact to outer magnet carrier.

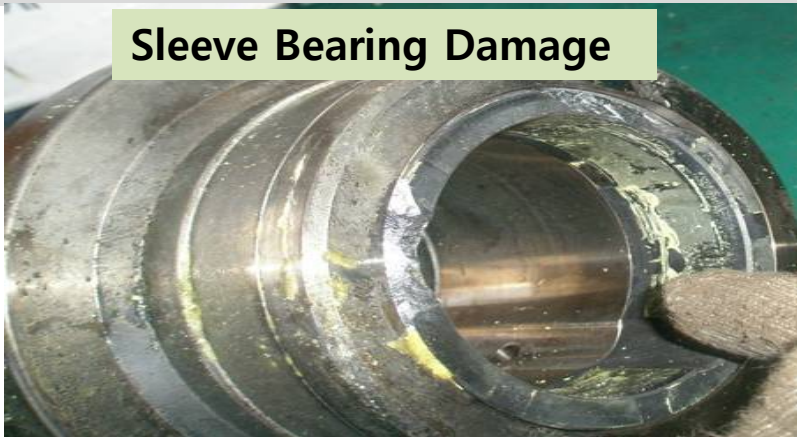
All major internal parts were severely damaged.

Sleeve Bearing Damage

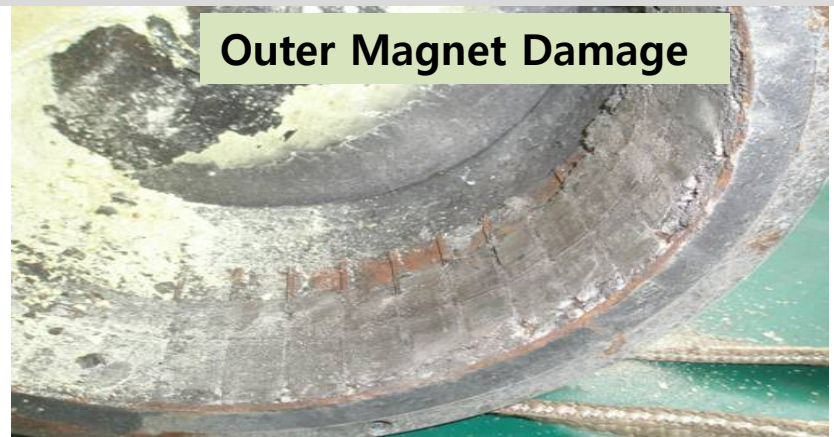
Outer Magnet Damage

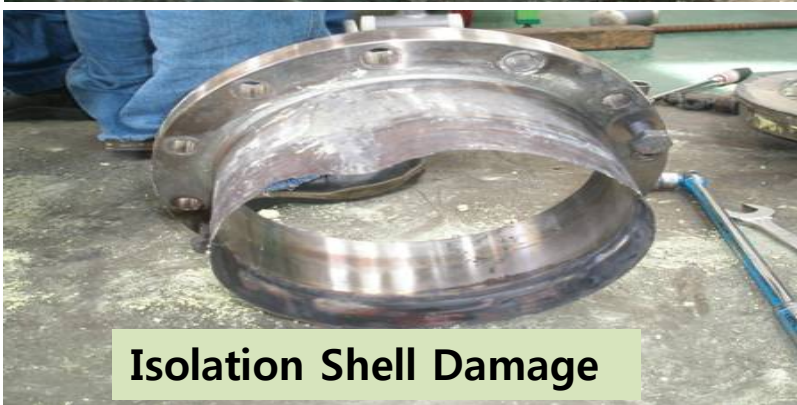
Isolation Shell Damage

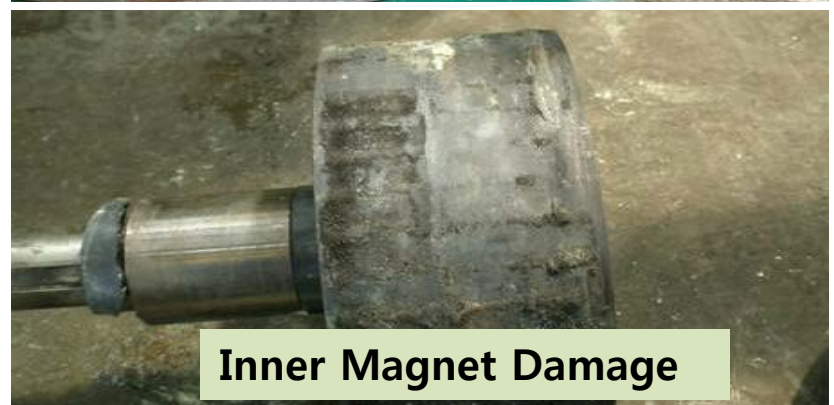
Inner Magnet Damage

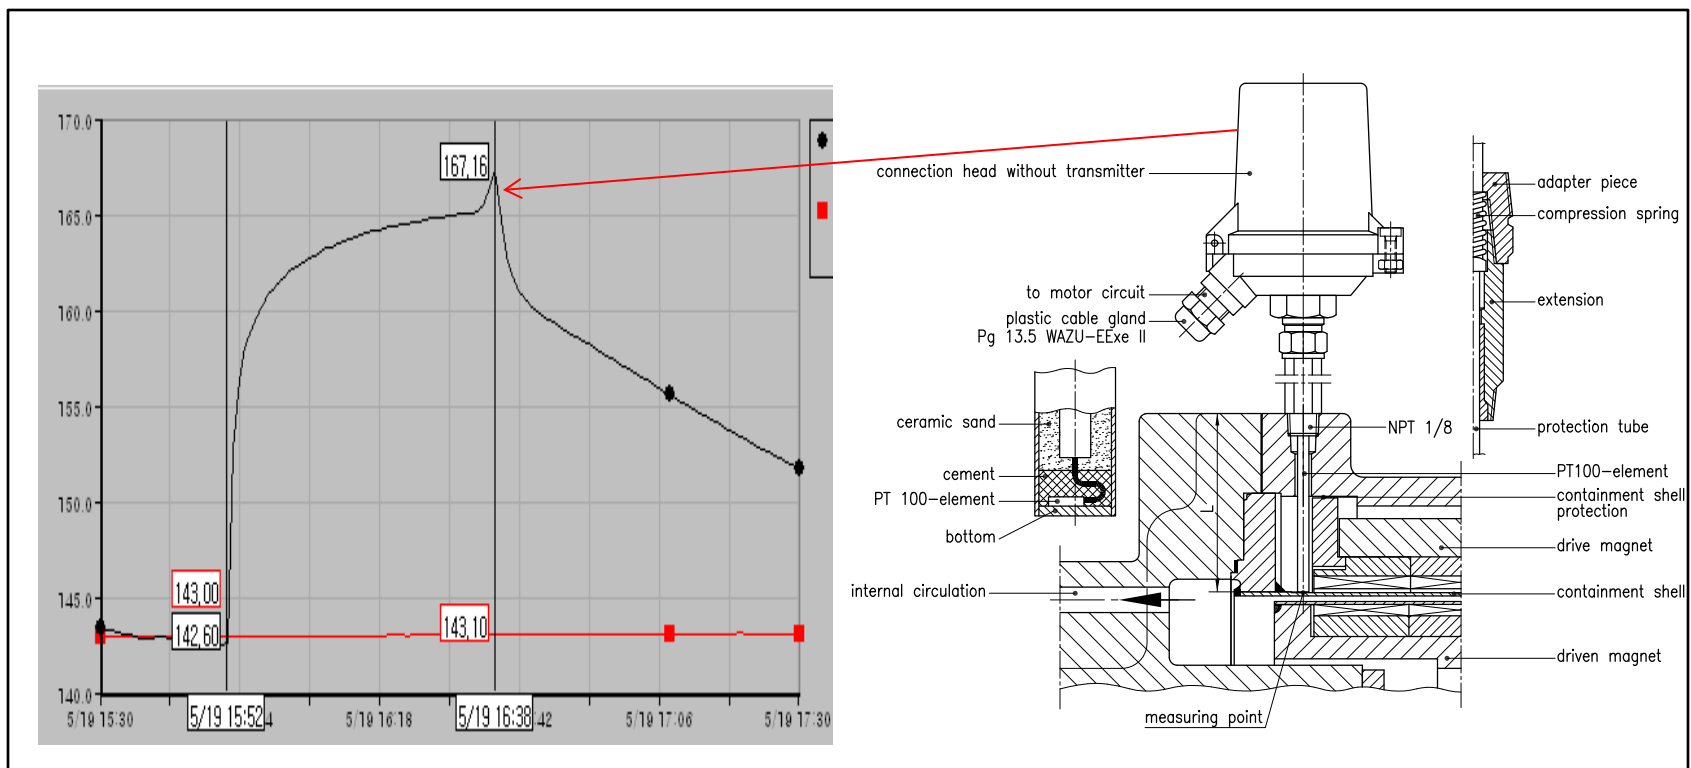
Shell Temperature was increased up to max. 167°C so that the molten sulfur solidified inside of pump magnetic shell. Finally the motor was tripped by overload motor current.

① Modification of Heating & Cooling System
- Heating before pump start,
- Cooling after pump start

② Increase the internal cooling flow

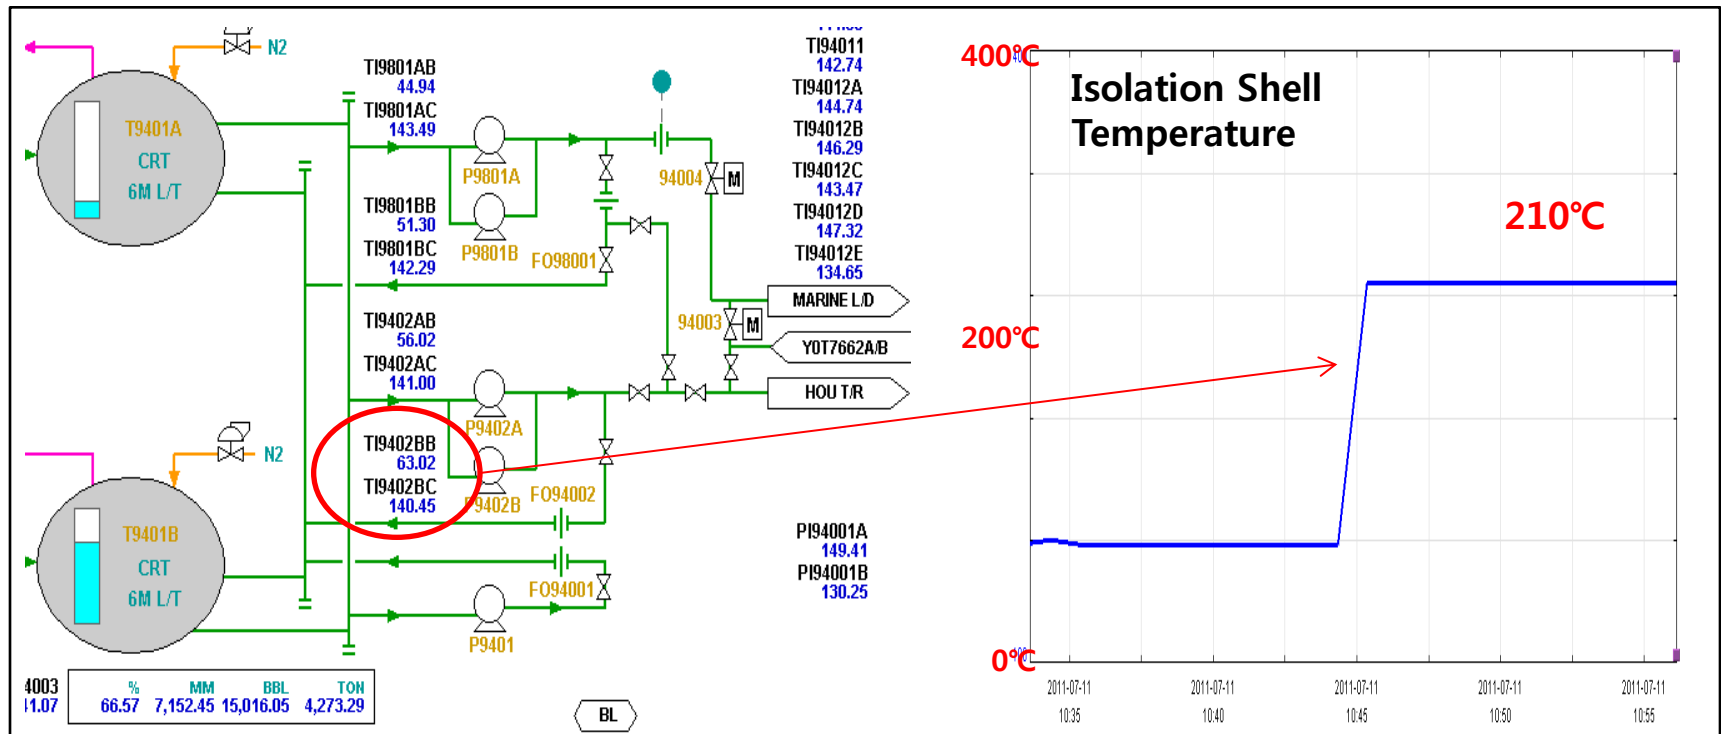
- Pump started and operated for 3 minutes, then smoke was seen coming from the pump.
- Isolation shell temperature increased over maximum temperature sensor range(**210°C**)

Root Causes	Solutions Provided	Aspect
Ⓐ Insufficient a orifice Size for minimum flow bypass	▪ Enlarge a orifice size to increase a minimum flow bypass	Design
Ⓑ Insufficient Magnetic coupling torque	▪ Increase torque rating of magnetic coupling	Design
Ⓒ Pump didn't stop as soon as magnetic coupling was slipped	▪ Implement proper protection system <ul style="list-style-type: none">- Shell Temperature Monitoring & High Trip- Motor Amp. Low Trip for slip of Magnetic Coupling	Protection System

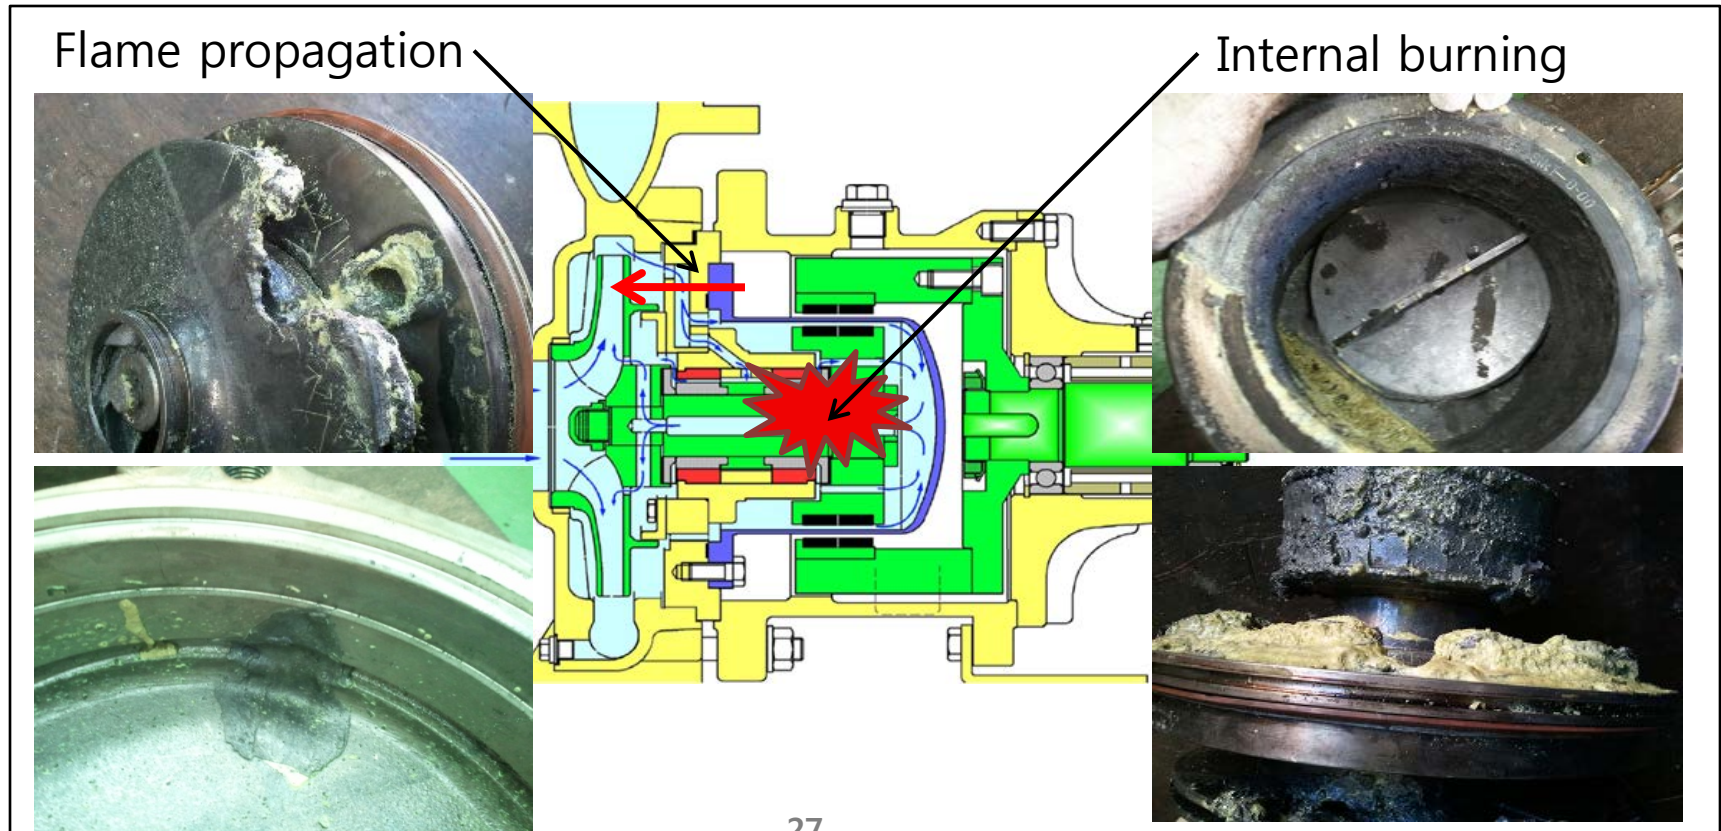
- Results of overhaul inspection
 - Isolation shell, impeller, casing were partially melted.
 - Inner & outer magnet were demagnetized

- Shell temp. increased due to magnet slip and parts were thermally expanded and finally touched each others
- Air entered through damaged shell by contacting with rotating outer magnet
- Parts were melted due to high heat generation by reaction of molten sulfur and oxygen. (molten sulfur ignition point : 247°C)

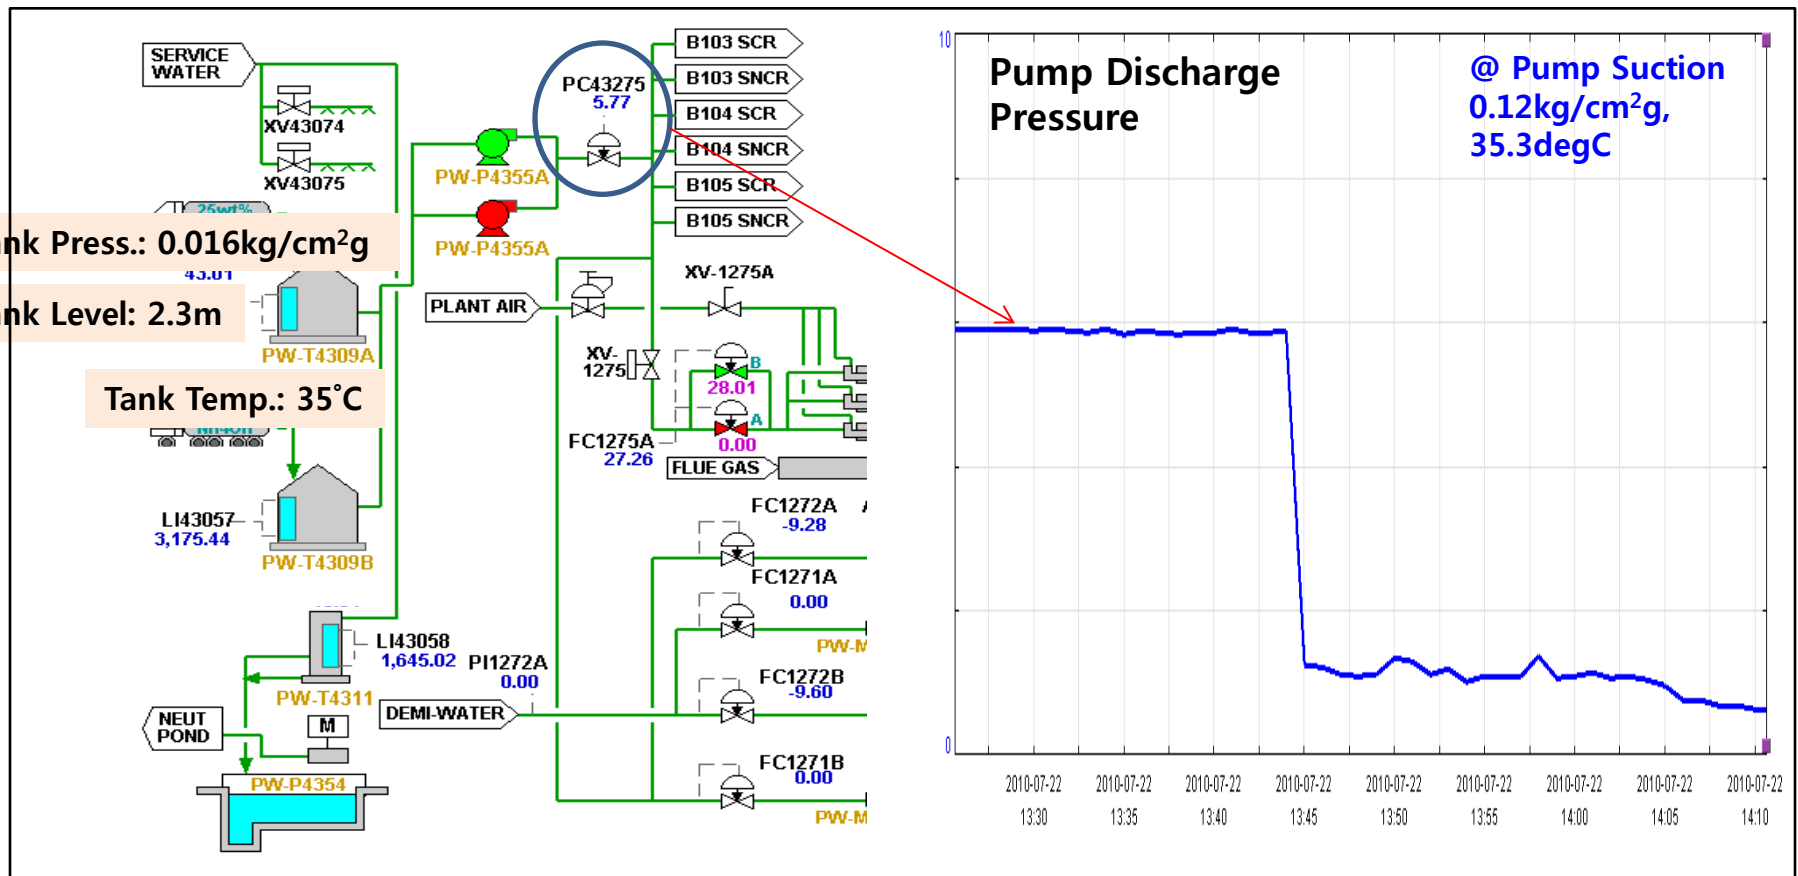
Discharge pressure of ammonia water pump in SOx Removal System for boiler was decreased (5.9→1.2kg/cm²g), even though stand-by pump was automatically started, the pressure wasn't restored.

- ① Suction temperature was +2.2°C higher than design (Design: 31.8°C, Actual: 34°C)
 : Did not properly reflect summer conditions (**NPSHa ↓**)
- Design NPSHav = $H_a + H_s - H_f - H_{vp}(0.872\text{kg/cm}^2\text{abs}) = 1.79 \text{ m}$ (@ 31.8°C)
 - Actual NPSHav = $H_a + H_s - H_f - H_{vp}(0.950\text{kg/cm}^2\text{abs}) = \mathbf{0.91 \text{ m}}$ (@ 34°C)
- ② The Heat was generated +3°C during pumping by Pumping Heat and Magnetic & Bearing Cooling Heat (**NPSH3 ↑**)
- Design NPSH3 : 0.5 m , - Actual NPSH3 : 1.8m

Root Causes	Solution Provided	Aspect
Ⓐ Decrease NPSHa	<ul style="list-style-type: none">▪ Improvement of NPSHa<ul style="list-style-type: none">- Protect pump suction line from radiation of sun- Increase Tank Level for summer	Operation
Ⓑ Increase NPSH3	<ul style="list-style-type: none">▪ Water jacketing for casing cooling	Design
Ⓒ Additional Remedy	<ul style="list-style-type: none">▪ Implement proper protection system<ul style="list-style-type: none">- Shell Temperature Monitoring & High Trip- Motor Amp. Low Trip for slip of Magnetic Coupling	Protection System

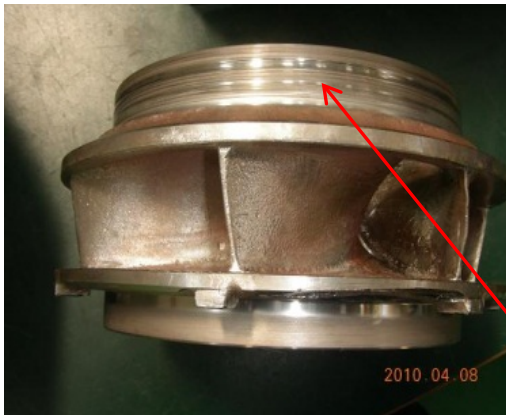
Internal parts were damaged **more than 30 times** during 2008~2012.

Impeller Damage

Root Causes	Solution Provided	Aspect
Ⓐ Improper material	▪ Improvement of material - CD-4MCU → Hastelloy-C	Design
Ⓑ Process foreign material	▪ Dual strainer	Design
Ⓒ Poor external flushing	▪ Change to pure external source (Demi-water)	Operation
Ⓓ Tolerance	▪ Change bearing type (no tolerance ring)	Design

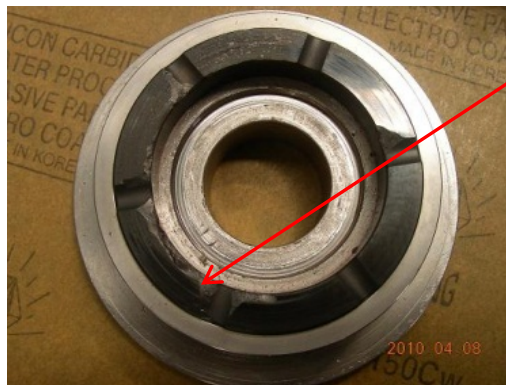
Thrust Bearing Damage

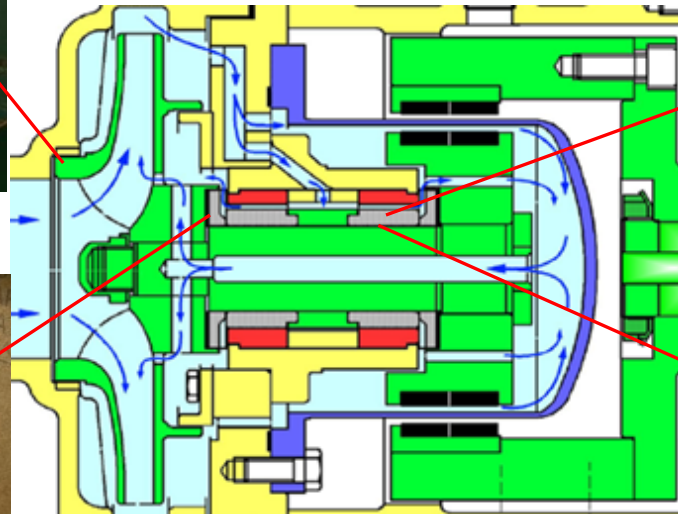
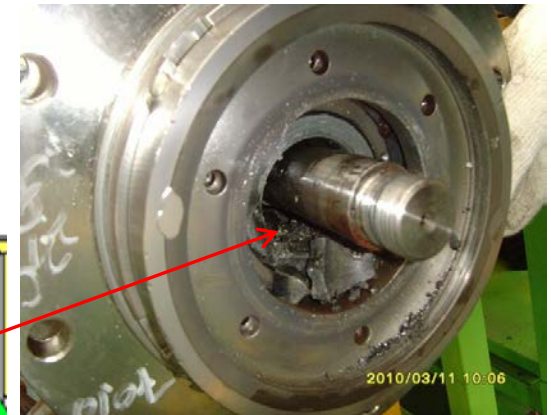
Sic Sleeve Bearing Damage

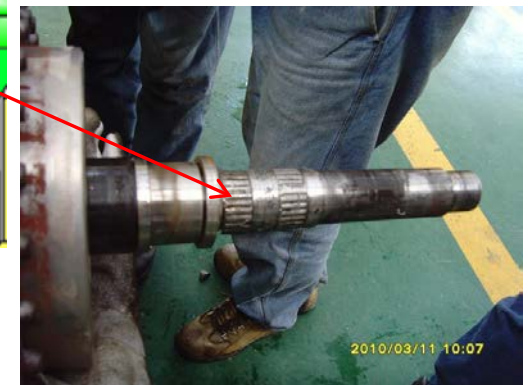
Tolerance Ring Damage
