# **Root Cause Analysis on a Multistage Centrifugal Pump in a Power Plant due to Shaft Crack Based on ODS and FEA**

**27<sup>th</sup> International Pump Users Symposium  
George R. Brown Convention Center  
Houston, TX  
September 12 - 15, 2011**

**Maki Onari**  
*Mechanical Solutions, Inc.*  
*Whippany, NJ 07981 USA*  
*Tel: (973) 326-9920*  
*[www.mechsol.com](http://www.mechsol.com)*

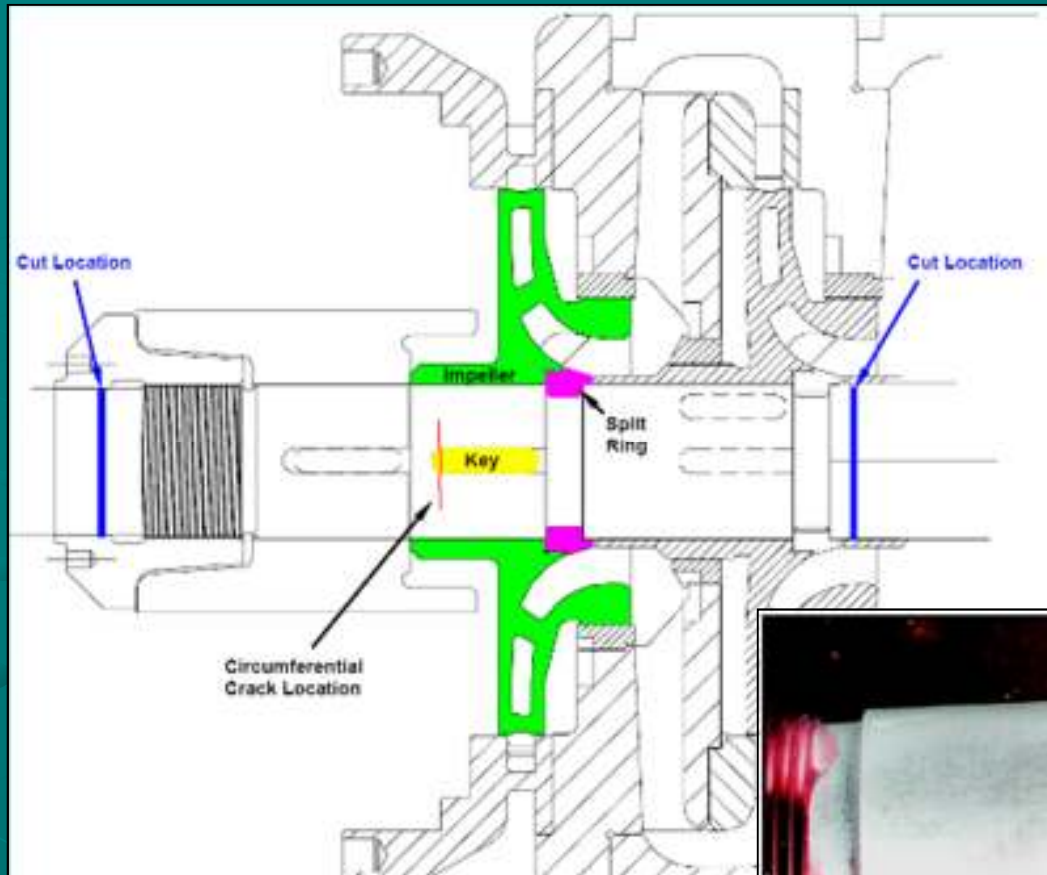
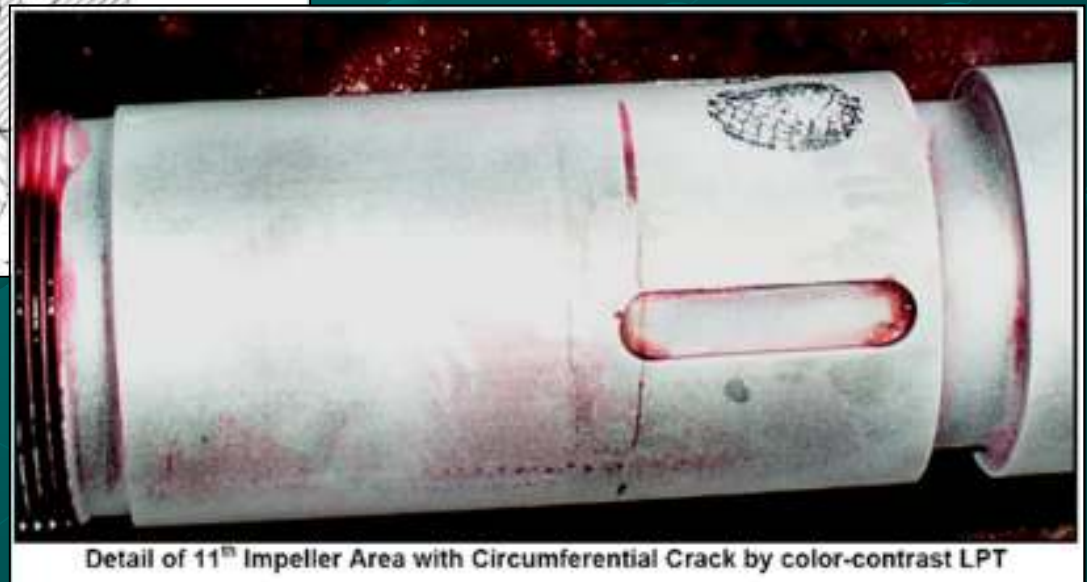
2007 Failure after 8 years of operation. Crack detected under 11<sup>th</sup> stage impeller hub.

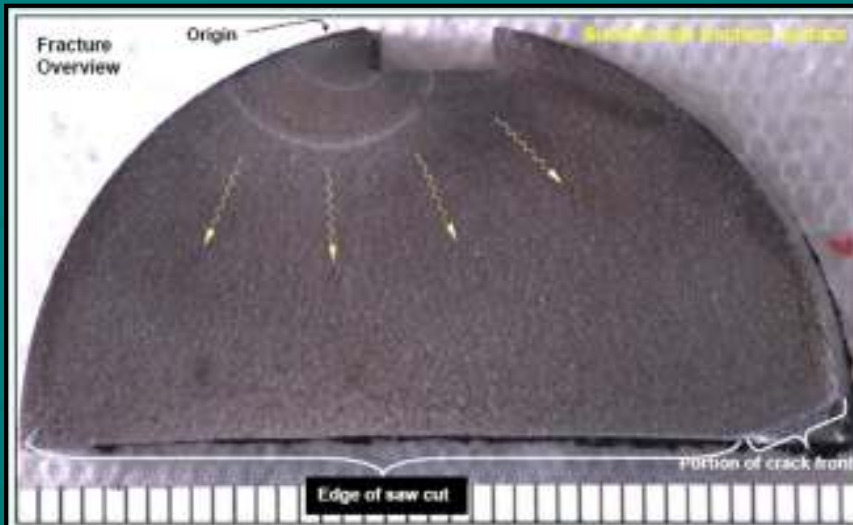
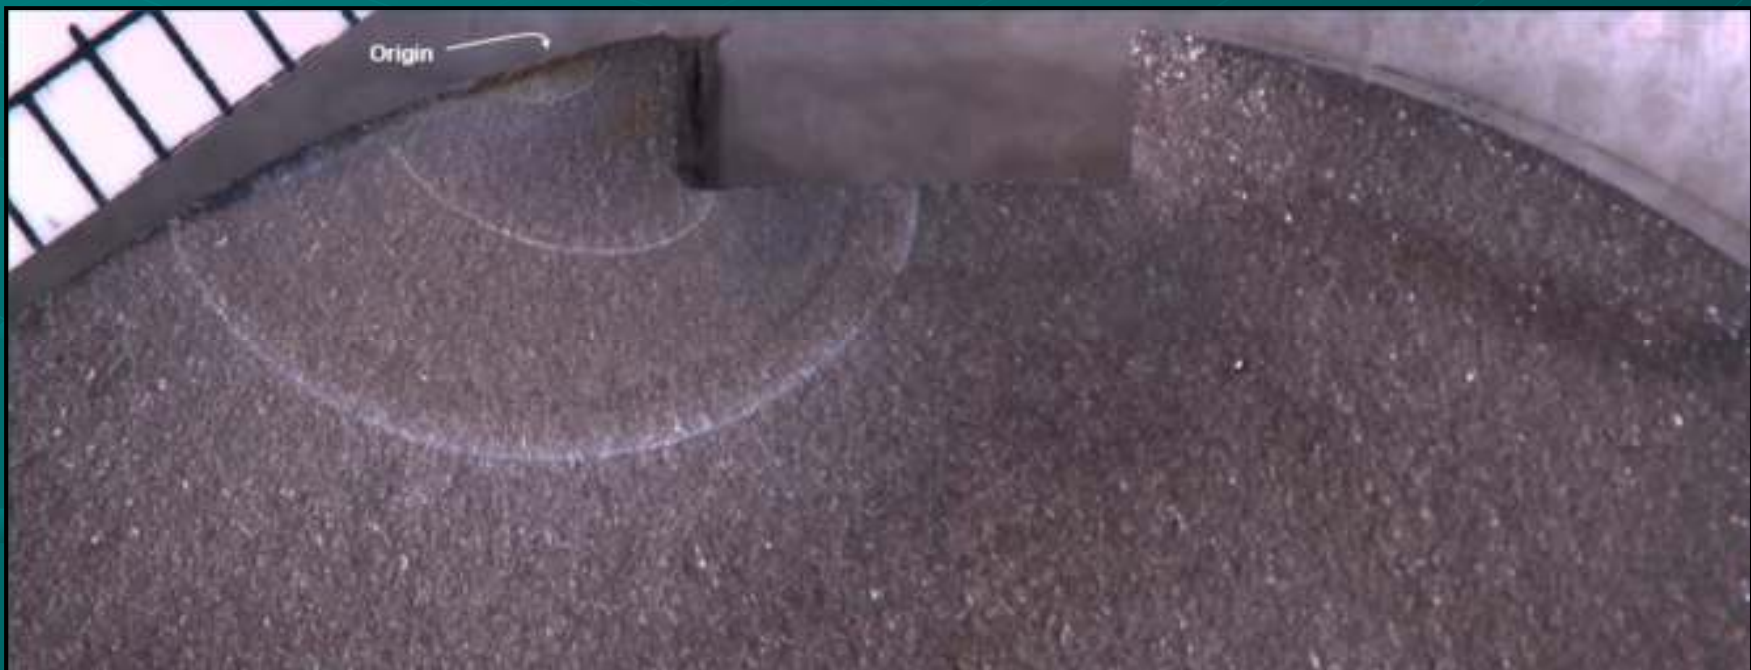
2007 Failure after 8 years of operation.  
Crack detected under 11<sup>th</sup> stage impeller hub with the origin away from the keyway.

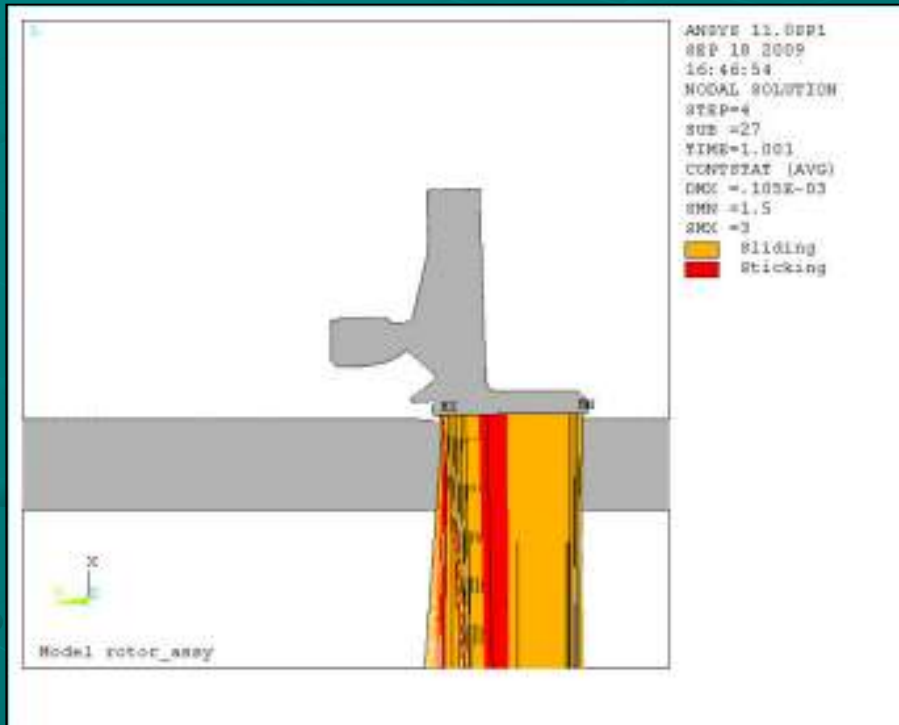
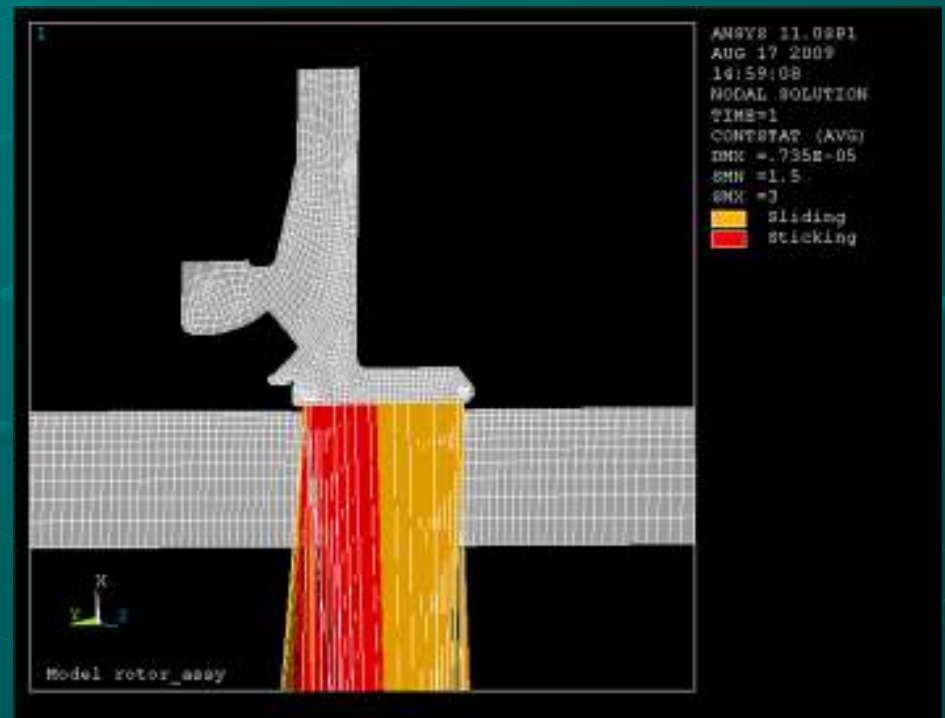
- **Transient dynamic analysis revealed that acoustic wave propagation past the impellers can result in micro-motion at the press fit interfaces.**
- **An idealized axi-symmetric model of the pump shaft and the last stage impeller predicted an impeller to shaft sliding condition.**
- **This sliding condition led to fretting damage and the crack initiation.**

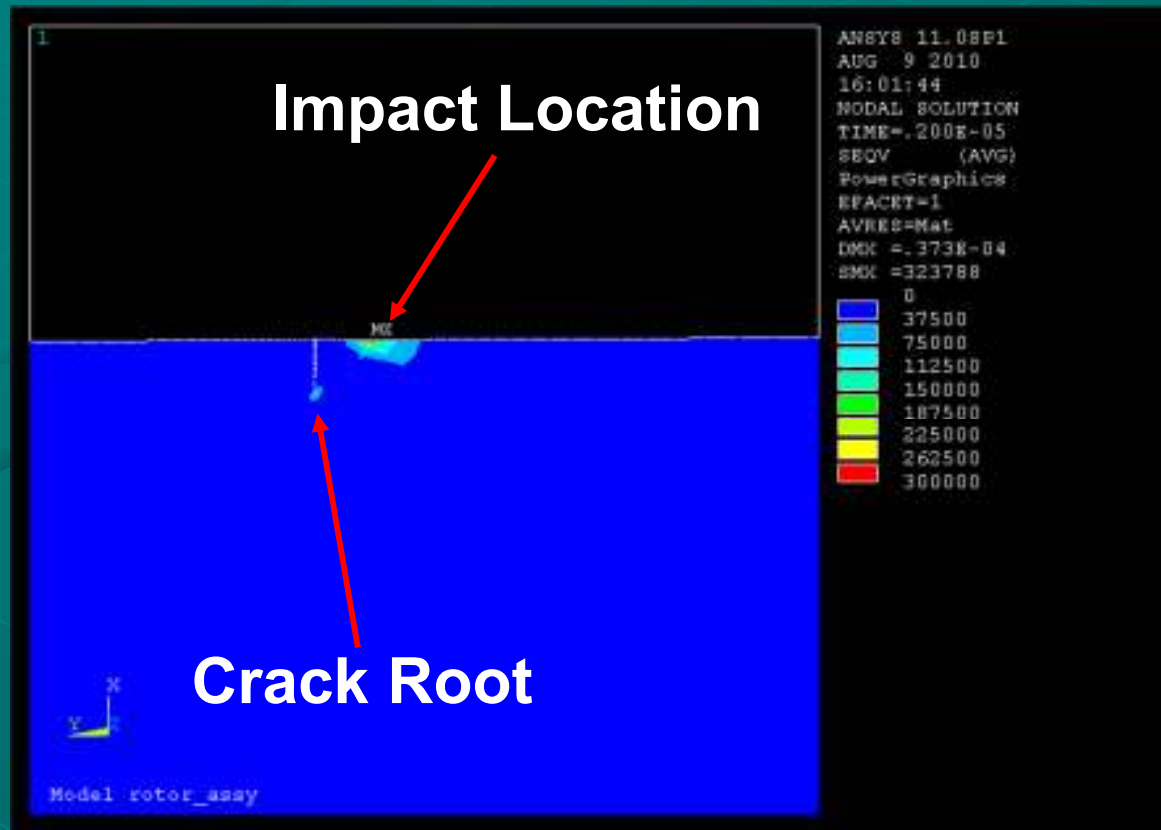
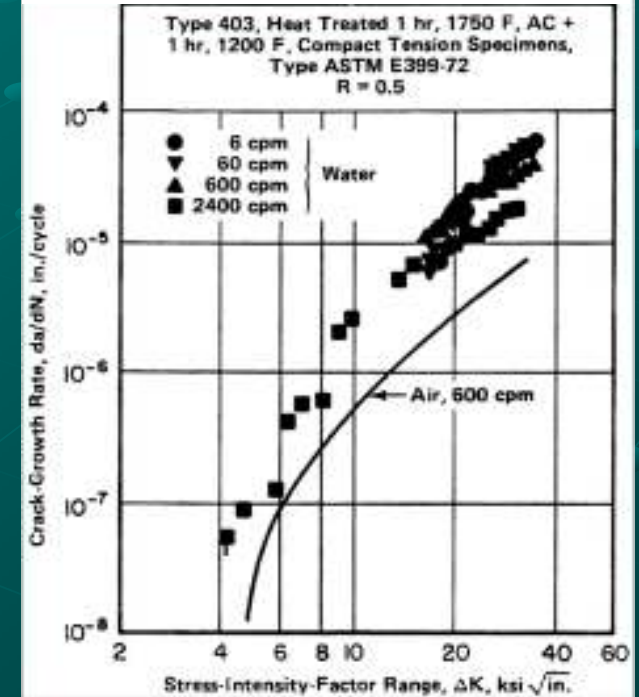
von Mises Stress Distribution (psi) In Vicinity of Crack

ANSYS Calculated Stress Intensity Factor  $\Delta K_I = 16.3 \text{ ksi}\sqrt{\text{in}}$
