SEVERE CASING AND IMPELLER EROSION : ANALYSIS AND RESOLUTION

AUTHOR : TETE SEDALO
TECHNICAL SERVICES ENGINEER

42nd Turbomachinery
29th Pump SYMPOSIA

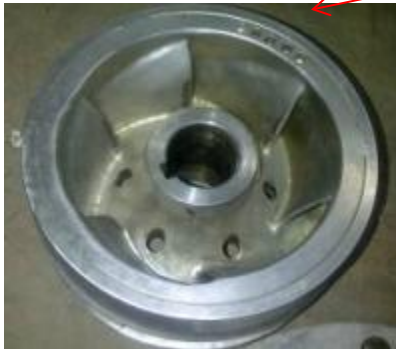
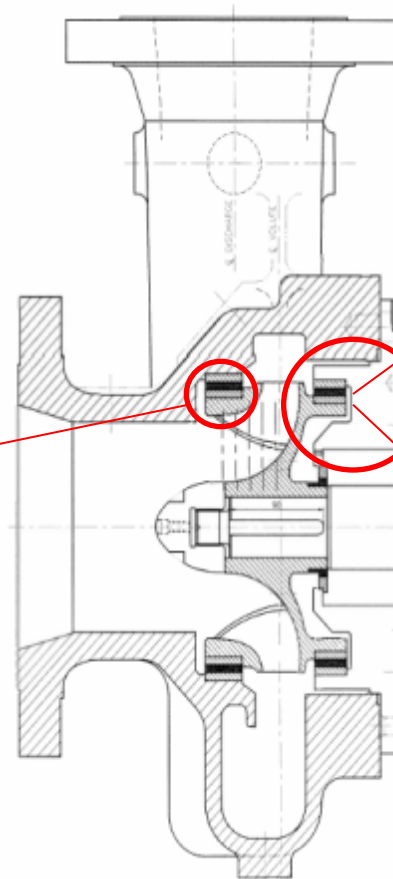
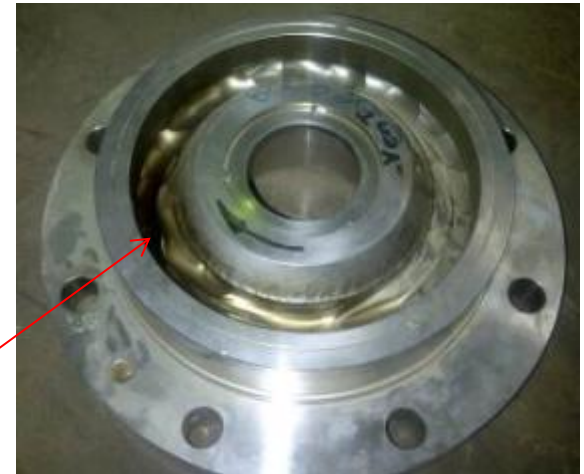
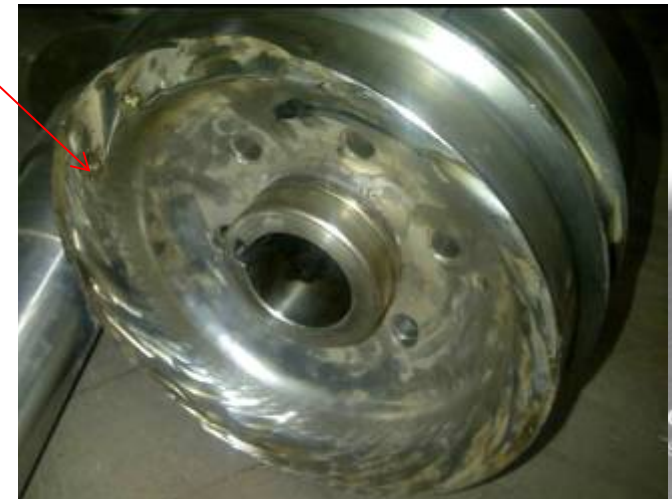
Erosion Pattern Location

- Pumps have been in service for 3 years without showing any performance degradation
- After mechanical seal failure, pump brought to maintenance shop for overhaul
- After dismantling severe erosion patterns on the backside of the impeller and cover at wear ring location
- No erosion pattern on front side of the impeller

- No erosion damage on the front side
- Severe fish skin erosion
- Impeller back at wearing neck
- Cover inner side

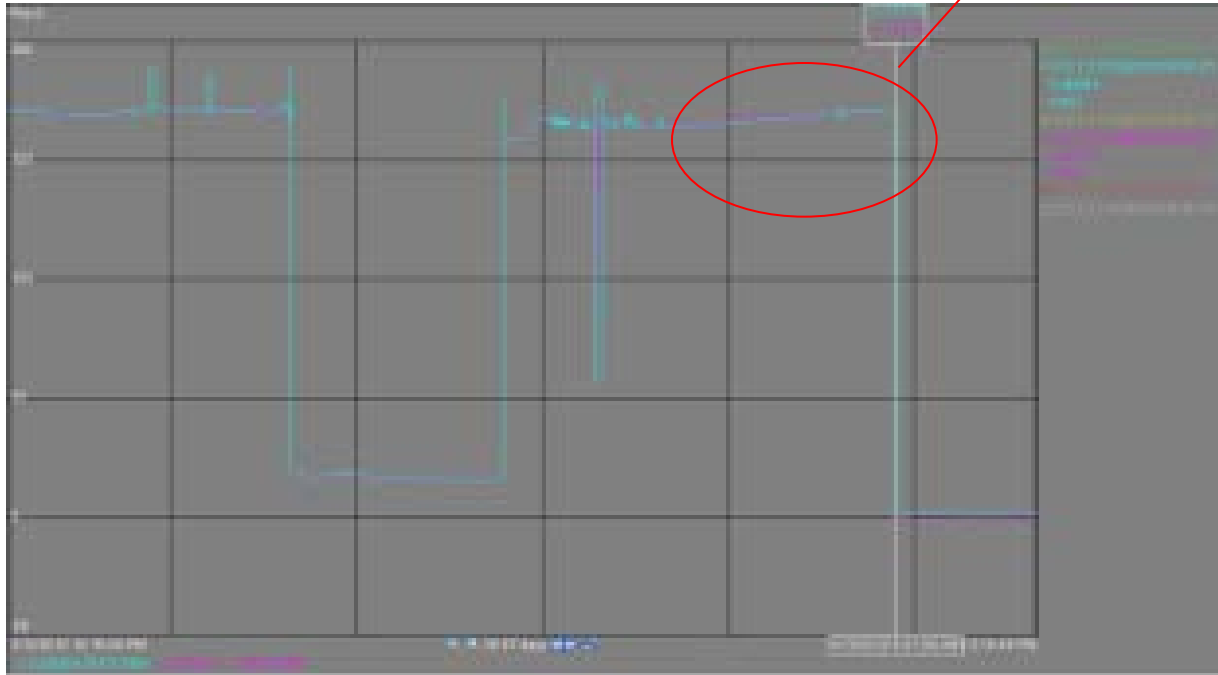
Main Discharge pressure
around 170 psi g

- Tdh @ operating condition
- Total diff pressure = 114 Psi
- Total diff head = 258 ft

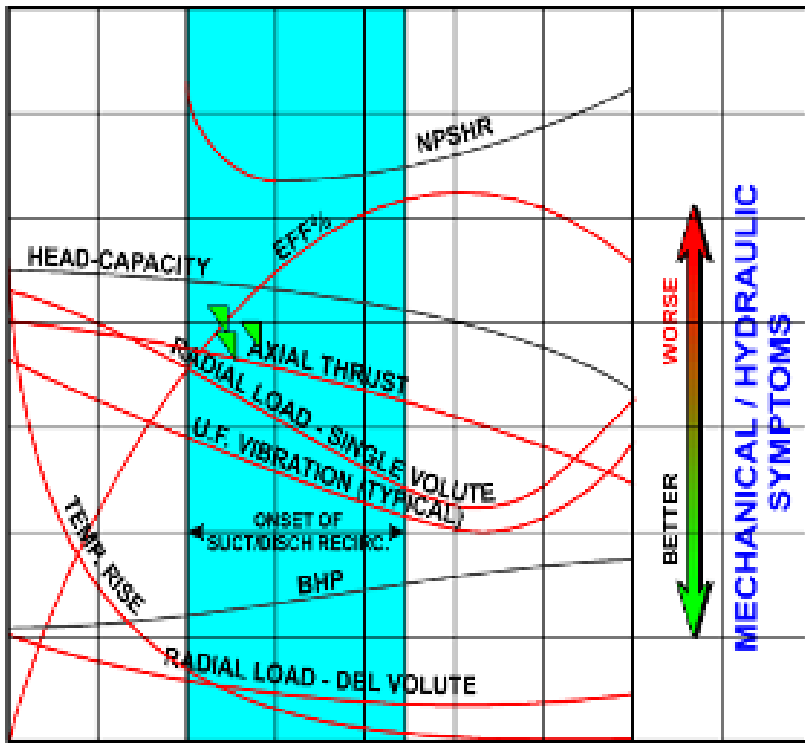
Operation far from BEP will result in:

- Amplification of known hydraulic phenomenon
- Pump fluid will transfer more energy to wall surface
- High turbulence in narrow clearance area

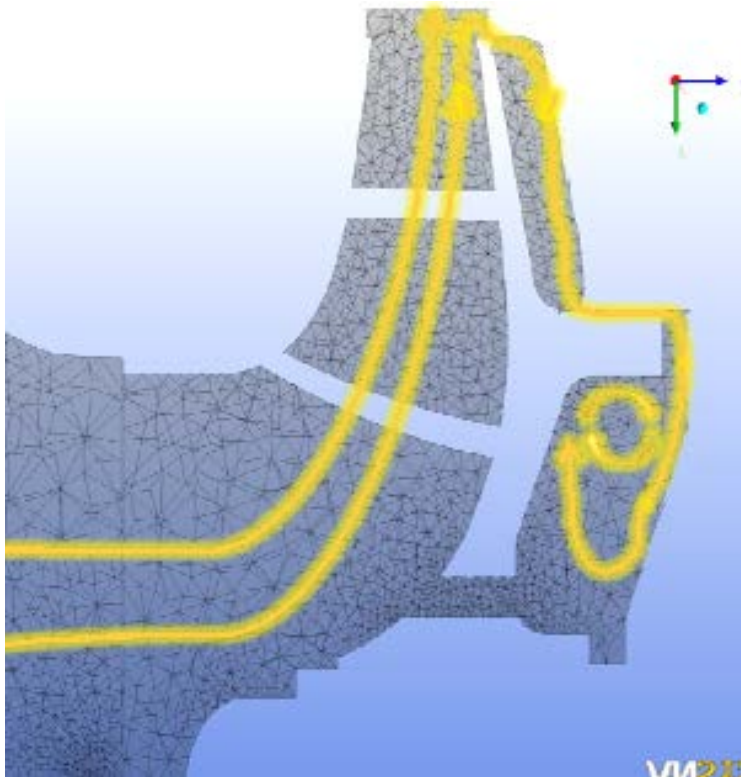
Flow Path Identification

An analysis of the leakage flow path study done by Flowserve in a more severe abrasive service environment has demonstrated:

- Particle diameter plays an important role, only particles with smallest diameter enter the back shroud chamber
- A portion of the flow entering in the back shroud chamber is trapped, thus particles suspended are trapped in this chamber resulting in an accelerated erosion damage

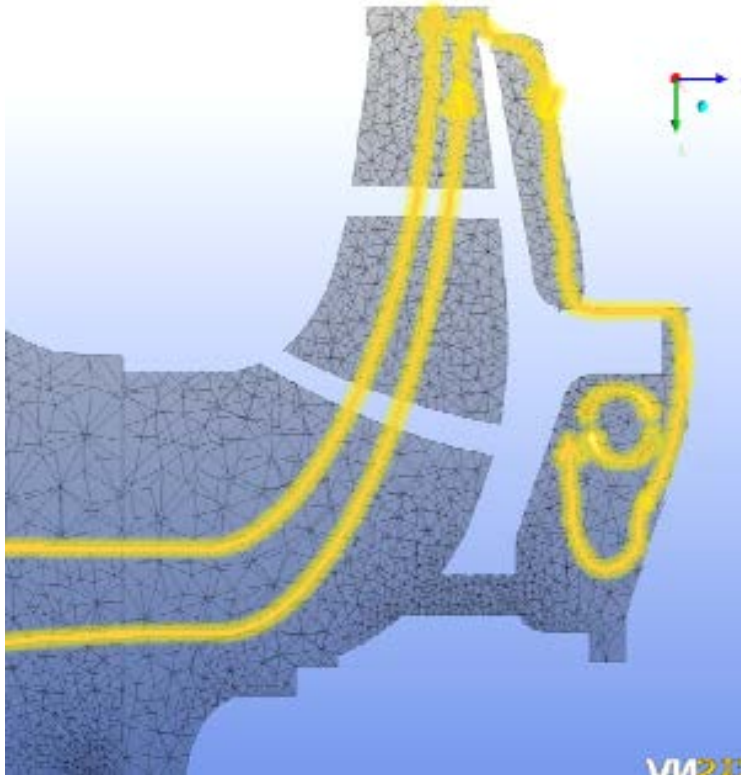
Flow Path Identification

- Erosion damage is more severe when operating off BEP with a high impinging energy thus resulting in a more severe erosion rate
- Current design suggests a dead zone on the back side of the impeller and cover.
- Trapped particles will remain and won't be flushed.
- Therefore increased erosion rate
