# SEVERE SUCTION BELL DAMAGE IN LARGE, OPEN IMPELLER, VERTICAL TURBINE PUMPS

by  
**Michael D. Smith**  
Pump Consultant  
Dupont Company  
Wilmington, Delaware

## ABSTRACT

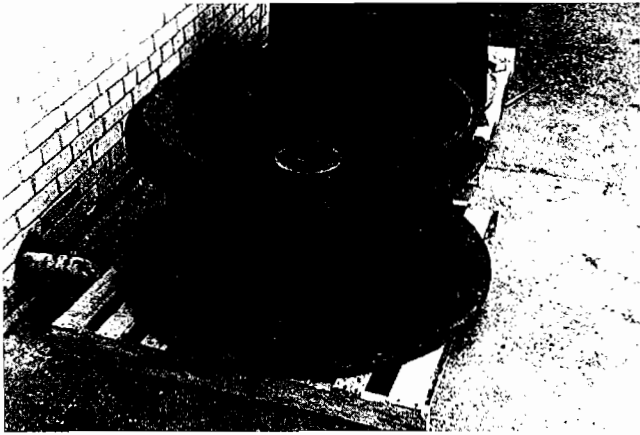
Nine 1500 hp single stage, vertical turbine, cooling water pumps suffered massive suction bell metal loss within 5000 operating hours (Figure 3). The same problem was observed, to a lesser extent, on seven 500 hp pumps in the same system. It took over 13,000 operating hours to reach the same level of damage as the larger pumps. Plant production depends on the availability of

Figure 3. Metal Loss Resulted in the Penetration of this 42 Inch Supply Pump Suction Bell.

The larger supply pumps had suffered much greater metal loss than the lift pumps, so there was no way to repair the suction bells or fit them with inserts. Also, there was concern that even the nickel-aluminum bronze might not be satisfactory in this service, given the inability of manganese bronze impellers to maintain an oxide layer (Figure 7). The long term solution was to convert the supply pumps to enclosed impellers. This allowed the new suction bells to be made from cast iron, since they would not be exposed to rising pressure. The new impellers contain all bubble collapse activity and are made of 316 SS, which was expected to be more than adequate for long life in these conditions.

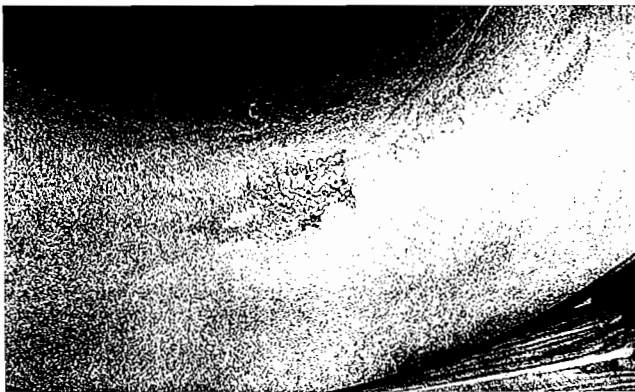
was removed for inspection. While the pump was apart for other work, a localized loss of metal was discovered on the suction bell in the area swept by the first third of the impeller vanes. The affected area was less than 3.0 in across, but had one pocket over 0.25 in deep (Figure 4). The belief at the time was that normal wear had uncovered a casting defect, and the supplier agreed to provide a free replacement bell.

Figure 4. Early Suction Bell Damage Is Localized.

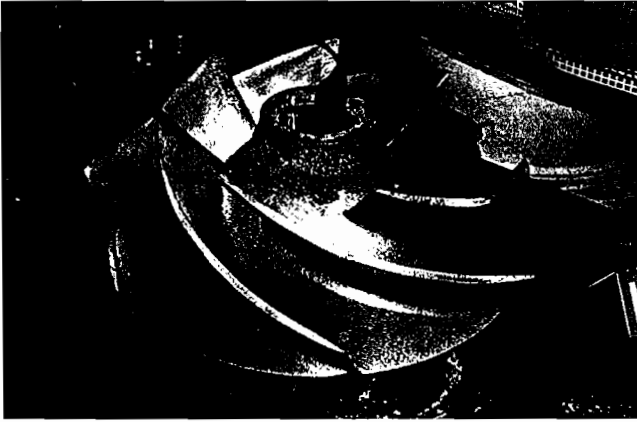
Figure 7. Supply Pump Impeller Has Developed a Dark Oxide Layer Only in the Hub Area.

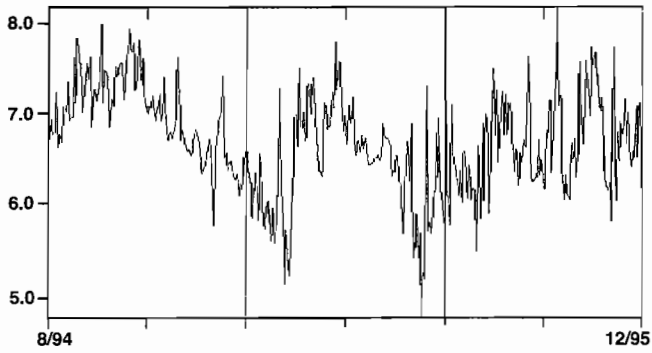
No evidence of an unusually high level of abrasives was found. Corrosion always plays a role in metal loss, whether due to erosion (oxidizing the newly exposed surface) or surface fatigue (corrosion lowers the endurance limit). There are several variables that impact how "aggressive" water is to cast iron. Temperature (Figure 8), pH (Figure 9), conductivity (Figure 10), residual chlorine (Figure 11), and total chlorides (Figure 12) were recorded throughout the life of the damaged pumps. While the two periods of low pH are suspicious, one supply and one lift pump were not in service during either period and accumulated the same damage as the other pumps. This indicates that the periods of low pH did not have a measurable impact.

Figure 9. Cooling Water PH During First 17 Months of Operation.

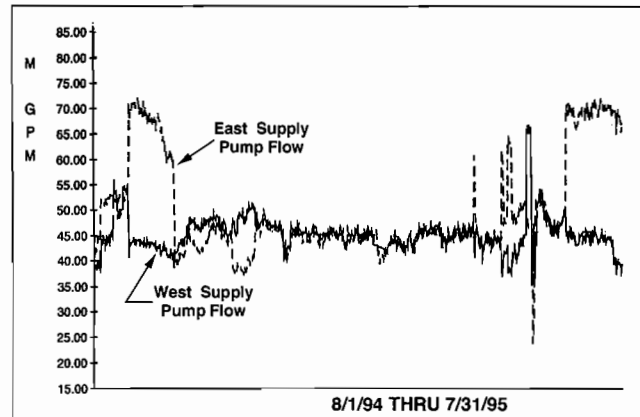
The plant cooling water system flowrates were also recorded (Figure 13). There is no pattern of operation above rated capacity and there were no reports from the field of the noise that would certainly occur if pumps of this size were cavitating.

Figure 13. Supply Pump Station Flowrates.
