THE USE OF BASIC HYDRAULICS TO SOLVE FIELD PROBLEMS: THREE CASES

CASE 1: COOLING WATER PUMP CASE STUDY— CAVITATION PERFORMANCE IMPROVEMENT

CAVITATION DAMAGE AS RELATED TO OPERATING POINT

CASE 3: USE OF BASIC PUMP HYDRAULICS TO SOLVE PUMP MAINTENANCE PROBLEMS

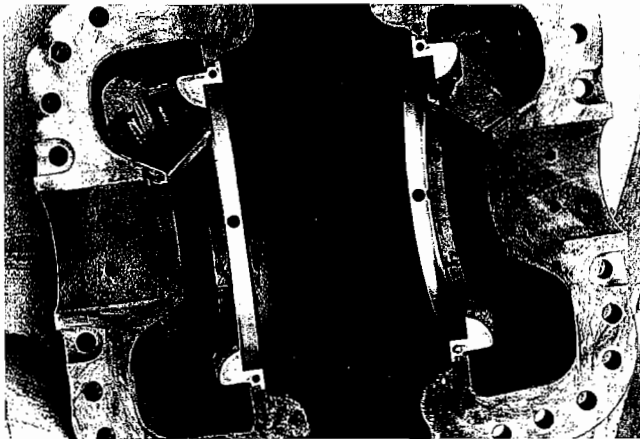
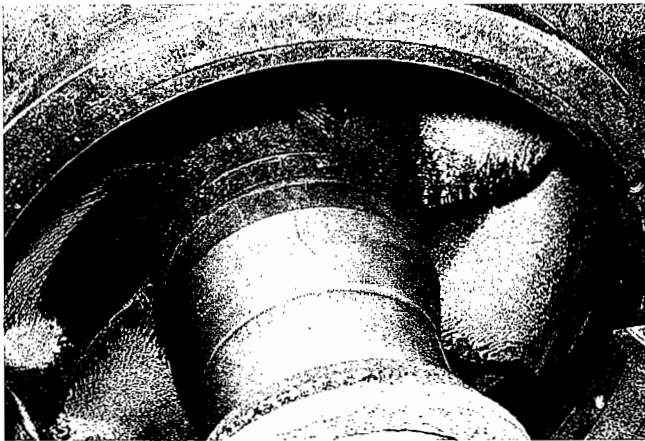
After three months, the pump "A" (with above modifications) was opened up and inspected (Figure 11). The damage pattern was different than before; it spread more evenly over a wider area of the suction side of the blades, but the depth of damage was less than originally experienced. It was apparent that the incremental improvement by the modification of the splitter and a bullring was not enough to achieve the desired impeller life of five years.

Figure 10. Special Bullrings and a Profiled New Splitter Shown Installed in the Casing, (top); on the bottom are Impeller Inlets, Suction Side, after Operating with above Combined Modifications for (3) Months.

Note the Damage Region now is in the Middle of the Blade, as Compared to original Damage Pattern (no Modifications) near Shroud.
