Vertical Pump Motor Synchronous Vibration Case Study

John Bezugly

Enterprise Products, LLP

Abstract

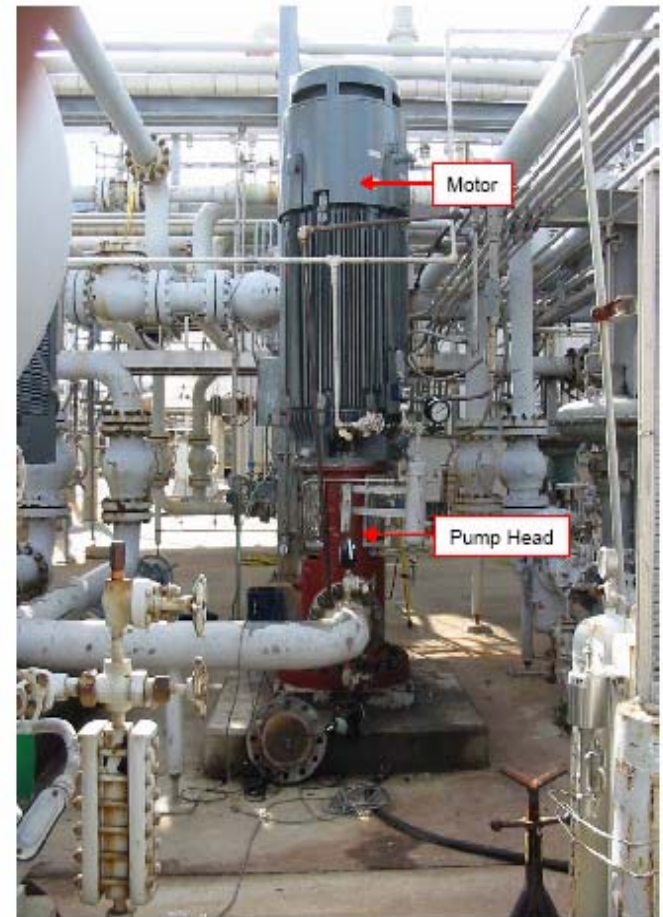
Iso-butane vertical pump

- July 2004 – Motor failed due to lightning strike
- Until failure motor ran between 0.2-0.25 in/sec
- Sent to motor shop for rotor and stator repair
- After installation motor vibration was nearly 2.0 in/sec. All at 1x (synchronous).
- Motor returned to shop twice after this:
 - Rotor slow speed balance checked $<4W/N$
 - Assembled motor balanced on steel and rubber surfaces to less than 0.1 in/sec
- Vibration level could not be reduced below 1.0 in/sec.

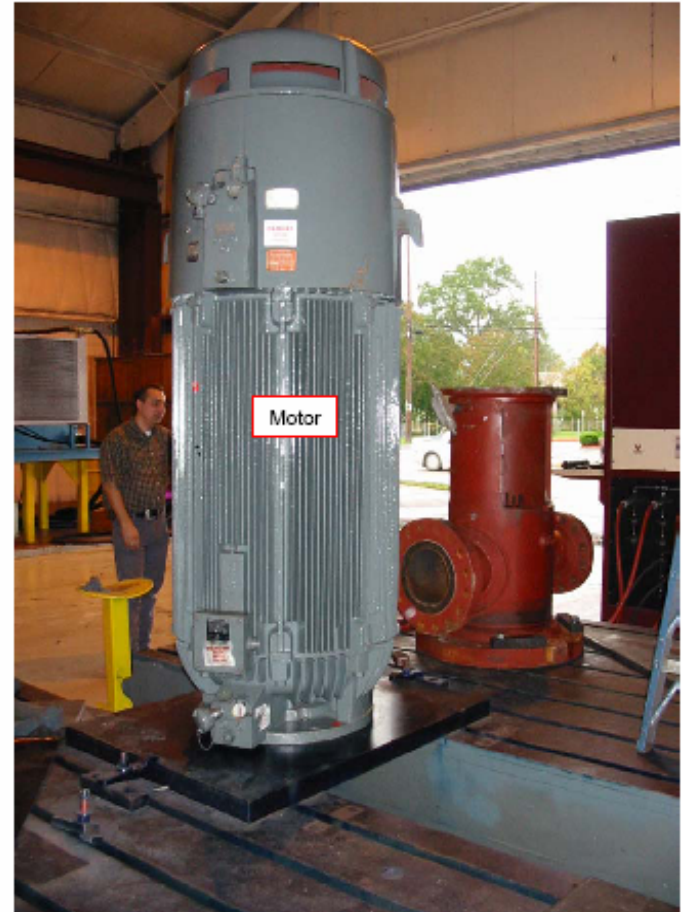
Motor Test with Pumphead

- Motor did not show signs of high vibration when tested alone at motor shop.
- Pumphead was brought to motor shop to evaluate motor vibration mounted on pumphead.
- Vibration of motor mounted on pumphead matched field observation of 1.0 in/sec.

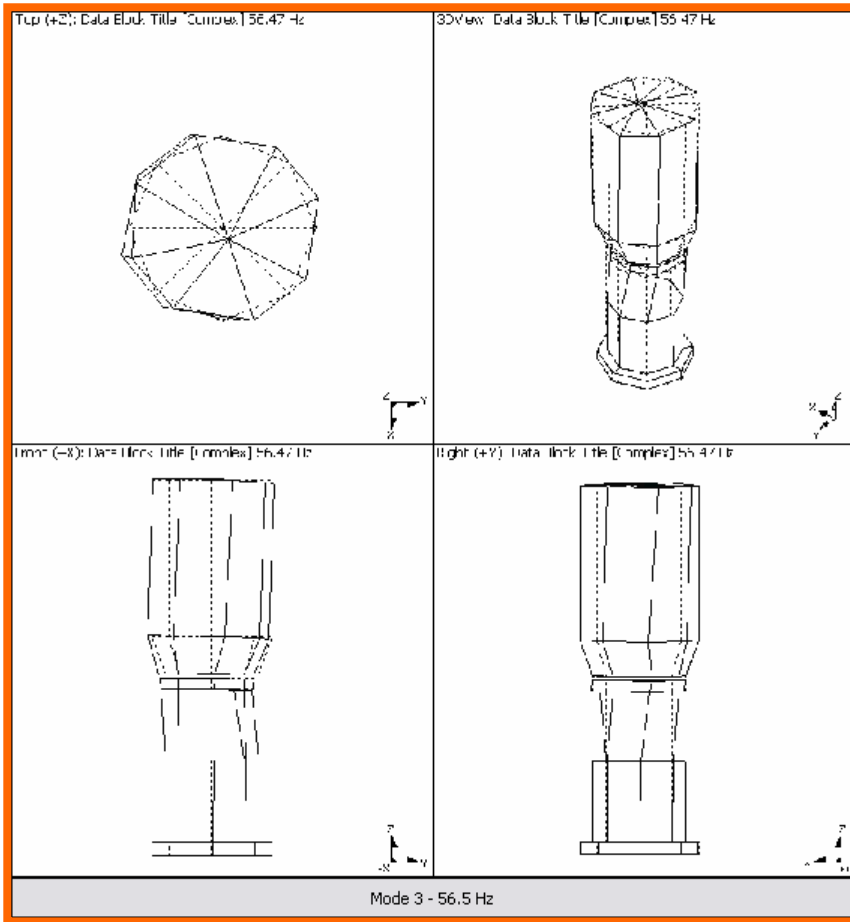
Torsional Mode 56.5 Hz

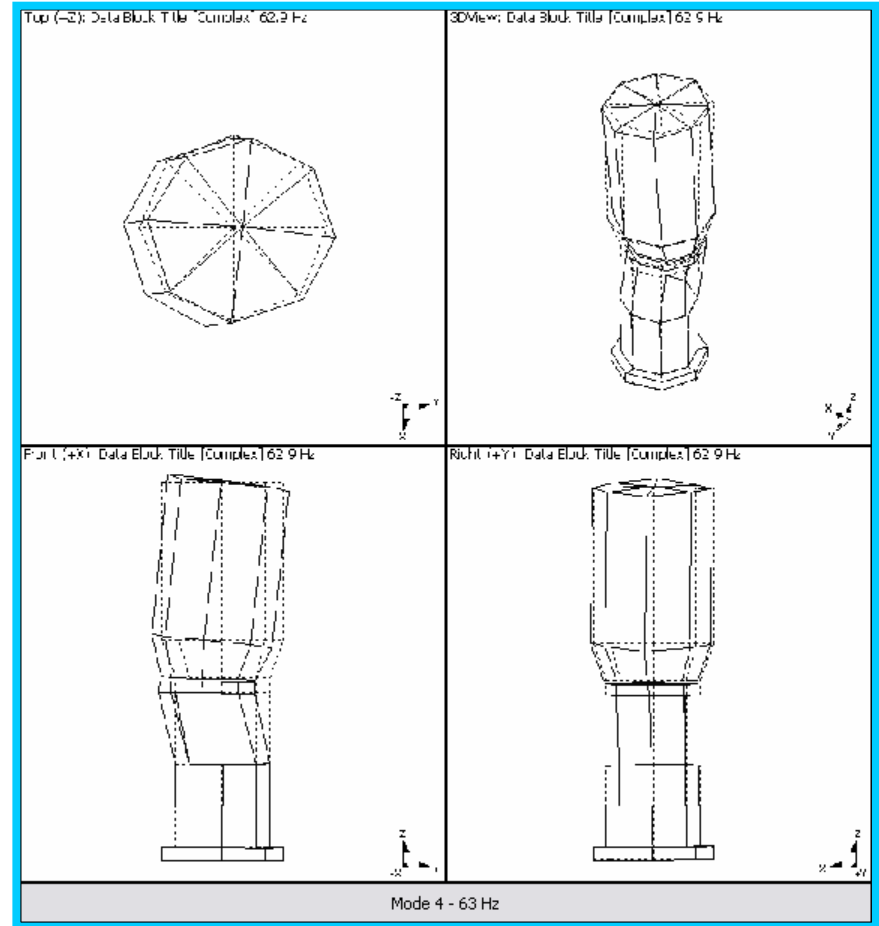
"Hula" Mode 63 Hz

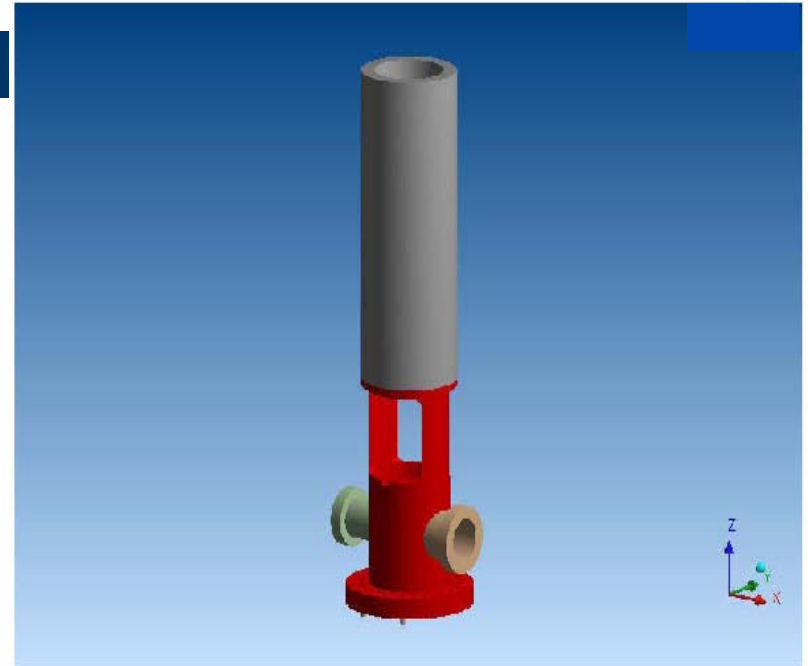
Motor-Pumphead FE Model

- Consultant recommended moving natural frequencies away from running speed by modifying pumphead structure.
- Consultant performed Finite Element Analysis (FEA) of motor pumphead system in order to determine most effective modifications.

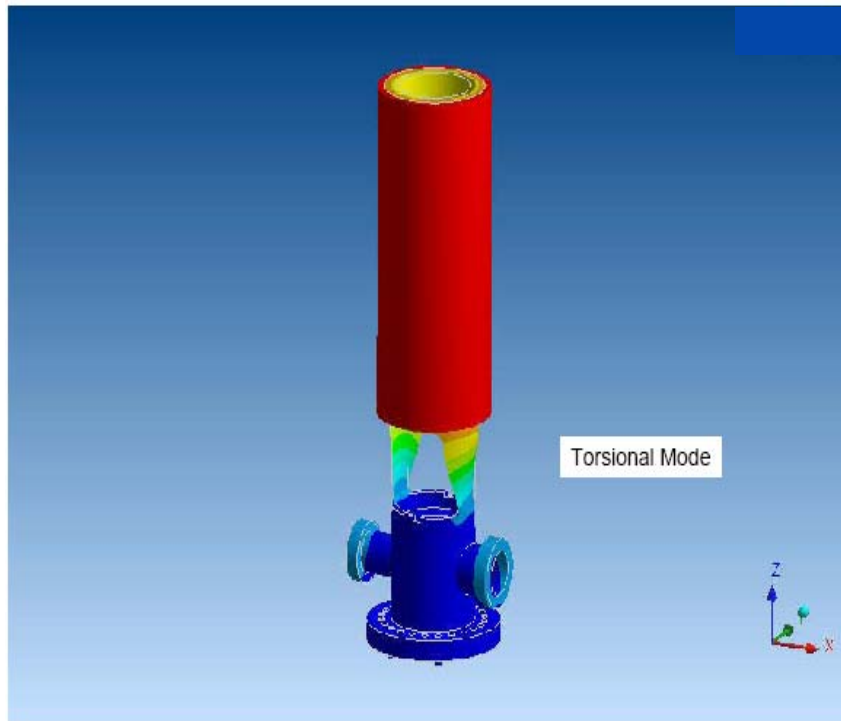
Torsional Mode 42 Hz

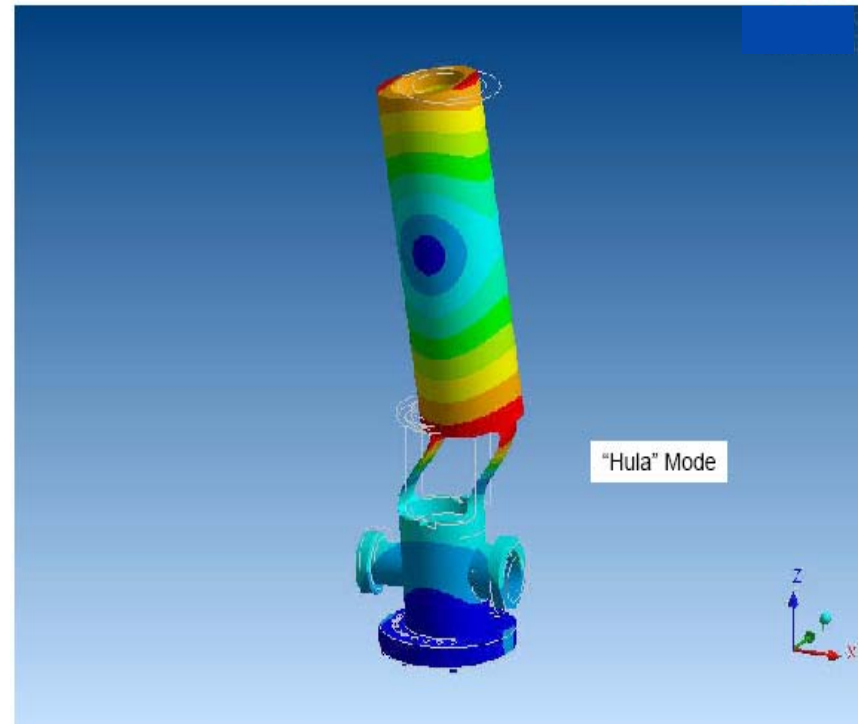
"Hula" Mode 52 Hz

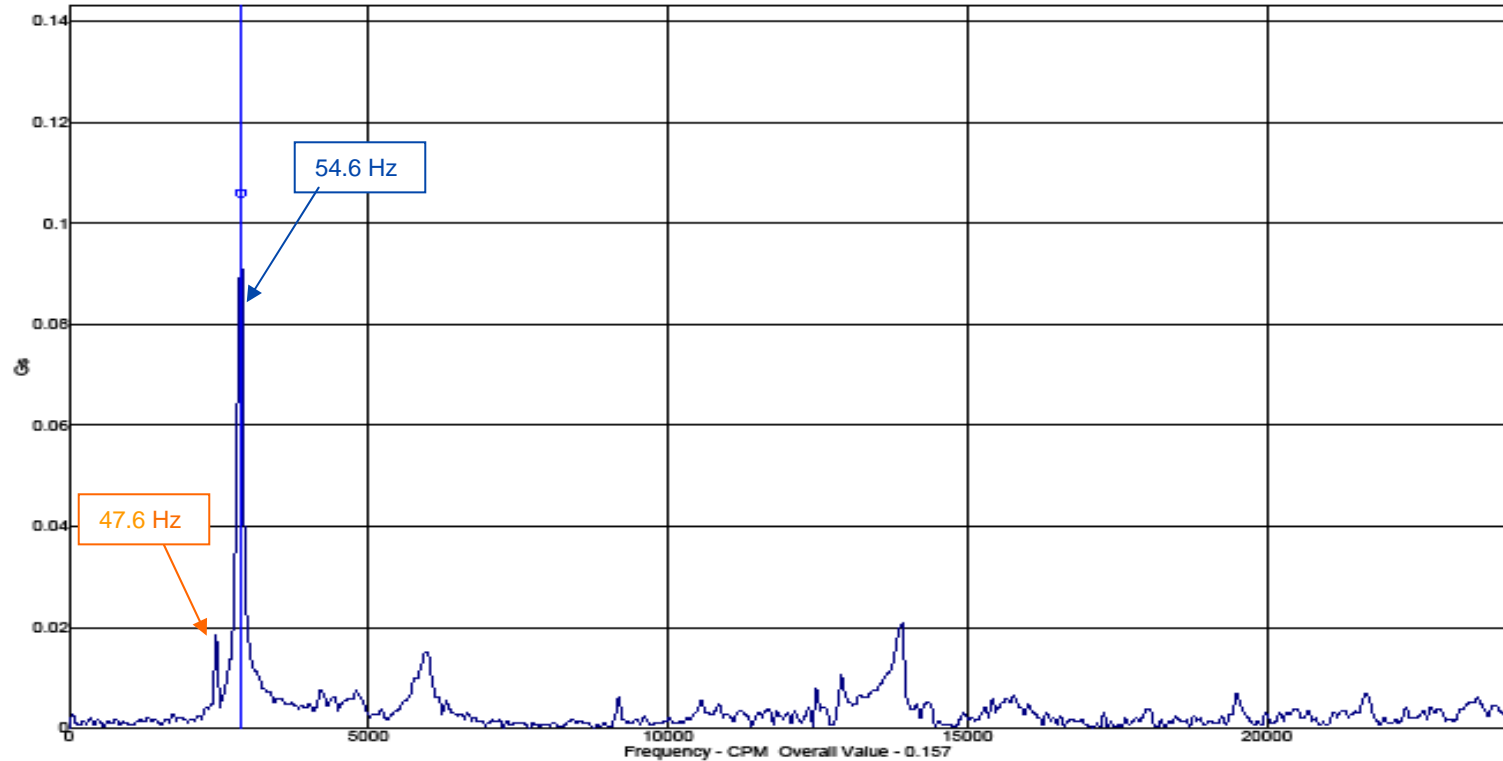
1st Modification – Bump Test Response

Modification Description	Torsional Mode (Hz)	1 st "Hula" Mode (Hz)	Overall Vibration (in/sec pk)
Original	None	56.5	62.8	~1.0
First Modification	Increase window size of pump-head	47.6	54.6	~0.76

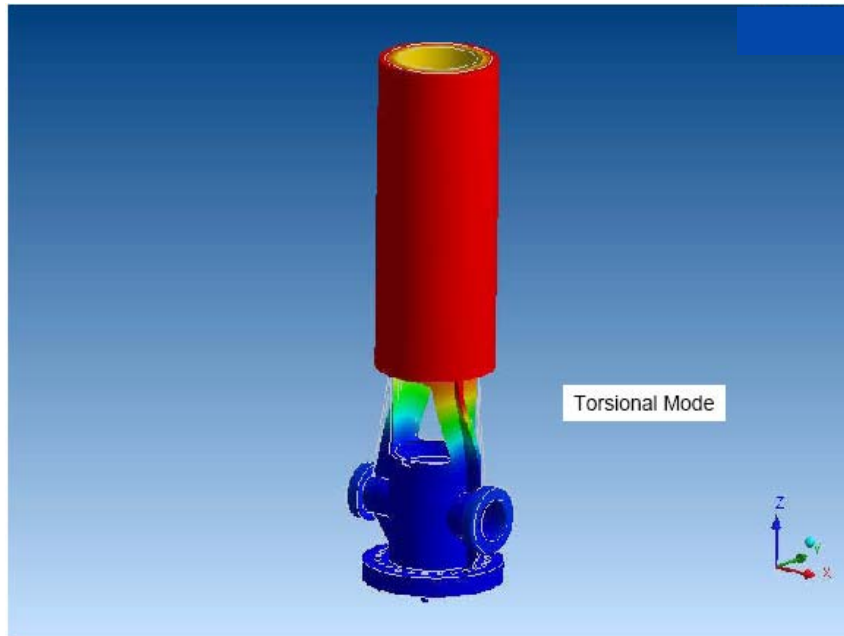
Torsional Mode 44 Hz

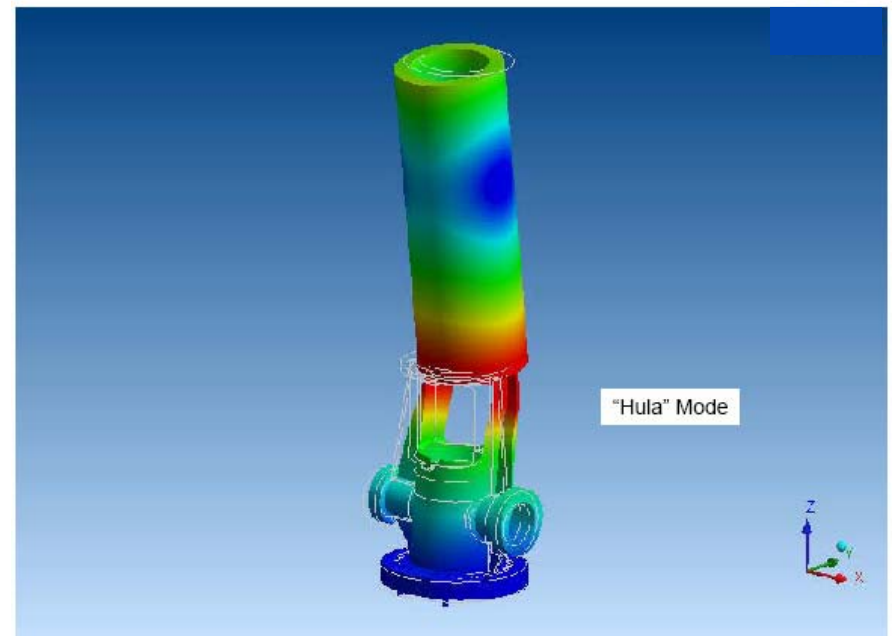
"Hula" Mode 85 Hz

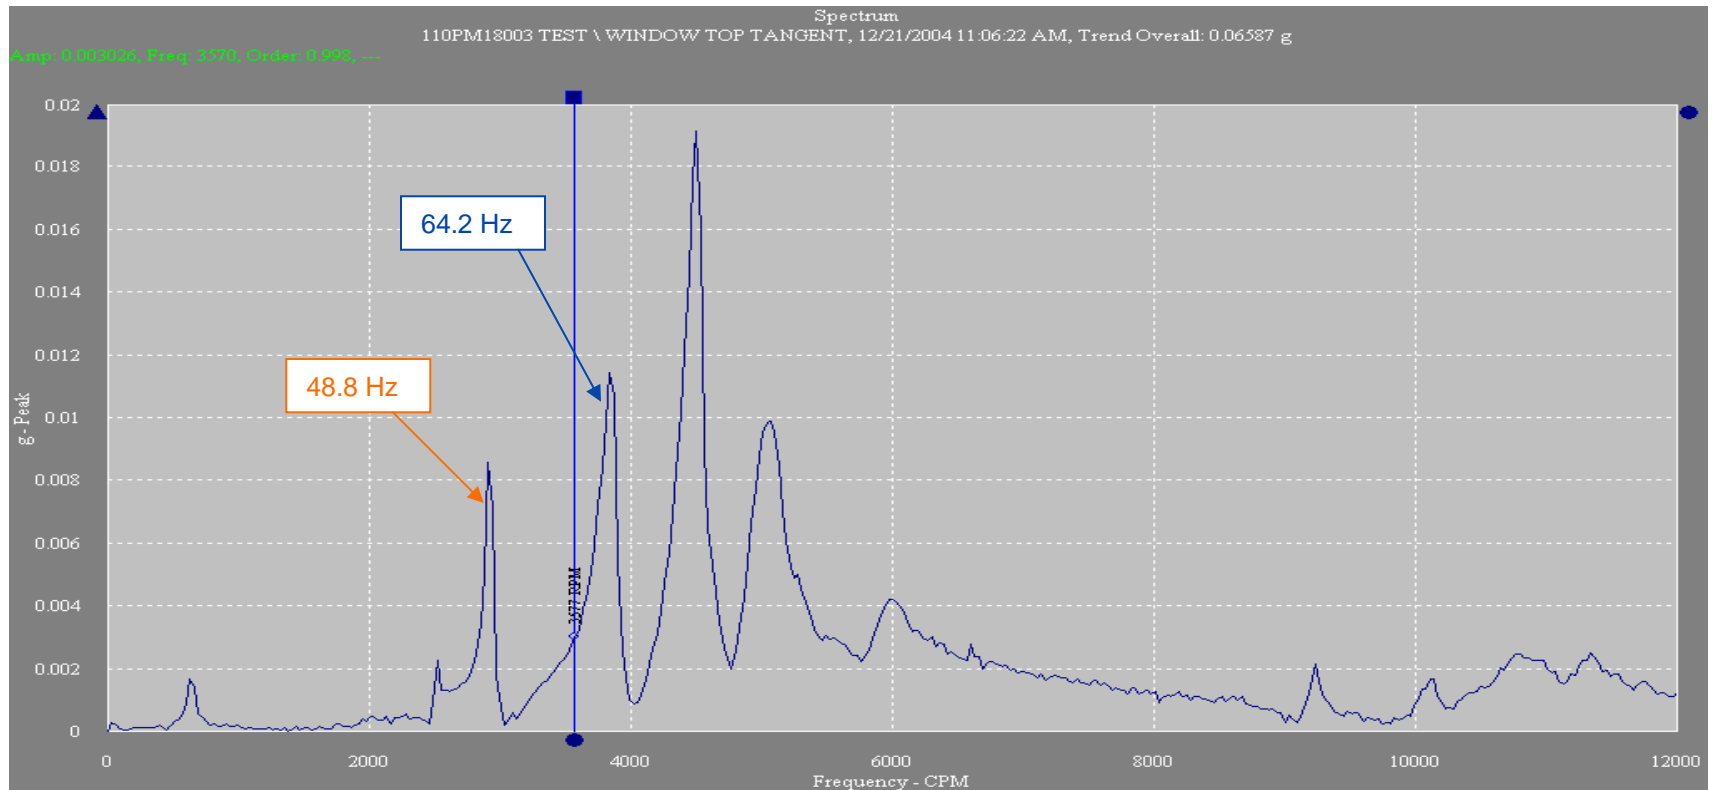
2nd Modification – Stiffening Gussets

Natural Frequency Changes to Motor/Pump-head and Effect on Running Speed Overall Vibration				
	Modification Description	Torsional Mode (Hz)	1 st "Hula" Mode (Hz)	Overall Vibration (in/sec pk)
Original	None	56.5	62.8	~1.0
First Modification	Increase window size of pump-head	47.6	54.6	~0.76
Second Modification	Add stiffening gussets to pump-head	48.8	64.2	~1.01

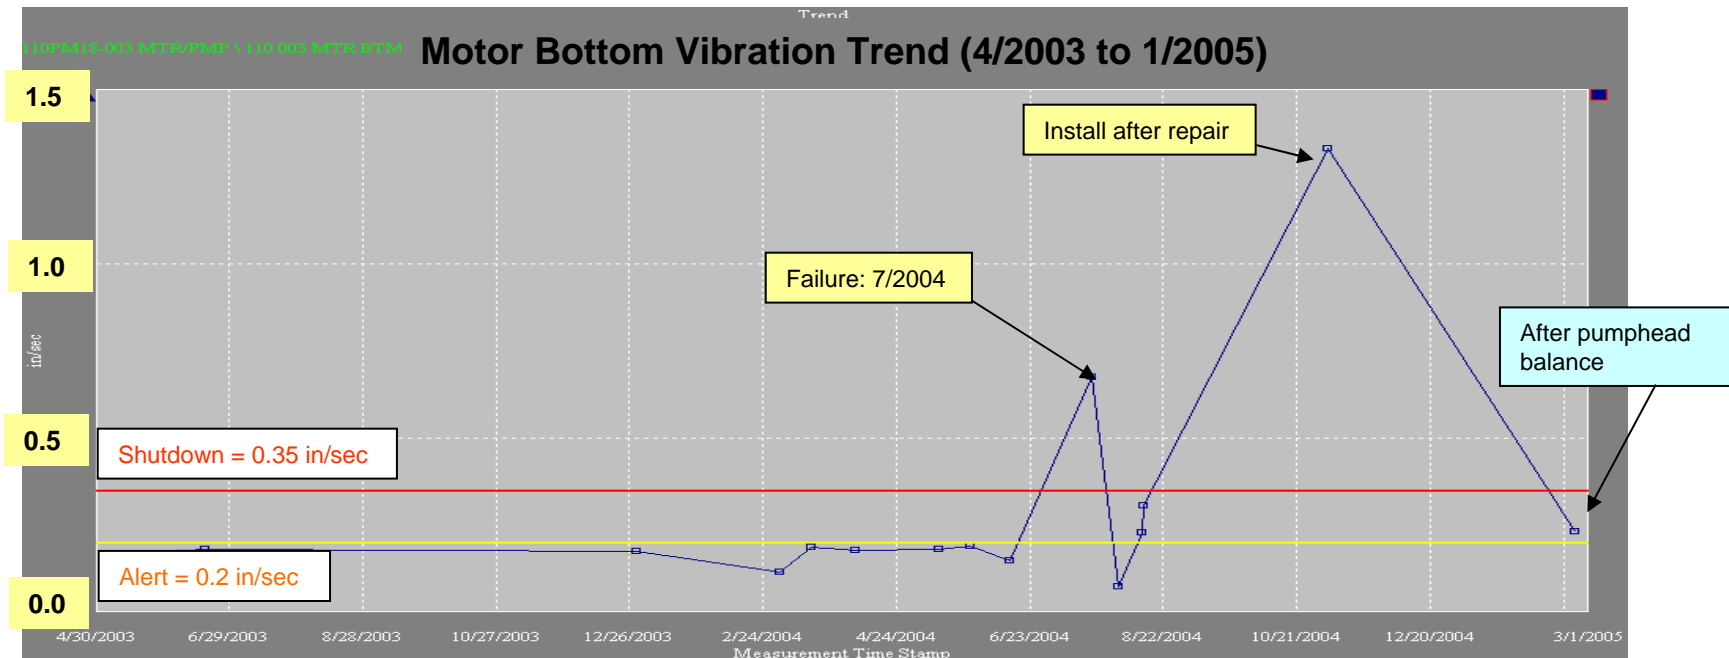
- Balancing on pumphead had not been attempted before because:
 - Balancing of the motor on rubber and steel to less than 0.1 in/sec was thought to be sufficient. After first repair attempt this criterion was lowered to less than 0.05 in/sec on this motor.
 - Balancing of the motor on pumphead could require that motor be matched to the pumphead.

- Detuning effort was not successful and consultant recommended new pumphead design.
- Since this motor had been running for many years with no natural frequency issues and sister pump of same design did not exhibit such behavior decision was made to attempt balancing motor on pumphead.
- Motor shop two-plane balanced motor to 0.1 in/sec. Top and bottom of motor were nearly 180° out-of-phase.
- Motor and pumphead were installed in the field and ran at 0.25 in/sec.

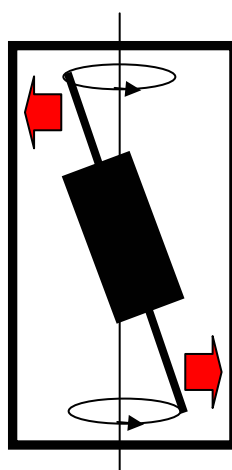
Conical Mode
(2nd Critical)

Need to couple balance suggests possible 2nd critical near running speed or very high couple unbalance.

- Rotor balance is a slow speed balance. Did not correct for couple unbalance present at 3600 RPM.
- Couple unbalance of 2000 lb rotor in 7500 lb stator did not produce significant vibration of assembled motor on rubber and steel.
- Motor rotor couple unbalance caused deflection of flexible pumphead.

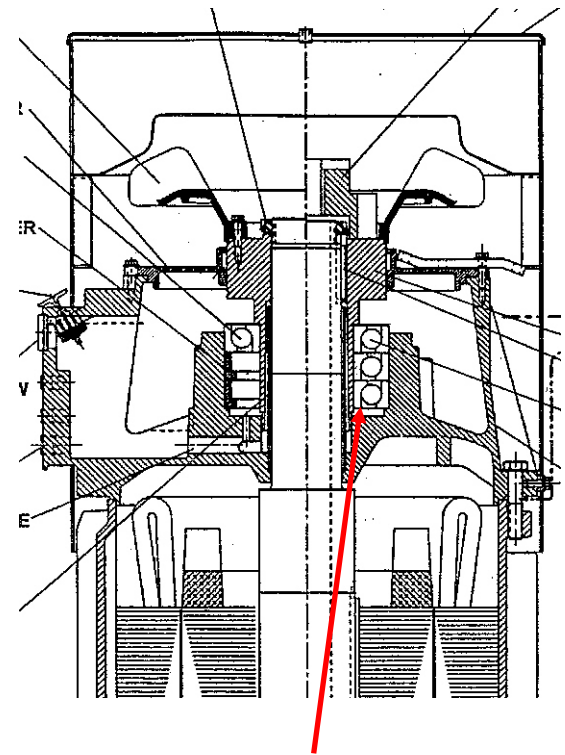
High Thrust Bearing

- All these motor applications had high thrust bearing design consisting of 3 angular contact bearings (2 down, 1 up).
- Lack of precision of fits at upper thrust bearing could create high unbalance due to eccentricity.
- Insufficient down thrust causing improper loading of bearing and affecting stiffness.
- Other motor shop experience suggests significant attention needs to be paid to thrust bearing area during assembly with 3600 RPM high thrust motors.

- 1) Consider check balancing of 3600 RPM, 4160 V vertical high thrust motors on pumphead.
- 2) Close inspection of thrust bearing fits.
- 3) On some of the new motors that exhibited this problem it was found that installing a wavy washer above the bottom bearing stabilized the vibration.
