# DESIGN AND OPERATION REFINEMENT OF A MULTISTAGE LIGHT HYDROCARBON PUMP

**Kenneth R. Laplant**

**Charles R. Rutan**

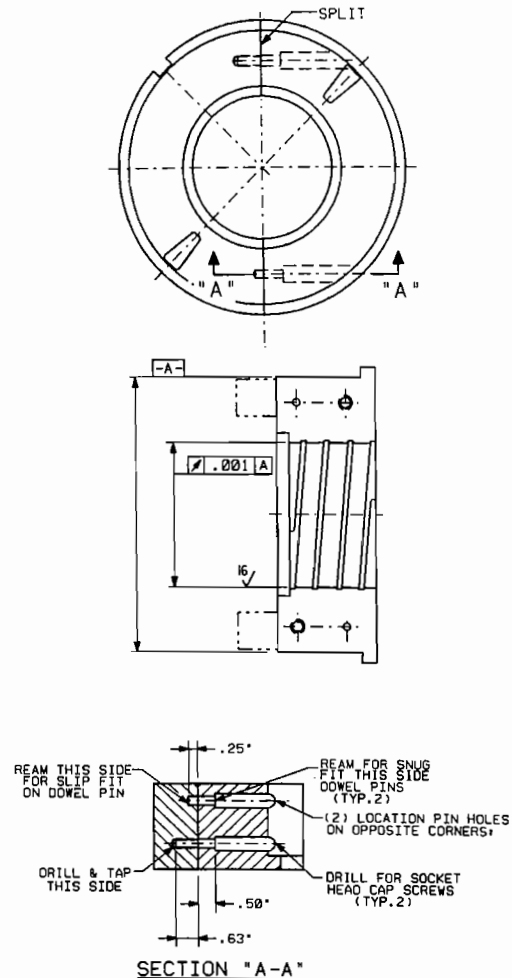
Figure 4. Split Bushing.

The interstage bushings and most of the impeller hub case rings were converted to a split design (Figure 4). The impeller hub case rings were converted in order to aid the balance operation and to eliminate the possibility of distortion of both hub and eye stationary rings during disassembly. Plant engineers worked with the pump manufacturer to design split bushings for a pump which was not originally designed with this in mind. Split bushings must be designed in a way that ensures the original integrity of the solid bushing and does not allow fasteners and alignment pins to loosen and fall into the pump during operation. The key to successful manufacture of split rings and bushings is to prepare the mating surfaces initially, with alignment pins installed, then clamp the halves together. The part should then be match marked and finished as a whole part. A valuable secondary benefit of this design is that it allows accurate runout checks on the assembled rotor. However, in order to obtain good runout data, the interstage sleeves where the rollers are to be placed must have concentricity and runout limited to 0.0005 in.

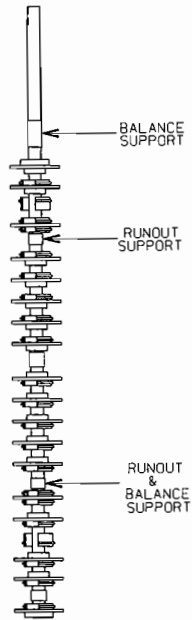
Figure 5. Pump Rotor.

The balance sequence for the rotor starts with an individual balance of all impellers to the, API 610 7th edition, 4W/N tolerance. In the balance stand (Figure 5), the rotor is set with rollers placed at the second interstage sleeve and at throat bushing sleeve. The impeller eye case rings and the two bypass cylinders are held away from any moving parts with tape supported from a piece of pipe. The balance operation then proceeds working from the middle out until the 4W/N tolerance is met. On this 500 lb rotor, this translates to 7.9 gram-in per plane.

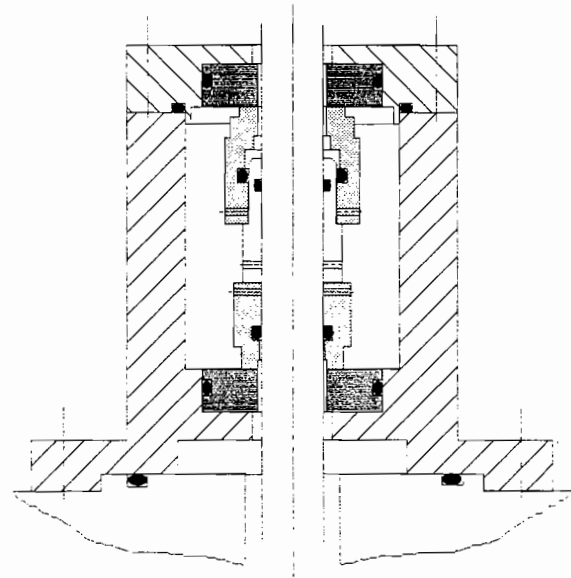
Figure 6. Double Seal Arrangement.

The original design specifications for this pump requested the use of a double mechanical seal. The seal was a standard pusher type seal with an unbalanced inner seal and a balanced outer seal. The seal system (Figure 6) employed the use of a reservoir which was outfitted with an elastomeric diaphragm and a 50 lb plate which was placed on top of the diaphragm. The lower side of the reservoir beneath the diaphragm and the volume between the two seals was inventoried with ATF fluid to a predetermined level. The top side of the diaphragm was referenced to the process side of the seal and had a small amount of methanol placed on top of the diaphragm to act as a lubricant and to provide a buffer between the process gas and the diaphragm. As a result, the inner seal carried a steady state load of 50 lb, while the outer seal carried the load of the process pressure plus the 50 lb weight, approximately 400 lb. A process recirculation line was provided at a point just above the top guide bushing (throat bushing) and directed back to the suction of the pump. Its purpose was to provide a continuous flow across the bushing and to maintain a stuffing box pressure approximately 75 lb above suction pressure.

The pump manufacturer claimed that this design had been used in many cryogenic applications with enormous success. However, in this case, the process temperature is a "mild"  $-37^{\circ}\text{F}$  with the pump located outdoors on the hot Texas Gulf Coast. As a result, the outer (load seal) produced so much heat that the seal was failing on a monthly basis. The ATF was replaced with an ethylene glycol and water solution which resulted in a minor improvement. A makeshift cooler and circulating pump had to be added to alleviate the problem. Also, during preparation for startup, the inner seal mating ring was often dislodged by the sudden introduction of nitrogen and methanol. Attempts to pin the ring and modify the "air free" procedure were made with little success. It was obvious that this particular design had been misapplied. In addition, this setup, as designed, created other problems as follows:

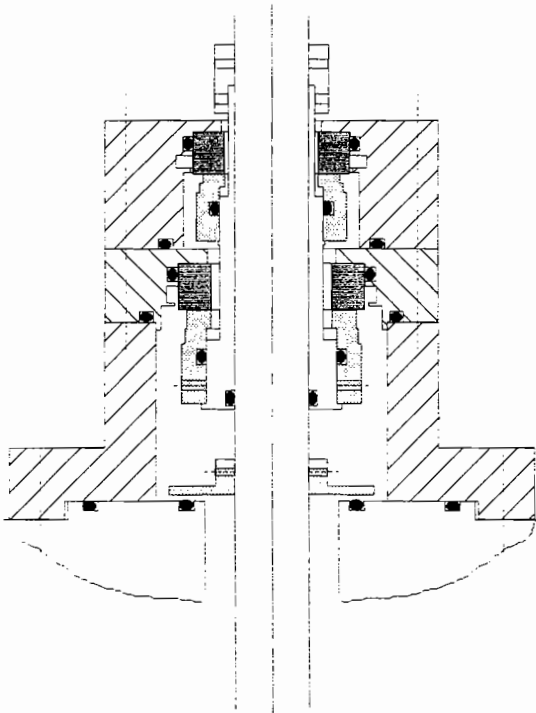
Figure 7. Tandem Seal Arrangement.

The plant personnel surmised, based on past experience, that a tandem seal system would be far superior in this case and also could be designed in a way that would address the other problems (Figure 7). The tandem seal design, also a pusher type, required a new seal chamber design with a larger bore and a standard seal pot. The new chamber was designed to be lighter (to facilitate an improved alignment technique) and to provide the seal with a hospitable environment in which to operate. With these changes, seal orientation would no longer be a problem and the presence of a weighted elastomeric diaphragm would no longer be required. Additionally, a plan 13 flush arrangement was incorporated, which was routed back to the vapor space of the suction vessel, thus providing adequate cooling to the seal. Also, the pump would remain liquid full, via gravity flow, even when on standby. Care was taken not to pocket this line in order to encourage a continuous cooling flow during standby. The recirculation line is no longer used, and the pump remains ready to start at any time without bleeding off valuable product from the inner pump case.

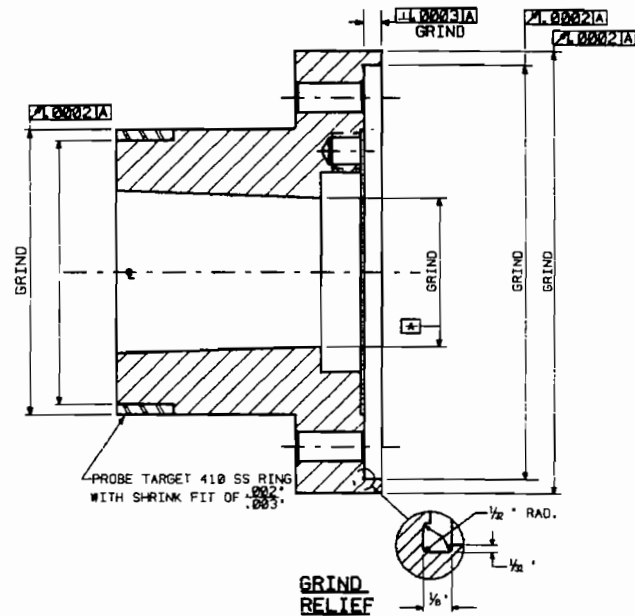
Figure 8. Coupling Assembly on Mandrels.

The coupling for this pump is a rigid type hub and spool coupling with a lift nut for setting the pump rotor position in the pump (Figure 8). This type of coupling has been a standard for applications such as ours for many years and has a good record throughout industry. However, the authors recognized after several long arduous alignment sessions, that perhaps the coupling itself could be the cause of most of their alignment woes. After all, they have gone to great lengths to ensure the straightness of the pump and motor shafts. What else could make the rotor system appear to be bent or bowed sometimes, but not other times? Great care was taken to carefully machine the coupling during repairs and during occasional manufacture without much improvement in performance.

Assembly of the coupling for check out and balance requires the use of a set of precision mandrels. The mandrels that are used have been coated with chrome oxide in the fit areas to ease the removal of the hubs and to reduce the chance of scuffing or galling. The mandrels for both pump and motor hubs allow for a 0.0005 in to 0.0020 in shrink fit. A detailed check of each phase of the assembly is made using a diagram and check list. In all, four different diagrams are used and seven sets of data are taken during the check out process. The fourth diagram (Figure 8) is used four times while

The manufacture of the coupling components is a straight forward process but, requires attention to detail. Partial drawings shown in Figures 8 and 9 show limits of perpendicularity of 0.0003 in, parallelism of 0.0002 in and concentricity of 0.0002 in. Note the

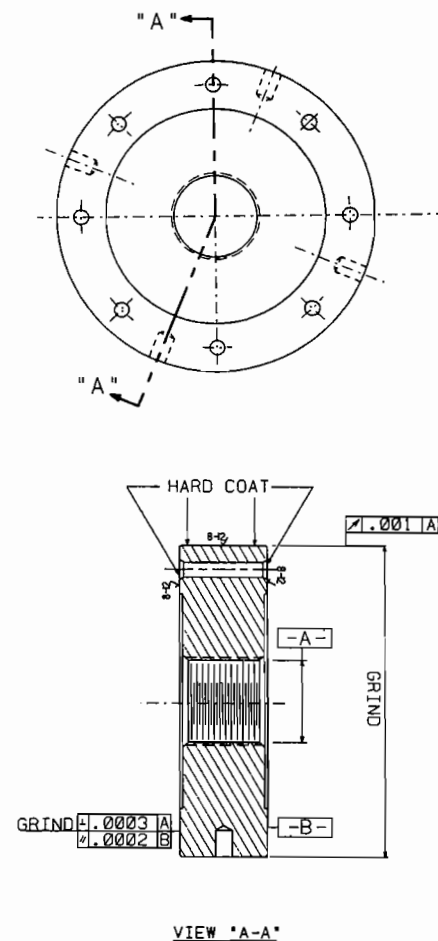
Figure 9. Coupling Hub Detail.

use of grind reliefs and chamfers in the design, which aid in manufacture of the coupling to these tolerances. The bolting design does not include a body bound assembly. However, it does result in a close tolerance fit, which does not create unacceptable balance drift during subsequent assembly operations. After manufacture, the coupling is assembled and checked for runouts. Corrections are made as required at this time.

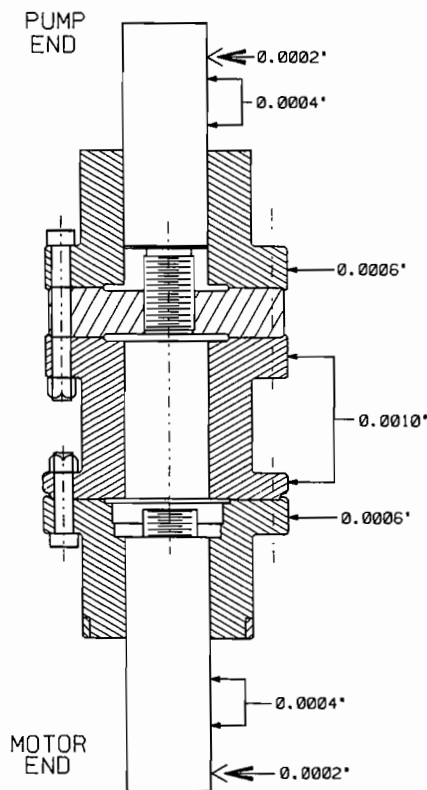
Figure 10. Lift Nut Detail.

taking runout readings with the lift nut set at 90 degree intervals through one turn. These extra steps virtually assure a successful field installation. The maximum runouts shown must be met or rework will be necessary.

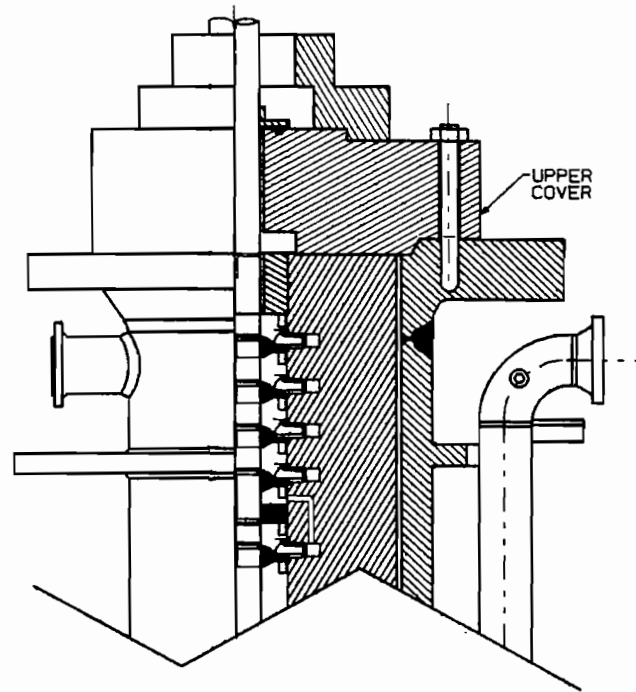
Figure 11. Pump Mounting Cross Section.

Alignment of a critical, vertical process pump starts at the foundation. The mounting plate, when grouted into place should be level within 0.002 in/ft. The mounting flange on the "can" must provide a surface for the pump case to sit on, which will maintain the level provided by the foundation (Figure 11). This requires precision machine work at the factory as well as conscientious care of these mating surfaces in the field by the users technicians.

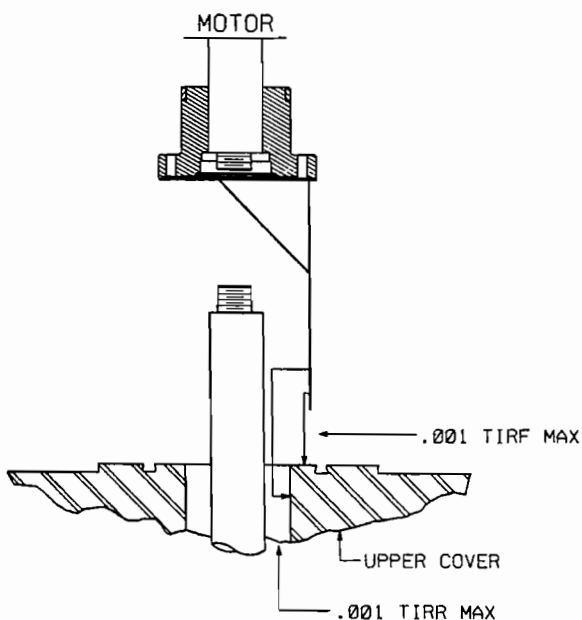
Figure 12. Motor to Cover Alignment.

With the upper cover mounted to the pump, the motor mounting bracket is installed and secured to the pump assembly. The motor is then installed with utmost attention to cleanliness at the fit surfaces. At this time, motor to pump alignment is performed by mounting a dial indicator to the motor coupling hub and indicating off the upper cover bore (0.001 in TIRR) and the upper cover face (0.001 in TIRF) on a 4.0 in radius (Figure 12). The preceding step was made possible by two modifications, which allow the installation of the seal chamber to take place after installation of the motor. First, the seal chamber was made much lighter by developing a more compact design, thus making installation possible without the assistance of an overhead lifting device. Also, in order

to fit between the two shaft ends, the pump shafts had to be shortened by  $\frac{3}{4}$  in.

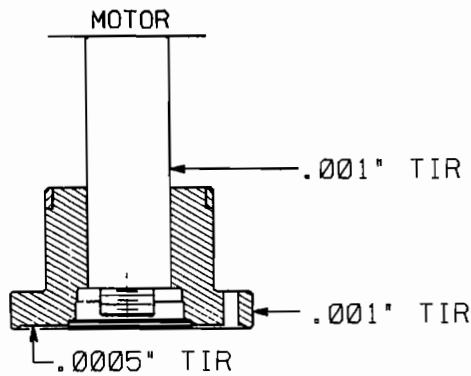
Figure 13. Motor Hub Runout Checks.

The coupling is now installed using a very meticulous procedure which was developed at the plant. The authors' experience has been that the pump manufacturers stress good alignment, but do little to assist the user in developing good procedures which are applicable to the plant environment. Also, factory alignment for test stand purposes is accomplished using equipment often not available in the field and usually performed by "old timers" who carry the procedures in their heads. The rigid coupling design used on this pump has eight mating surfaces that must be in near perfect condition in order to obtain an acceptable long lasting alignment. The rigid coupling, in effect, makes the pump and motor rotors behave as one rotor. Therefore, any distortions introduced at the coupling will essentially kink the rotor system. All parts must be very clean, protected and have passed a detailed visual inspection. If in doubt, a detailed mechanical inspection is made. Installation begins with the motor hub being fit to the motor shaft with a shrink fit. A slip fit was used by the manufacturer but, good alignment often was difficult to obtain and shaft fretting was a problem. The motor hub is normally installed at a repair facility, usually after an overhaul, where runouts and fits can be checked and corrected as needed. After any installation, field or shop executed, hub runouts are checked (Figure 13). The motor in this system, having sleeve radial bearings and a tilting pad thrust bearing, is susceptible to "shifting" during rotation of the shaft. To determine if this is occurring, it is useful to have indicators both on the shaft and the hub during the runout check. Next, the pump hub and lift nut are positioned on the pump shaft. The coupling spool is then installed taking care to align the balance match marks. After evenly tightening the bolts to the prescribed torque values, another set of runout readings is taken (Figure 14). The total rotor float is checked at this time, and the "lift" is set within tolerance. Finally, the pump hub is connected to the spool while aligning match marks between hub and spool. Another set of runout readings is taken on the pump hub and shaft (Figure 15). Assuming that the previous alignment and coupling checks are accurate, out of tolerance runout readings at this time usually signify a bent shaft. If acceptable readings cannot be obtained, the problem is sought and found. Shimming or selective torquing of the coupling is not permitted. A final set of readings are taken and must be within the maximum values shown.

A. Motor Coupling Hub Flange	0.0010" TIRR
B. Top Spool Flange	0.0010" TIRR
C. Bottom Spool Flange	0.0015" TIRR
D. Pump coupling Hub Flange	0.0015" TIRR
E. Probe Target	0.0020" TIRR
F. Pump Shaft	0.0020" TIRR
