SOLUTION TO CAVITATION INDUCED VIBRATION PROBLEMS IN CRUDE OIL PIPELINE PUMPS

ABSTRACT

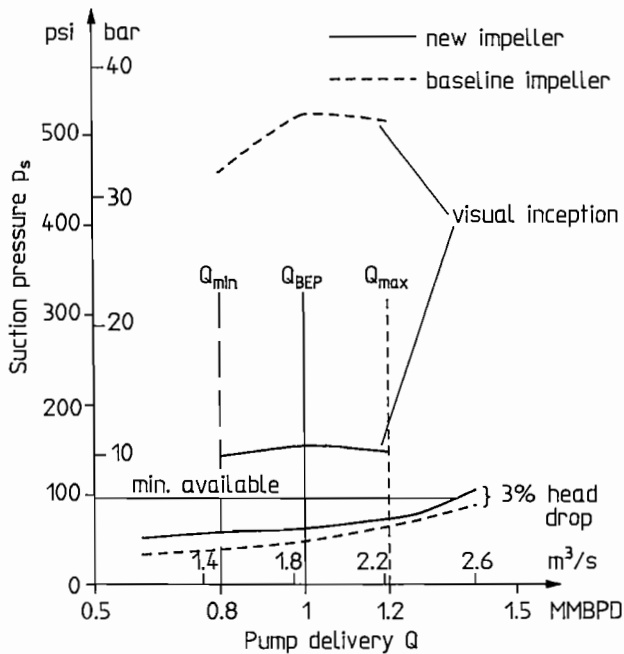
Figure 10. Cavitation Inception on Impeller Vane, Suction Side and Three Percent Head Drop, Observed on Model Pump, Converted to Full Size Pump at $n = 3600$ rpm. Original casing.

Between 80 and 120 percent of BEP-flow, the cavity length follows a pattern similar to that in Figure 9. At 60 percent flow no sheet cavitation occurred, and the flow shows clear recirculation for both impellers. The drastic improvement in visual cavitation inception (first bubbles recognizable) is shown in Figure 10. The three percent head drop is little affected, it even increases slightly for the new impeller. This figure makes clear, that cavitation inception, being mainly influenced by the leading edge geometry, and three percent head drop, which is influenced by cavitation bubbles reaching the throat area, are not directly related.

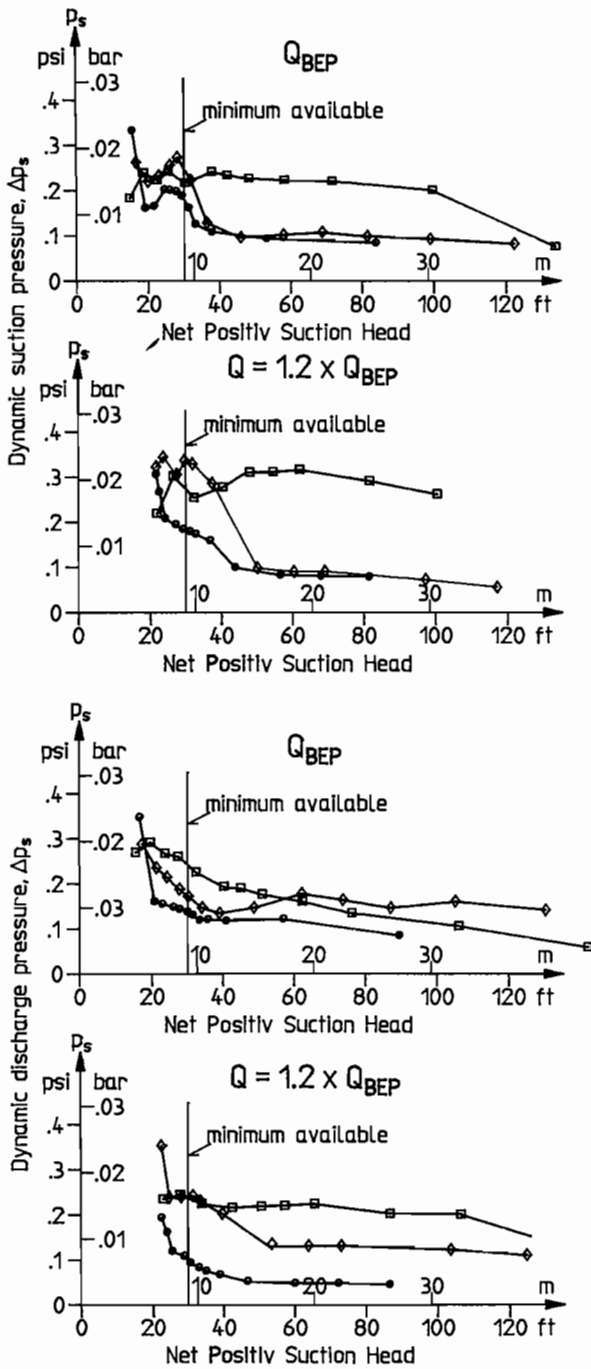
Figure 12. Pressure Pulsations at BEP and $1.2 \cdot Q_{BEP}$ Measured on Model Pump at $n=2000$ rpm. $\square-\square-\square$ = baseline hydraulic, $\diamond-\diamond-\diamond$ = new impeller, casing original conditions, $\circ-\circ-\circ$ = new impeller, modified casing.

The observations made so far all pertain to a reduction of the cavitation bubble extension on the impeller blades, based on the knowledge that smaller cavitation bubbles create less vibration excitation. A more direct measure of excitation forces is the pressure fluctuation in the suction chamber, as indicated in Figure 5. A piezoelectric pressure transducer with a resonance frequency of about 80 kHz is used for this purpose. For the analysis, two frequency bands were chosen, one from 800 to 2000 Hz, representing the frequency range of strongest vibrations, and the other from 550 Hz to 180 kHz, in line with a method developed for cavitation damage predictions [2, 3]. Results from this latter frequency range are called "cavitation noise." The cavitation noise is shown in Figure 11 for the baseline impeller, the new impeller, and the new impeller combined with the casing modifications shown in Figure 7. It is clear that the casing modifications contribute significantly to the reduction of the cavitation noise, particularly towards lower suction pressures. The pressure pulsations in the frequency band from 800 to 2000 Hz (Figure 12), also measured at the pump discharge, again clearly show the influence of the casing modifications at lower suction pressures, particularly at high flows. Based on these successful results, it was decided to realize

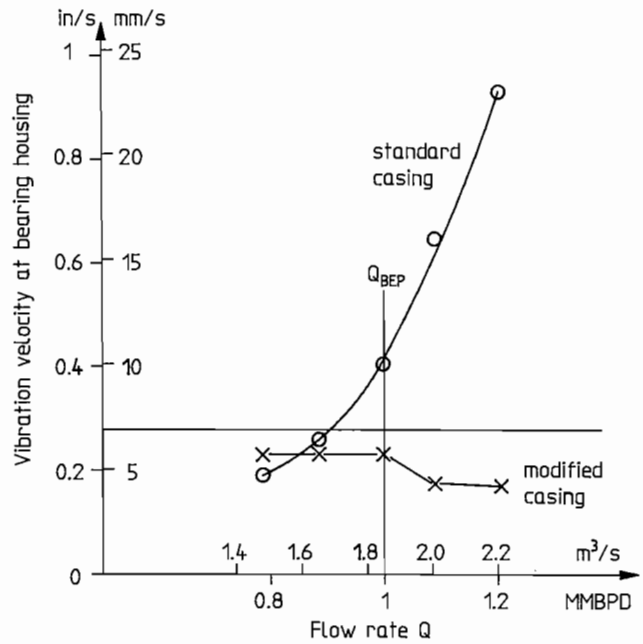
carried out at the lowest available suction pressure of 100 psig for various speeds and flows. In a second step, the casing modifications were carried out based on the model tests, and the vibration measurements were repeated. The results at 3600 rpm are shown in Figure 13. Only with both the new impeller and the casing modifications, as predicted by the model tests, could the required vibration levels be reached over the entire flow range. As expected, at lower speeds the vibration levels were even lower. The modifications were thus successful and are now being implemented step by step on all other pumps. The tremendous extension of the operating field is also indicated on Figure 4, where the dashed curves were extrapolated from the measurements at various speeds at 100 psig suction pressure.

Figure 13. Influence of Casing Modifications, Measured on Site with New Impeller. $n = 3600$ rpm, suction pressure = 100 psig (6.9 bar).
