SOLUTION TO CORROSION/ HIGH NSS PROBLEM AT PETROTRIN REFINERY

Presented by : Stanley Deonarine
Head, Mechanical Engineering
Petrotrin Refinery
2003 Nov 02

PROBLEM – TO IMPROVE RELIABILITY/SAFETY ON THREE HVGO PUMPS AT NO. 4 VDU

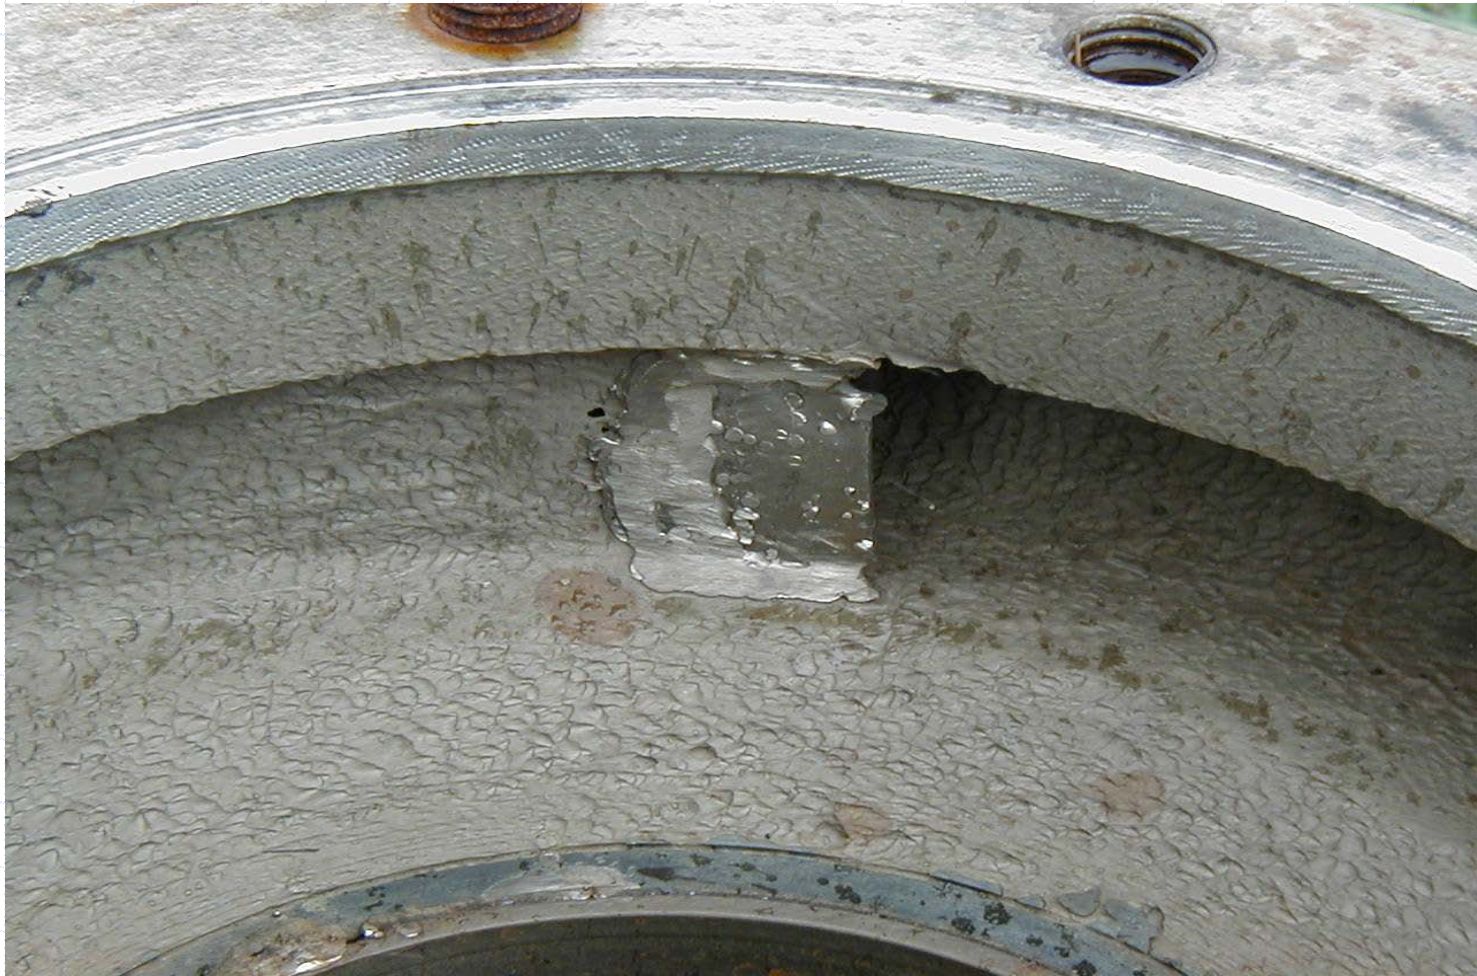
Pump Casing (12% Chr) – Gouging by Naphthenic Acid

- The pumpage (Heavy Vacuum Gas Oil @ 560 F) contained corrodents in the form of H₂S and naphthenic acid (TAN - 4.0 mg KOH/gm, sulfur – 1.8% wt). This acid though very minute in quantity is known to be very corrosive to 12% chrome steel (the metallurgy of the HVGO pumps) at temperatures above 400 F.
- It is doubtful whether the engineers who designed and procured these pumps (circa 1970) had an appreciation of the above factors.

- ◆ Develop a report to justify replacement of the pumps and identify key features of the new design :
- ◆ 316 SS metallurgy to resist the corrosion.
- ◆ API code BB2 construction.
- ◆ Design capacity to be a better hydraulic fit to the process -1600 usgpm instead of 2563 usgpm.

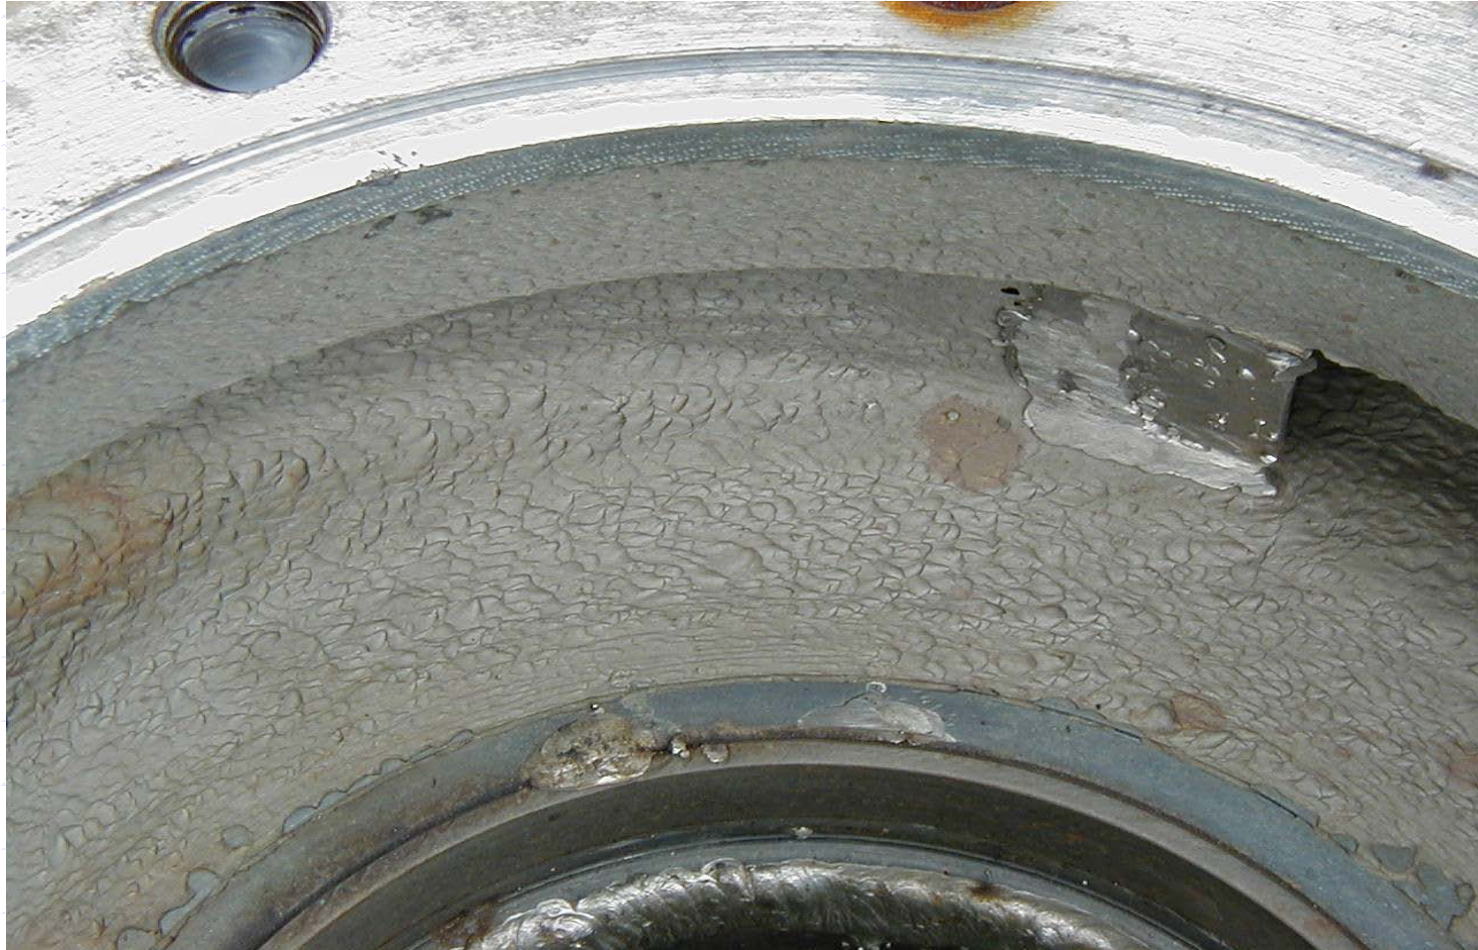
Pump Casing (12% Chr) – Gouging by Naphthenic Acid.

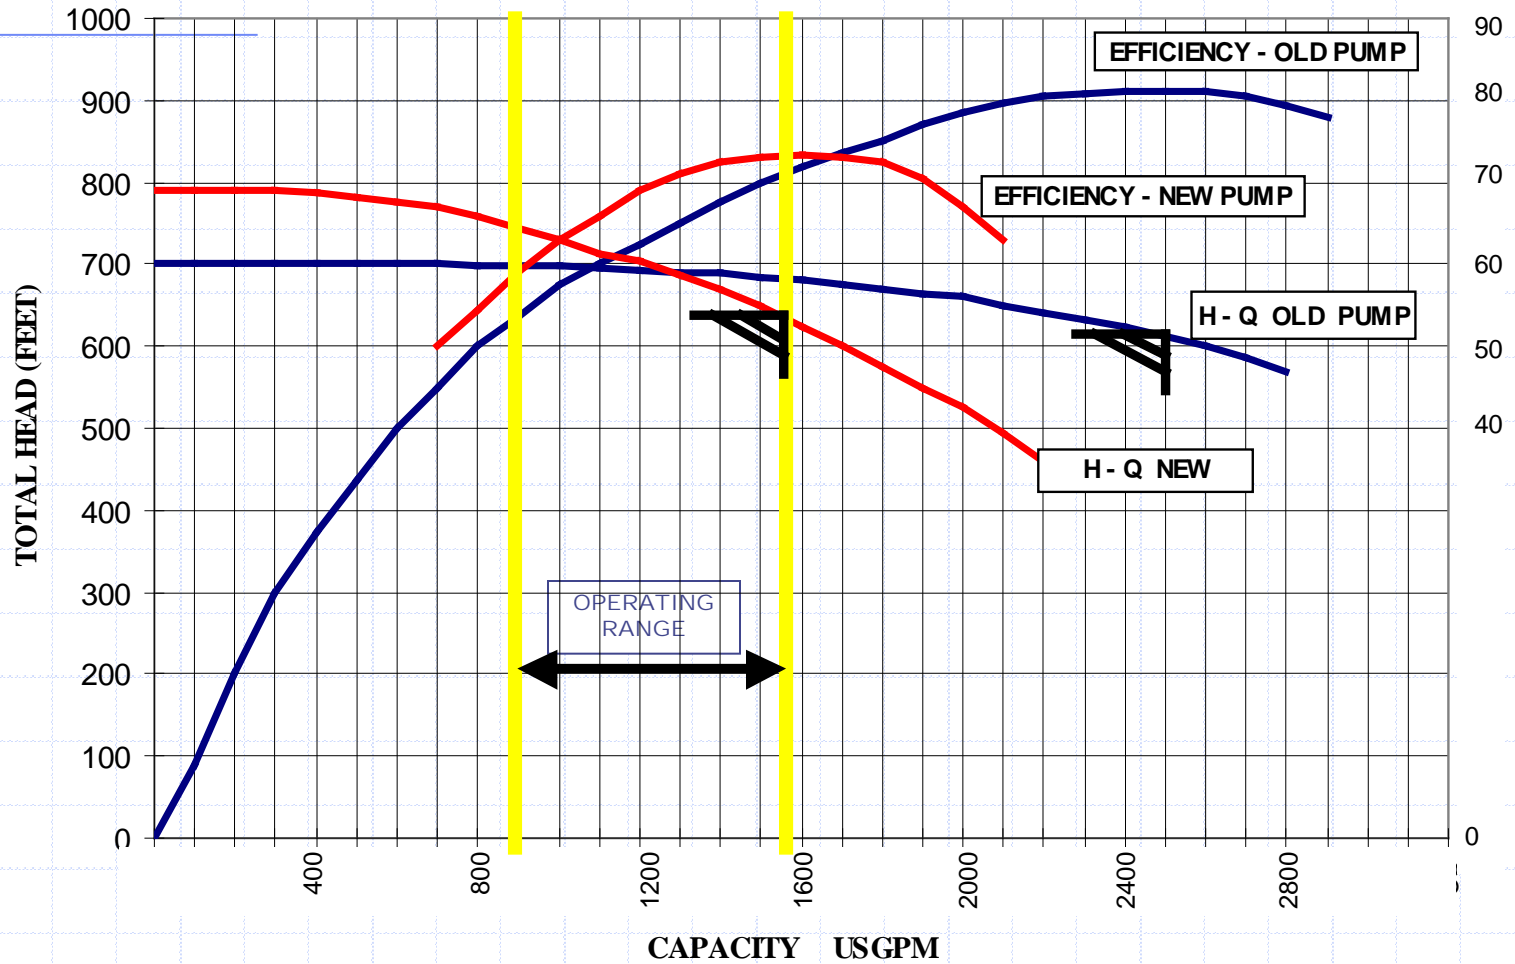
OLD HVGO PUMPS	NEW HVGO PUMPS
PUMP SIZE	6 X 10 X 13H	6 X 10 X 15A
FLOW RANGE USGPM MCSF - BEP	1081 TO 2563	550 TO 1800
SUCTION SPECIFIC SPEED	12,837	11,200
MOTOR HORSEPOWER	450	300
METALLURGY	12% CHROME STEEL	316 SS
API CODE	OH2 (IMPELLER OVERHUNG)	BB2 (IMPELLER BETWEEN BEARINGS)

PERFORMANCE CURVES - OLD AND NEW PUMPS

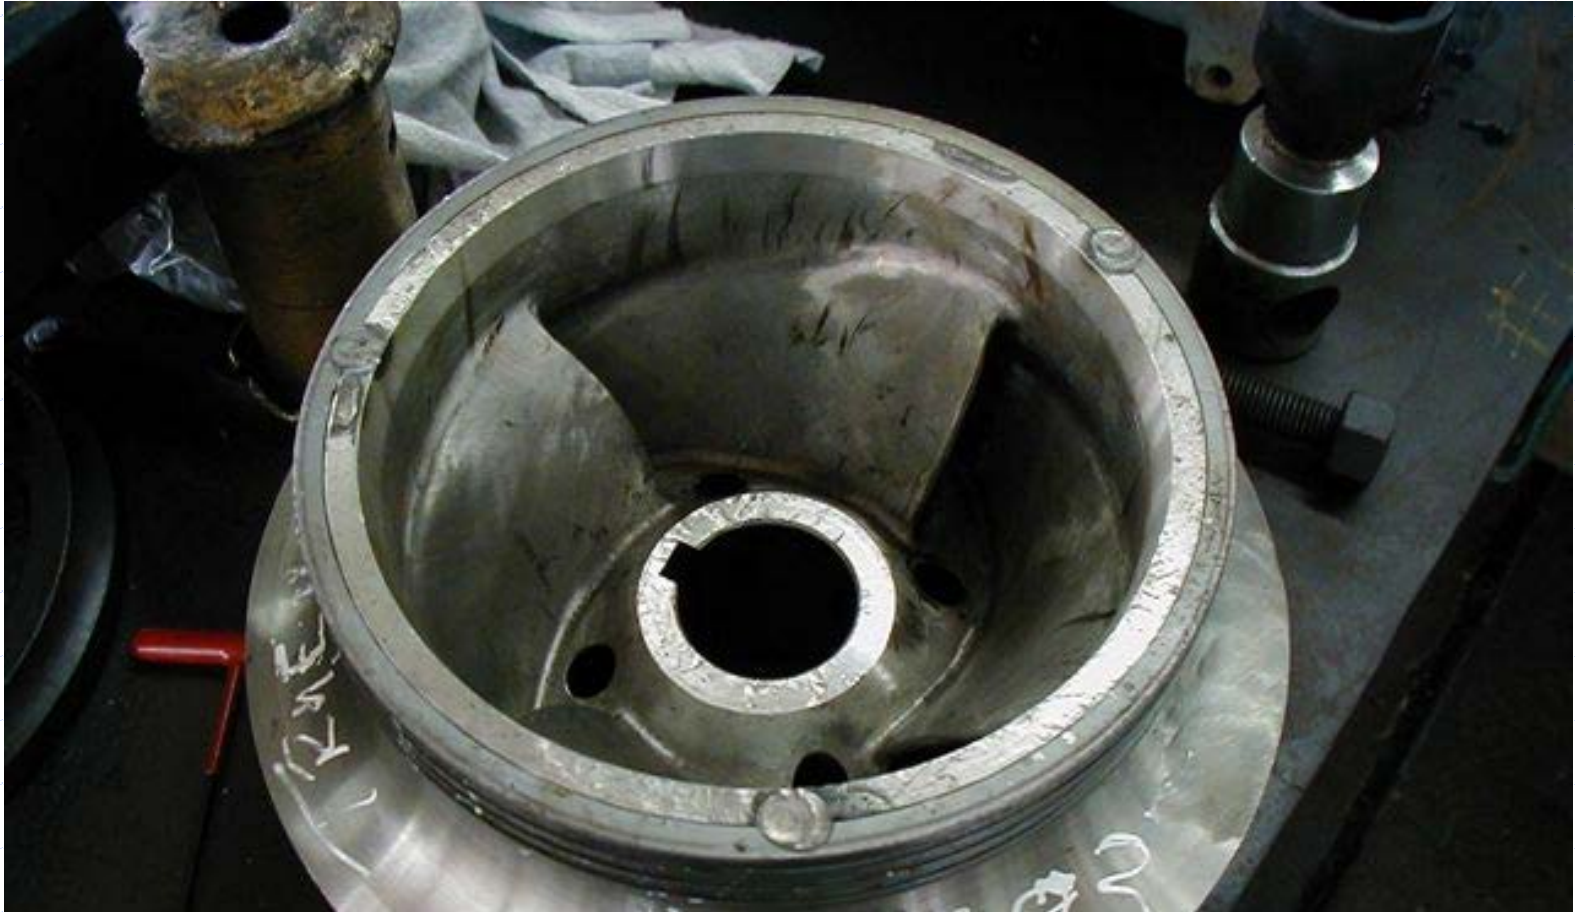
Impeller – 316 S.S (Corrosion Resistant)

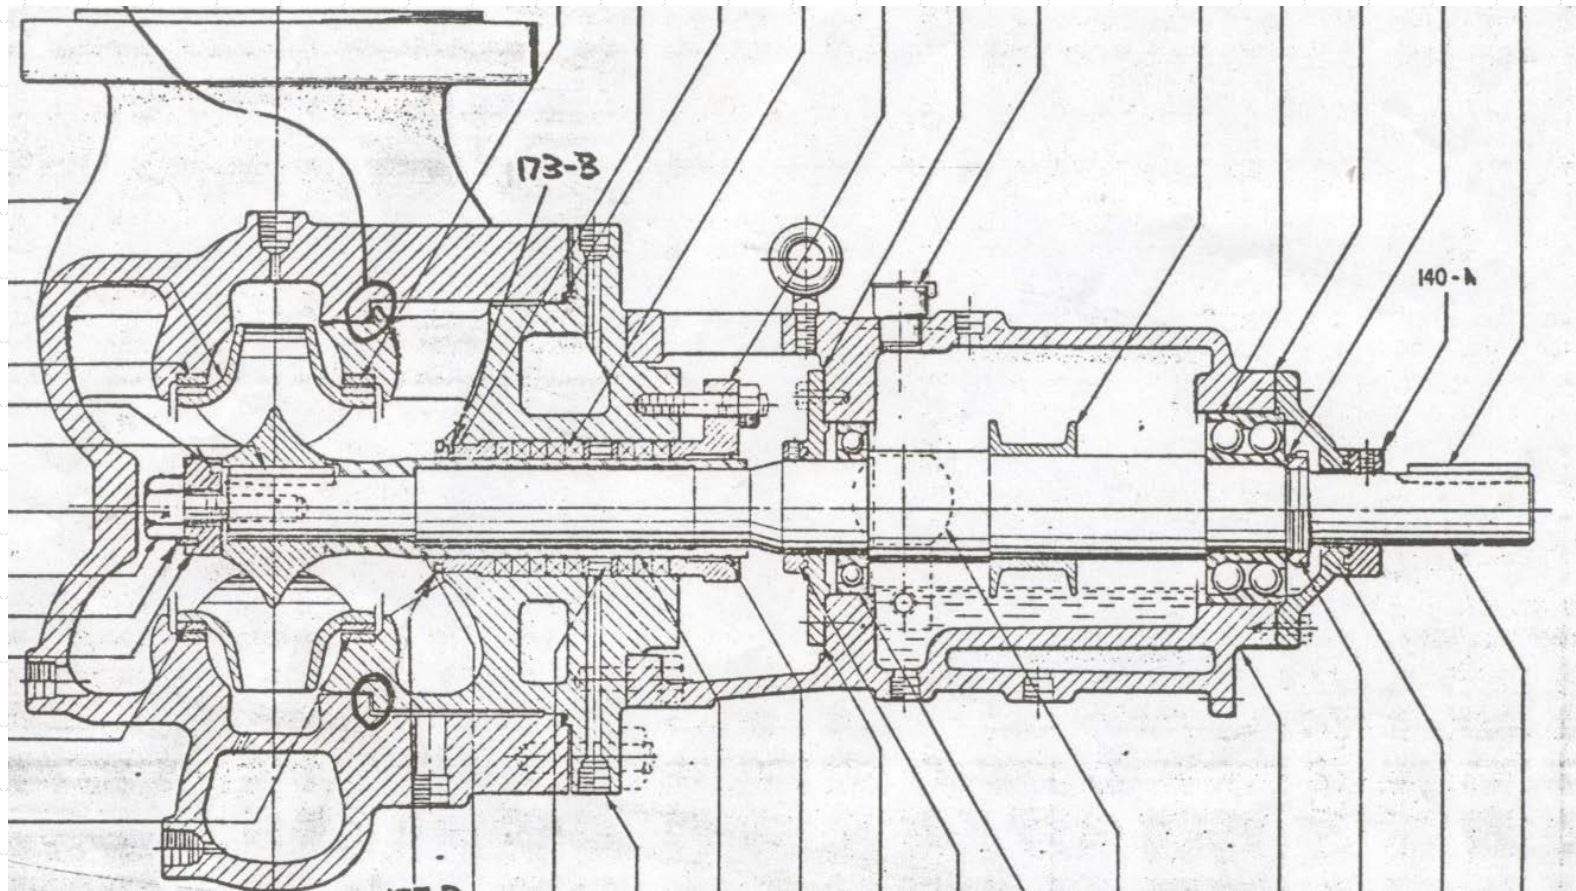
OLD HVGO PUMP - API CODE OH2

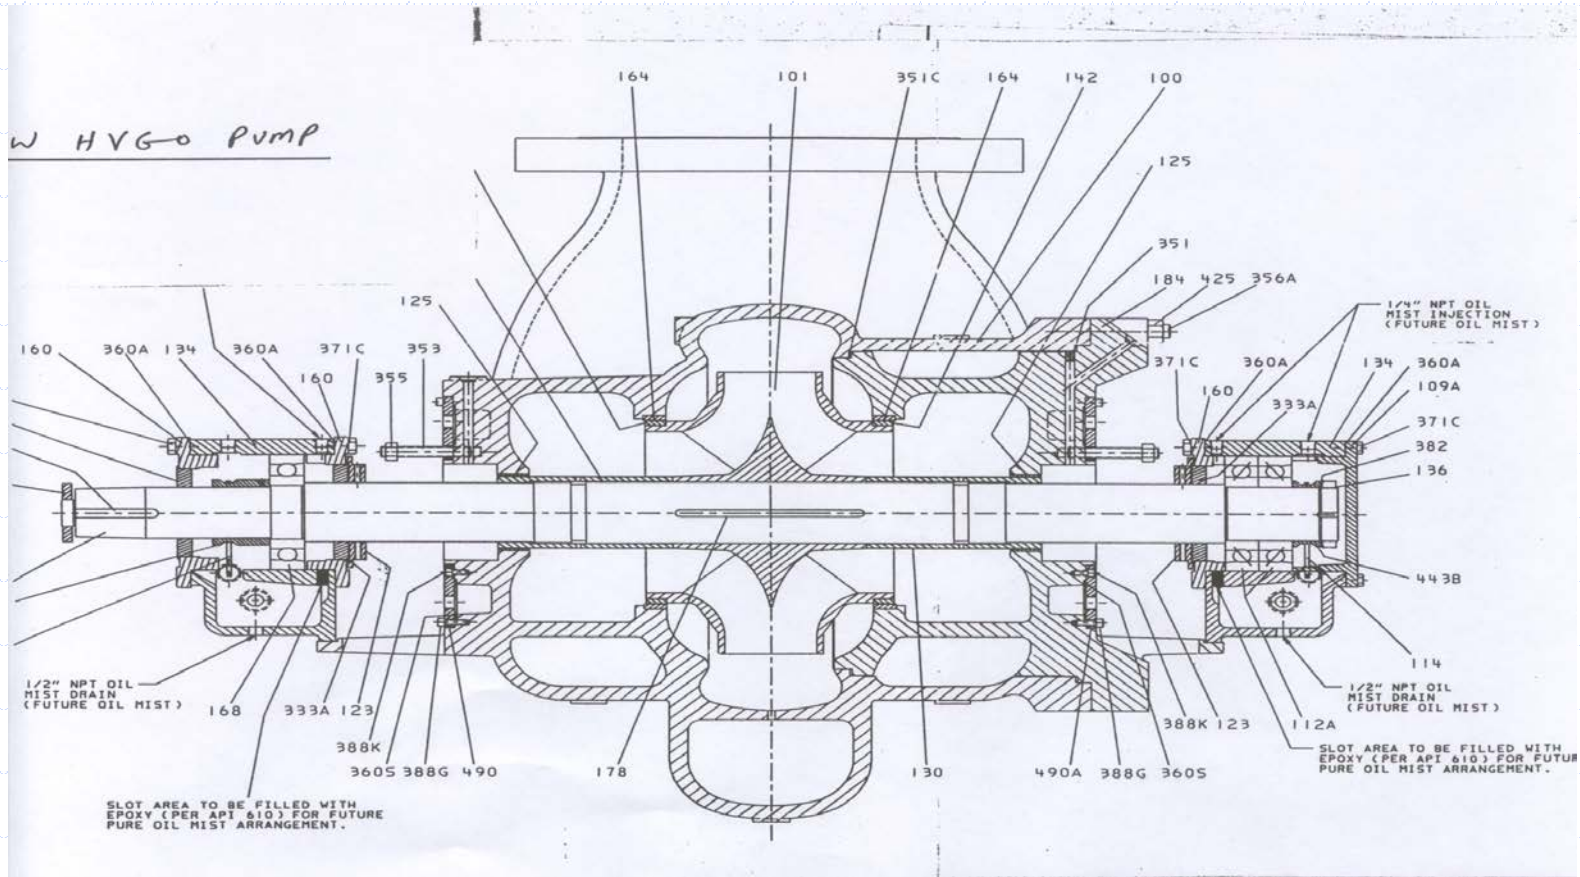
NEW HVGO PUMP - API CODE BB2
