# **Acoustical and Bearing Housing Resonant Vibration on a Centrifugal Pump**

***24th International Pump Users Symposium***

# 6x8x13 5/4 stage Pump, 2000 hp Pine Bend, MN

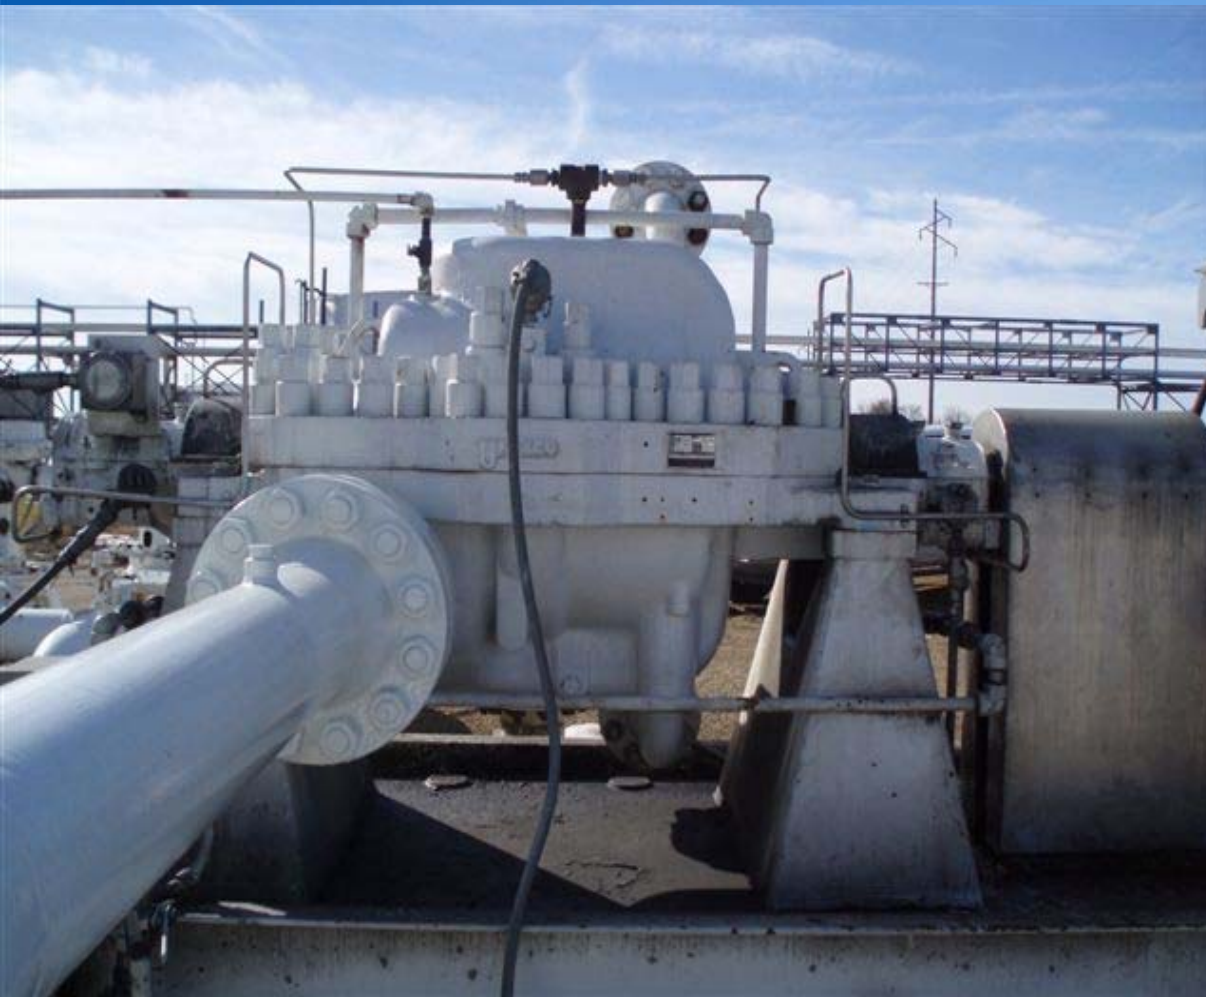
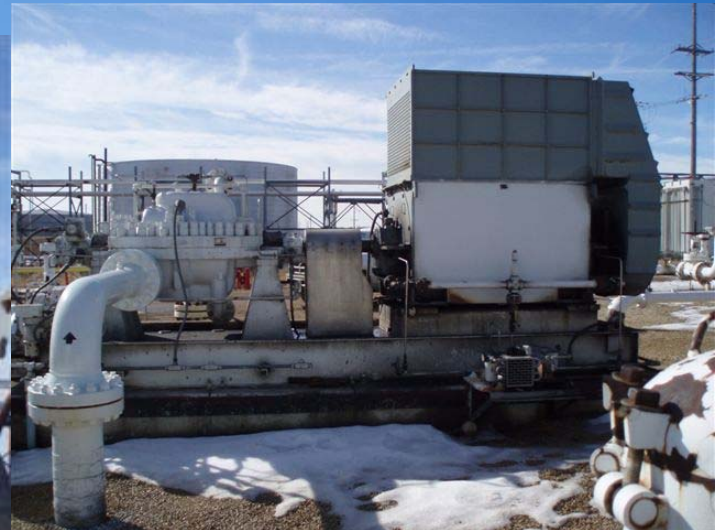
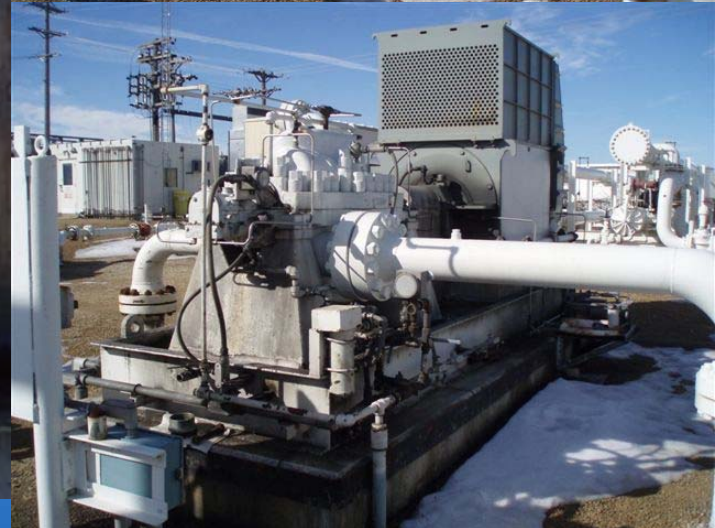
- ❖ Pine Bend, Minnesota, 2000 hp, 3600 rpm
- ❖ 6x8x13, 5/4 stage centrifugal pump, 4<sup>th</sup> stage is removed and 7 vanes on all impellers
- Power optimization study shows a VFD will pay for itself in a short period of time the way this pump is operated

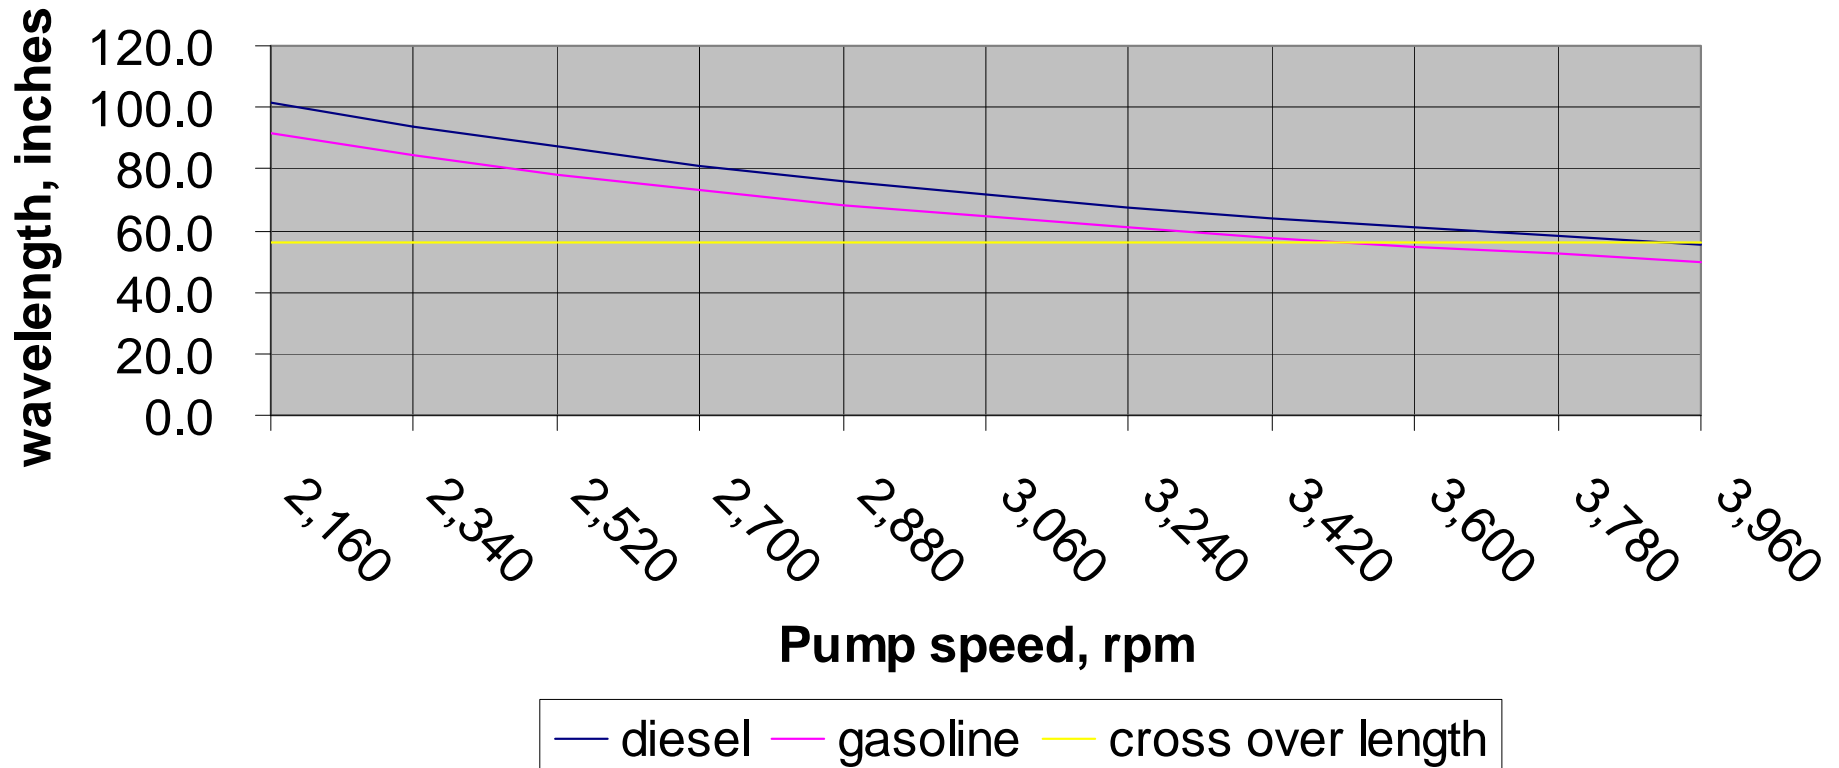
## Accoustical Resonance

# Acoustical Analysis of existing 7 vane impellers, shows problem at higher speeds

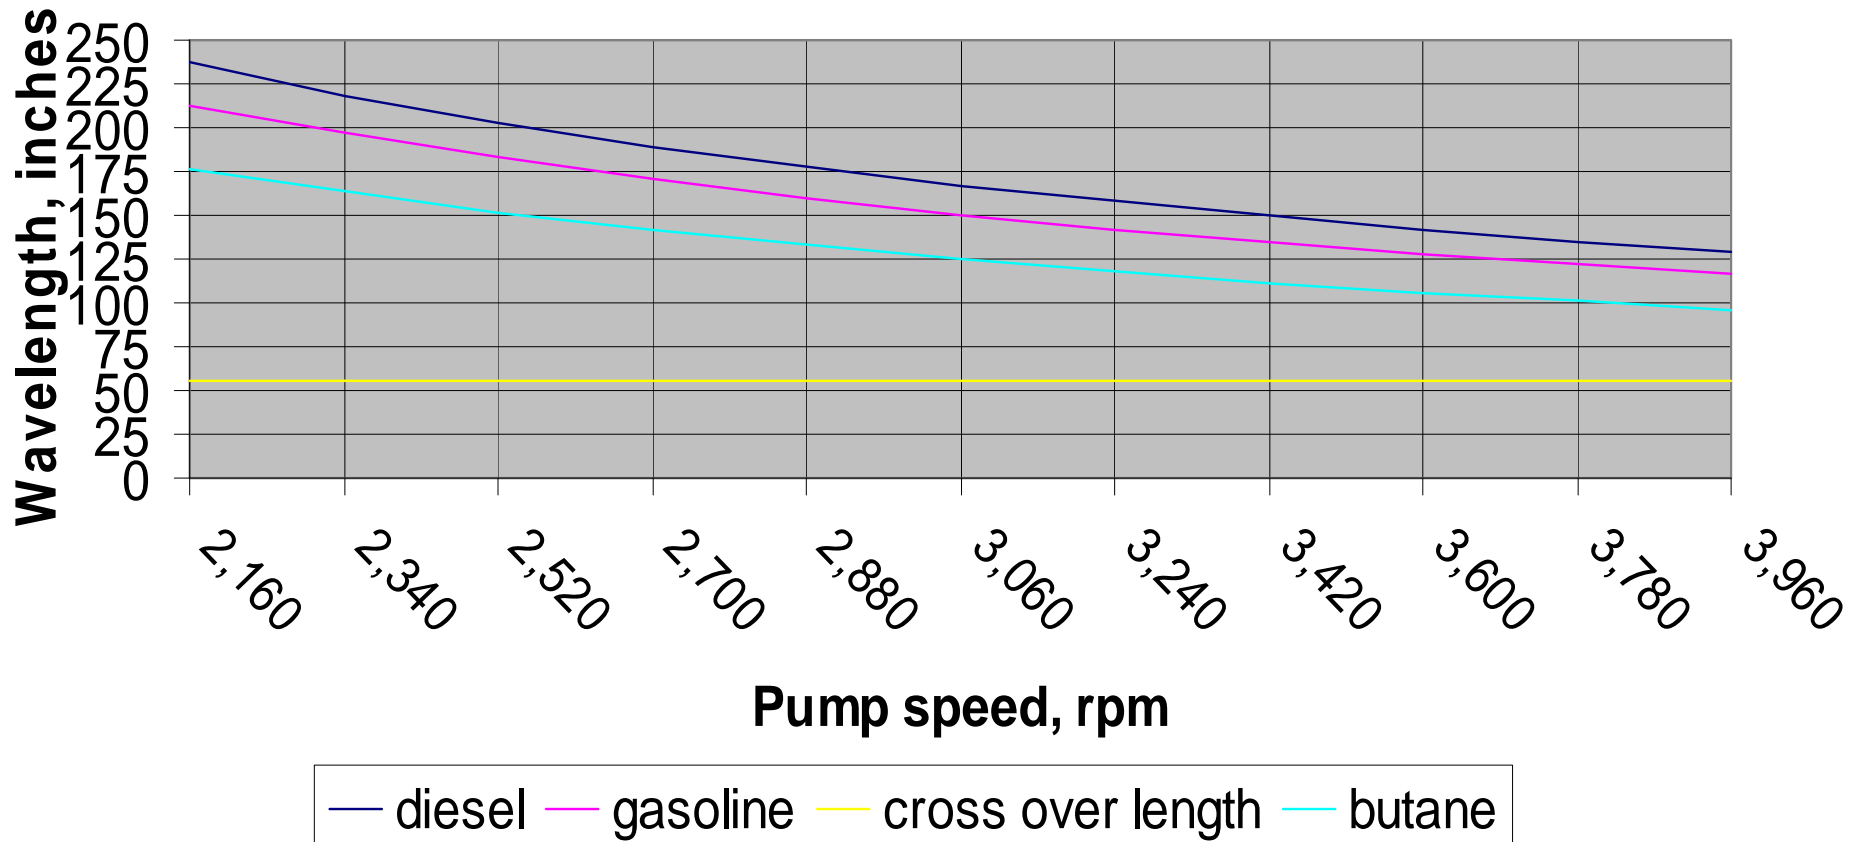
## Accoustical Resonance

# Acoustical Analysis of proposed 4 vane impeller, shows greater separation margin

The impeller feeding the cross over (2<sup>nd</sup> stage) was changed from a 5 vane to 4. All other impellers are still 7 vane (same as original pump from factory).

❖ All problems are now resolved and the pump runs with low vibration levels at all speeds while pumping all products.

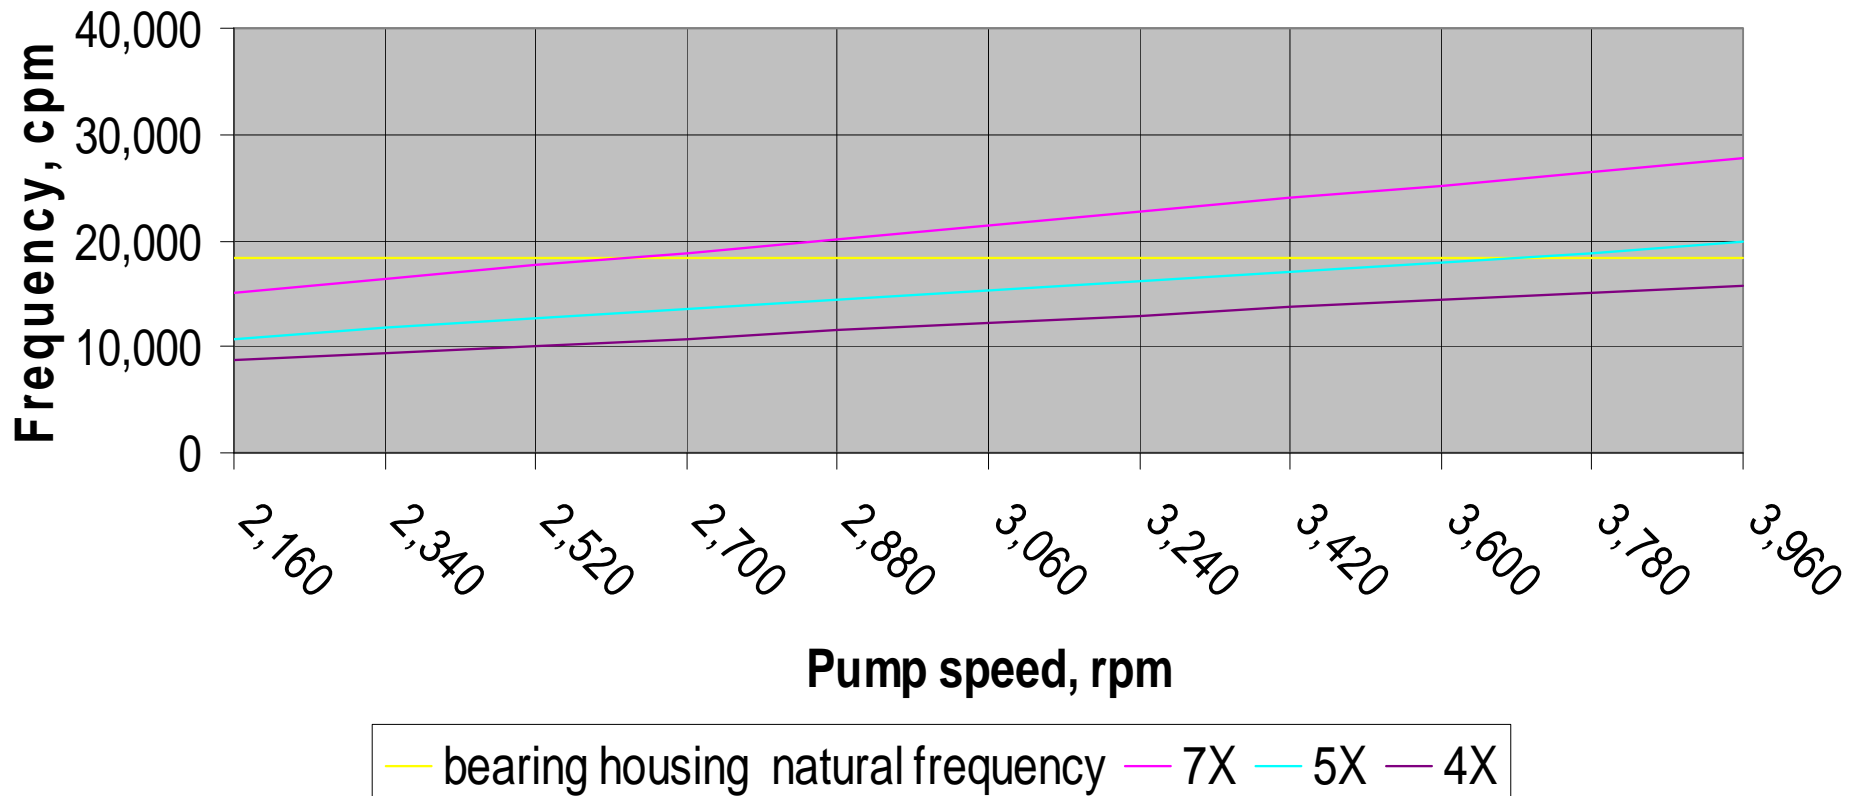
## Bump Test Analysis

# Bearing Housing Bump Test Analysis

natural frequency = 305 hz = 18,300 cpm  
5 vane shows a problem at 3600 rpm

- ❖ The modified pump and VFD were installed and everyone said it ran great for about a year. Then the seal flush tubing failed and a more thorough analysis was conducted and determined the pump had high vibration levels when pumping gasoline at higher speeds.
- ❖ The pump ran smooth on diesel fuel but rough on gasoline indicating an acoustical resonance problem. The bump test indicated that the inboard bearing housing in the vertical direction had a natural frequency which was also excited by the 5 vane impeller.
