WEAR REDUCING TECHNOLOGY NEWLY APPLIED TO SEVERE PUMPING SERVICES

TAMU Case Study 2011

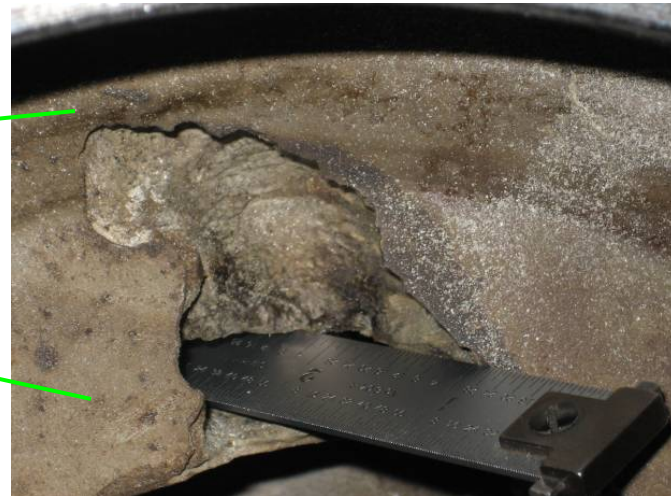
- P-8 case wear ring after 10 months
 - May 2005
- P-8 case gouge after 8 months
 - Oct 2008
- 1 unit shutdown, lost both pumps

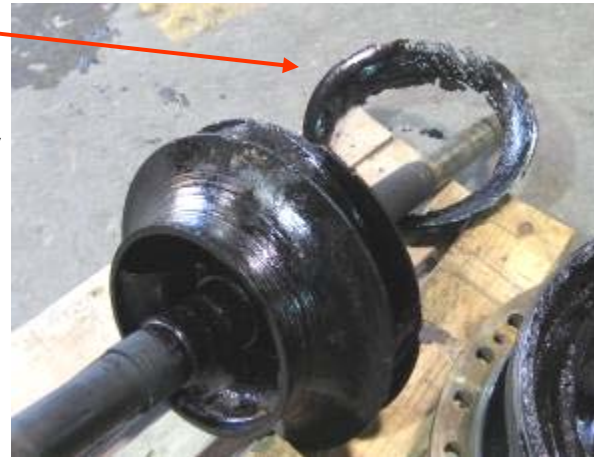
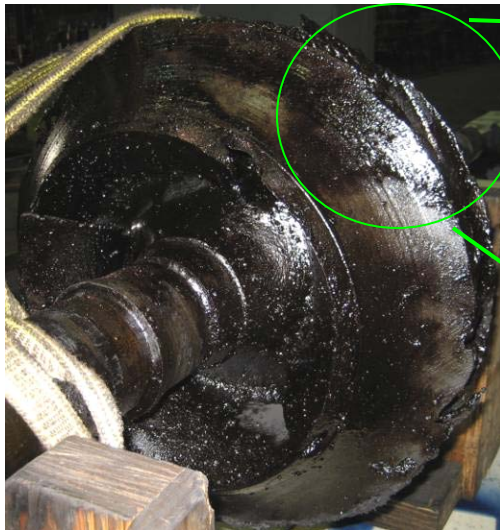
- Shredded P-3 wear plate
 - December 2007
 - Spare strategy left unit vulnerability
 - Unable to maintain top rate
- P-3 impeller, cut to ribbons
 - May 2009

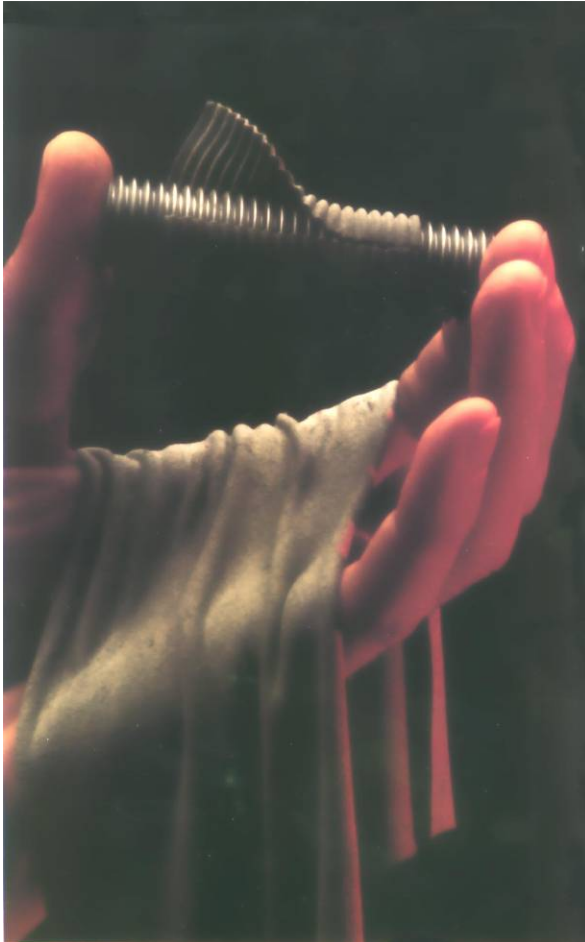
Flexible Tungsten Carbide cloth can conform to complex geometries.

Provides premium wear protection in previously difficult to reach locations.

Not limited by “line of sight” application.

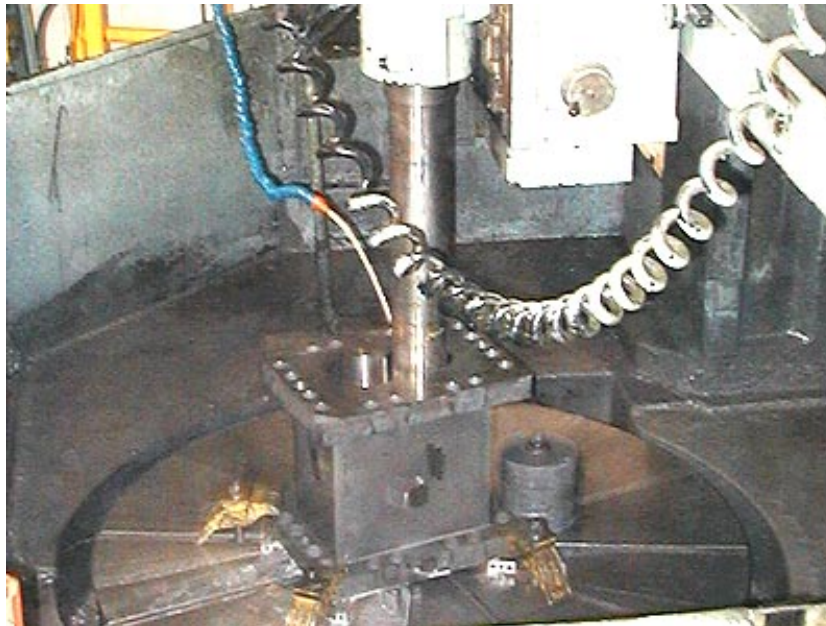
Finishing

- Parts should not be finished prior to cladding, due to distortion during brazing process.
- 0.125-0.25" Extra material needs to be left for important features (head & wear ring fits, etc.) to be finished after cladding.
- Ultra tight tolerances and fine finishes are possible with CNC machining centers and vertical grinders.

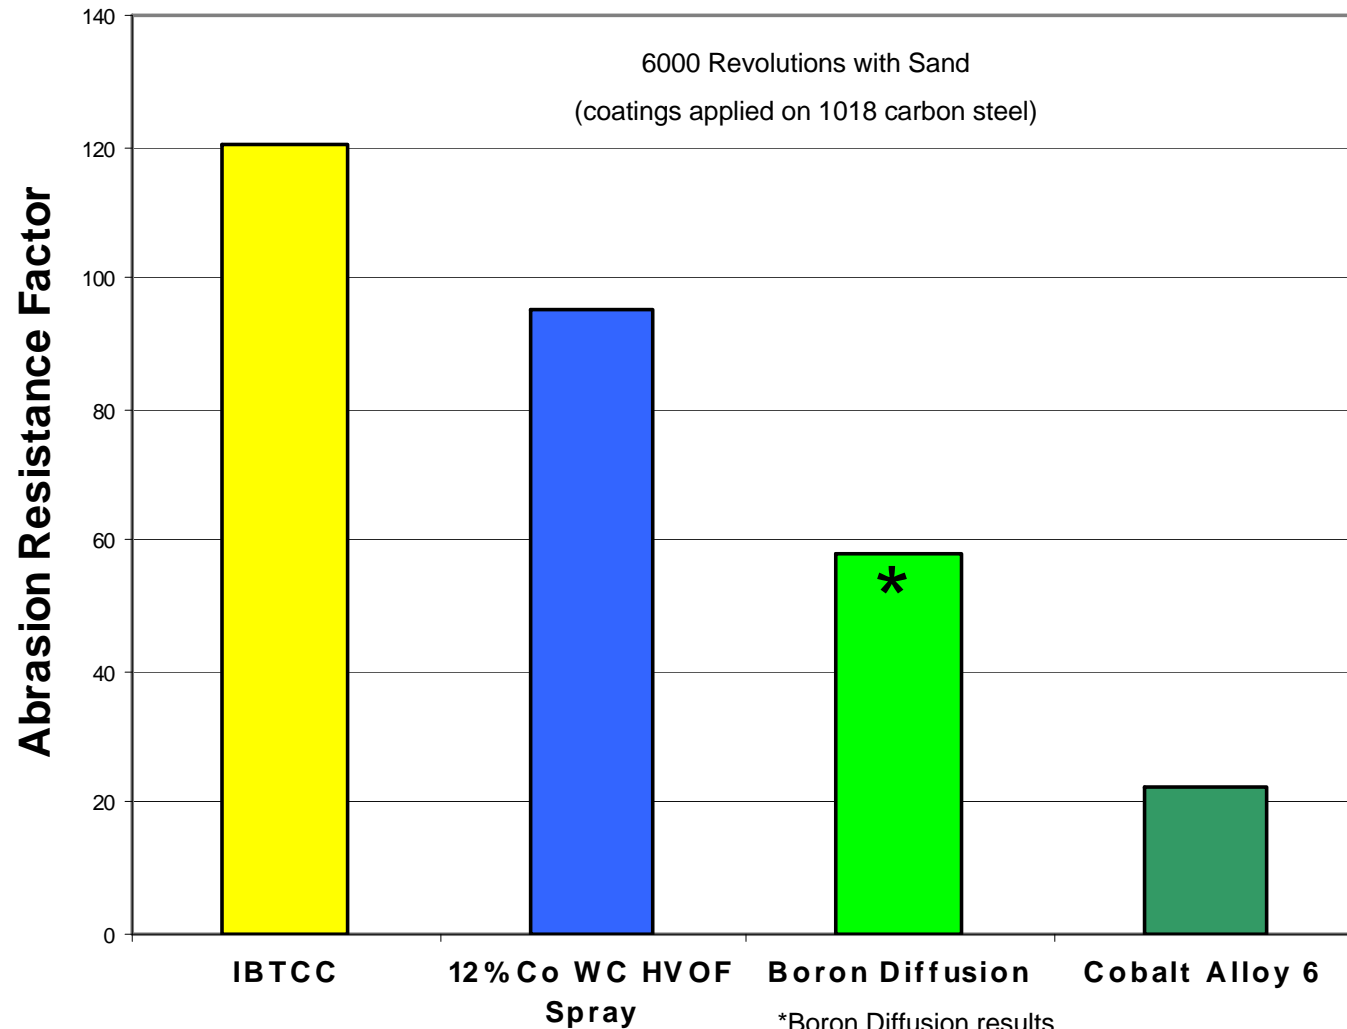
Abrasion Resistance (ASTM G-65)

*Boron Diffusion results extrapolated from 1000 revolution test due to coating thinness

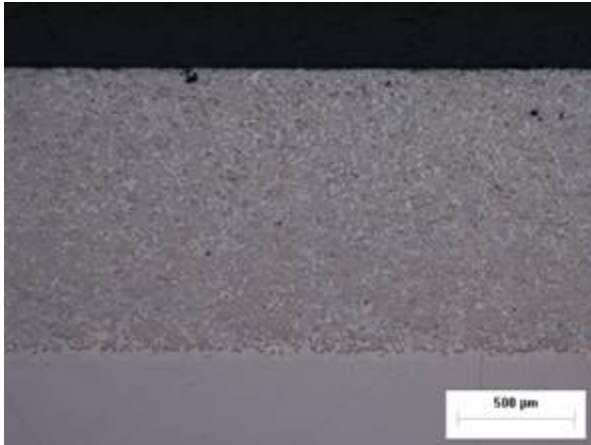
IBTCC (reference = 500 μm)

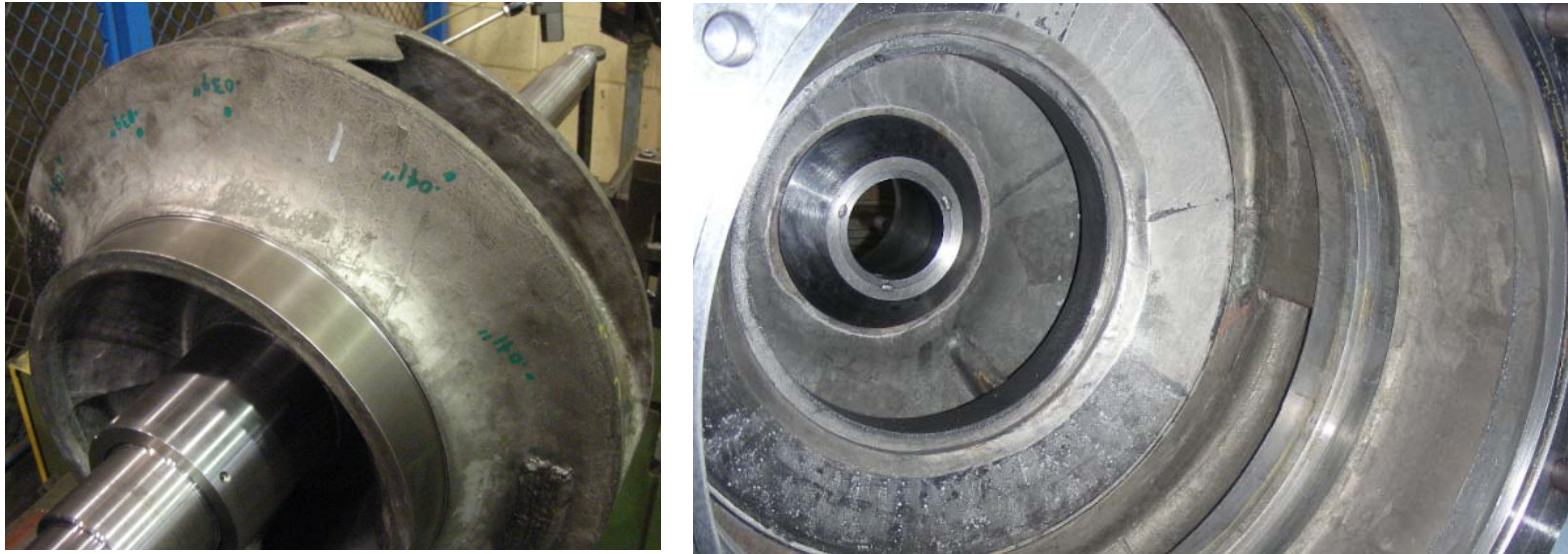
- IBTCC applied to new P-3 cases, heads, impellers, wear plates.

- Manufacturing Considerations: To machine or grind
- Areas to be clad need generous radii underneath, prefer 1/8" min.
- Weld balance pads on impellers or extra layer all around
- Build up to-be-ground areas to 0.06-0.08", leave nominal 0.030"
- Adjust casting patterns for more axial clearance
- Coating thickness – not much effect on large pump efficiency

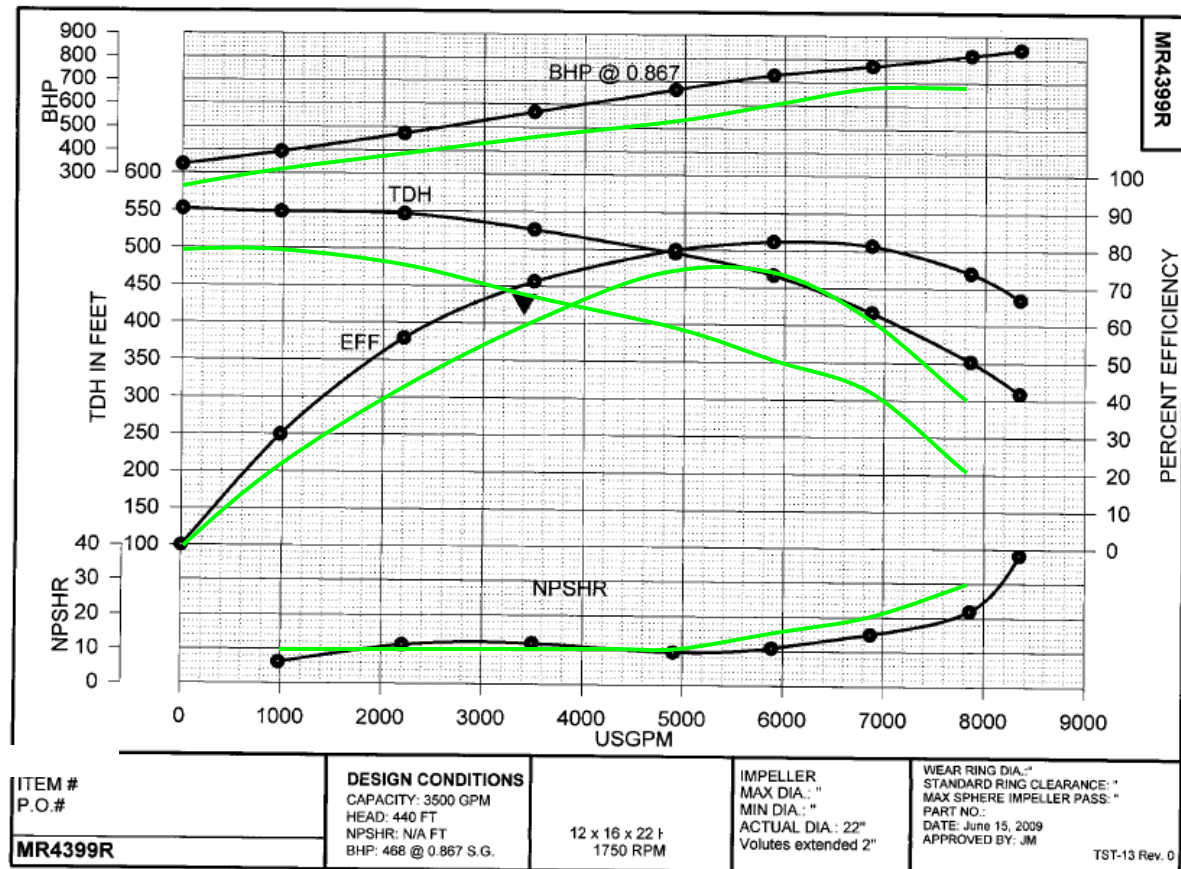
Hydraulic Performance

- OEM original 22" impeller vs. **IBTCC with 20.625" impeller**
- Measured thickness applied to various components 0.030-0.060", falls within typical casting tolerances.

- No signs of performance or mechanical degradation so far, ~1 and ~2 year ongoing run lengths

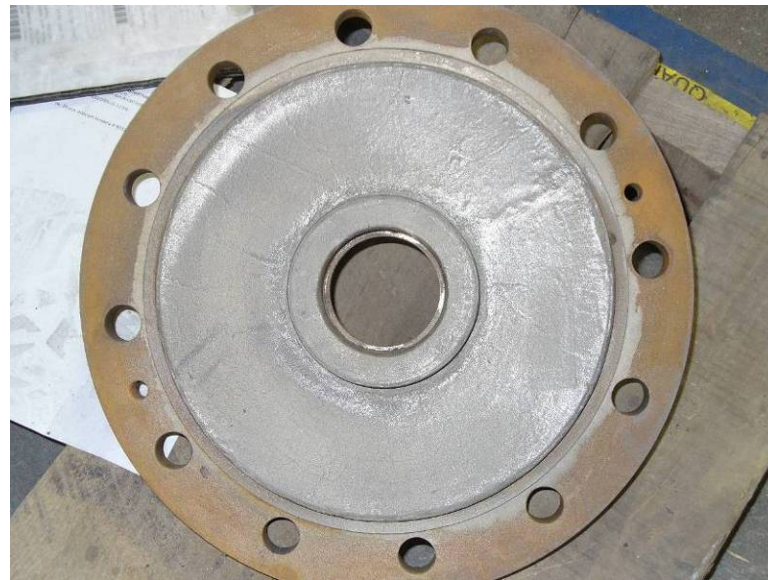
- Can balance to common specifications: 4W/N, ISO G2.5, etc.
- P-8 Clarified oil pump after one year of service with infiltration brazed tungsten carbide cladding, 0.004-0.008" at most material loss. See below. Did a slight cladding repair.
- Projected life extended to 3-4 years, from ~12 month max run with WC HVOF.
- Pump pulled due to strainer plugging. Impeller ran 3 months on the key alone, metal/metal against case. Could have reused except for oversize impeller bore.

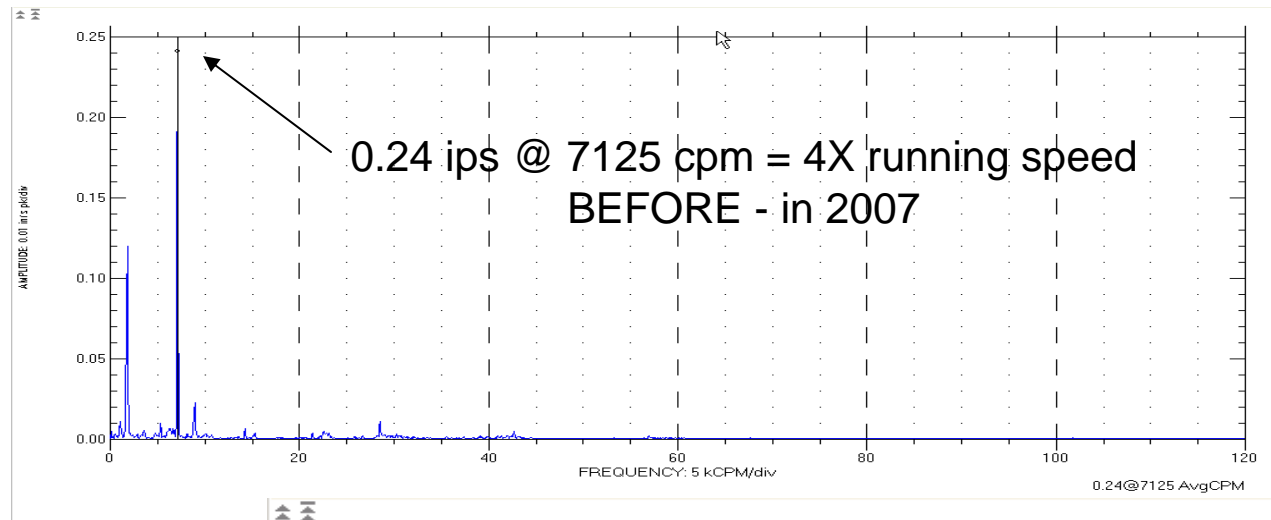
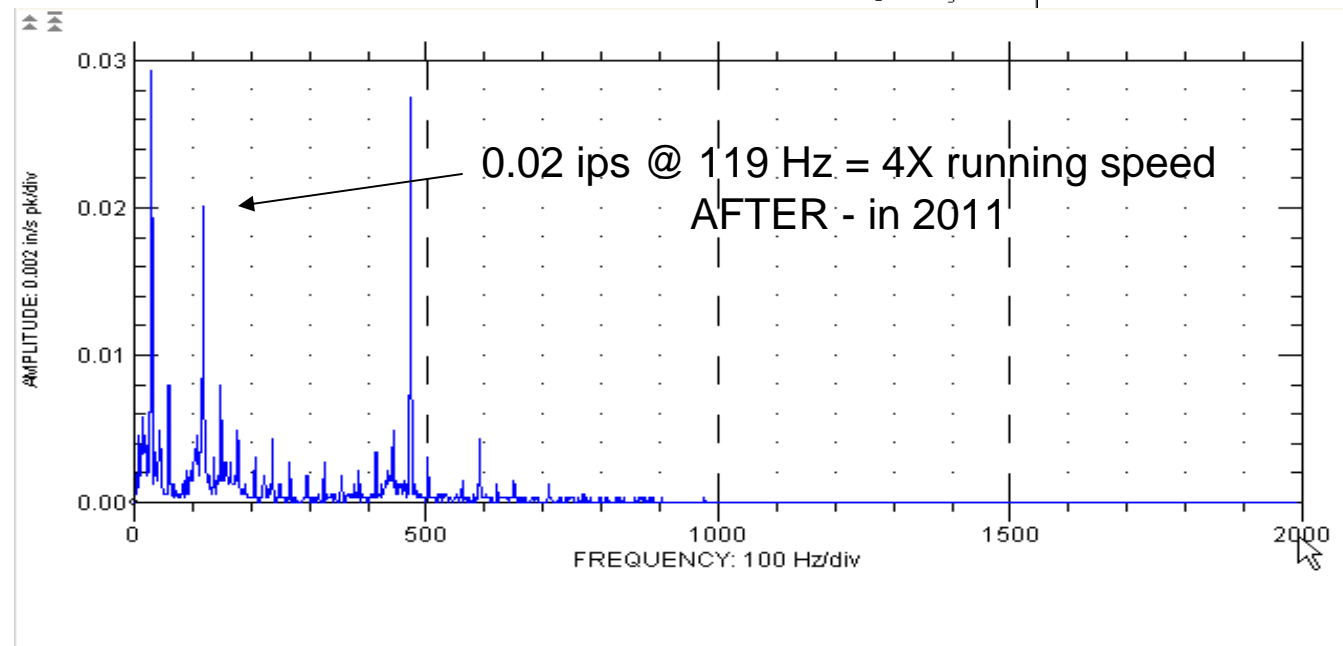
- Both P-518A/B IBTCC cases running ~4 years -no signs of vane pass vibration yet.

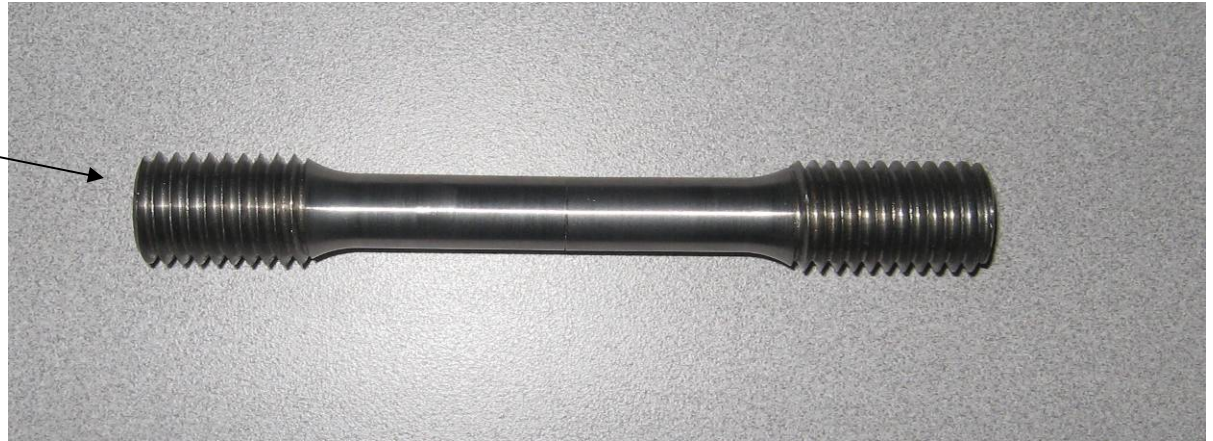
Bond Strength Evaluation

Threaded tensile specimens were made from hardened 4140. The “halves” were brazed together using the braze alloy and typical brazing cycle.

Specimens were tensile tested by an outside lab. All samples broke at the braze joint (as was intended). The average tensile strength from 26 pieces was 72,000 psi.

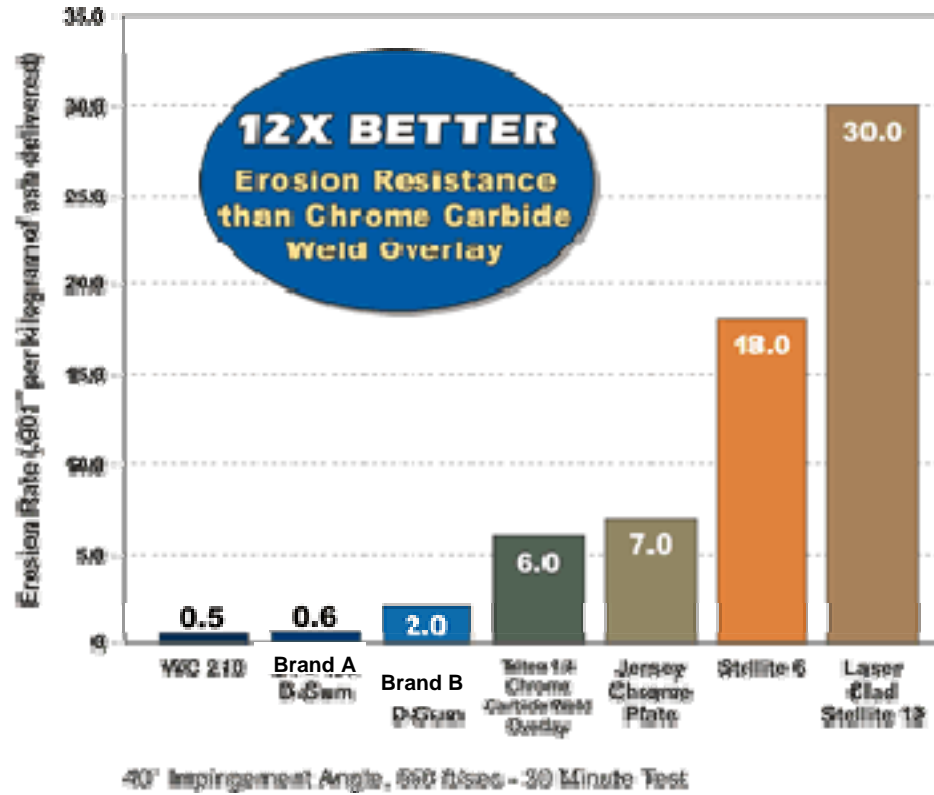
Fly Ash Erosion Test

EPRI (Electric Power Research Institute) testing found that IBTCC WC 210 provides superior erosion protection for power boiler fan blades exposed to high-velocity bituminous coal fly ash.

EPRI CS - 6068, Project 1649-4

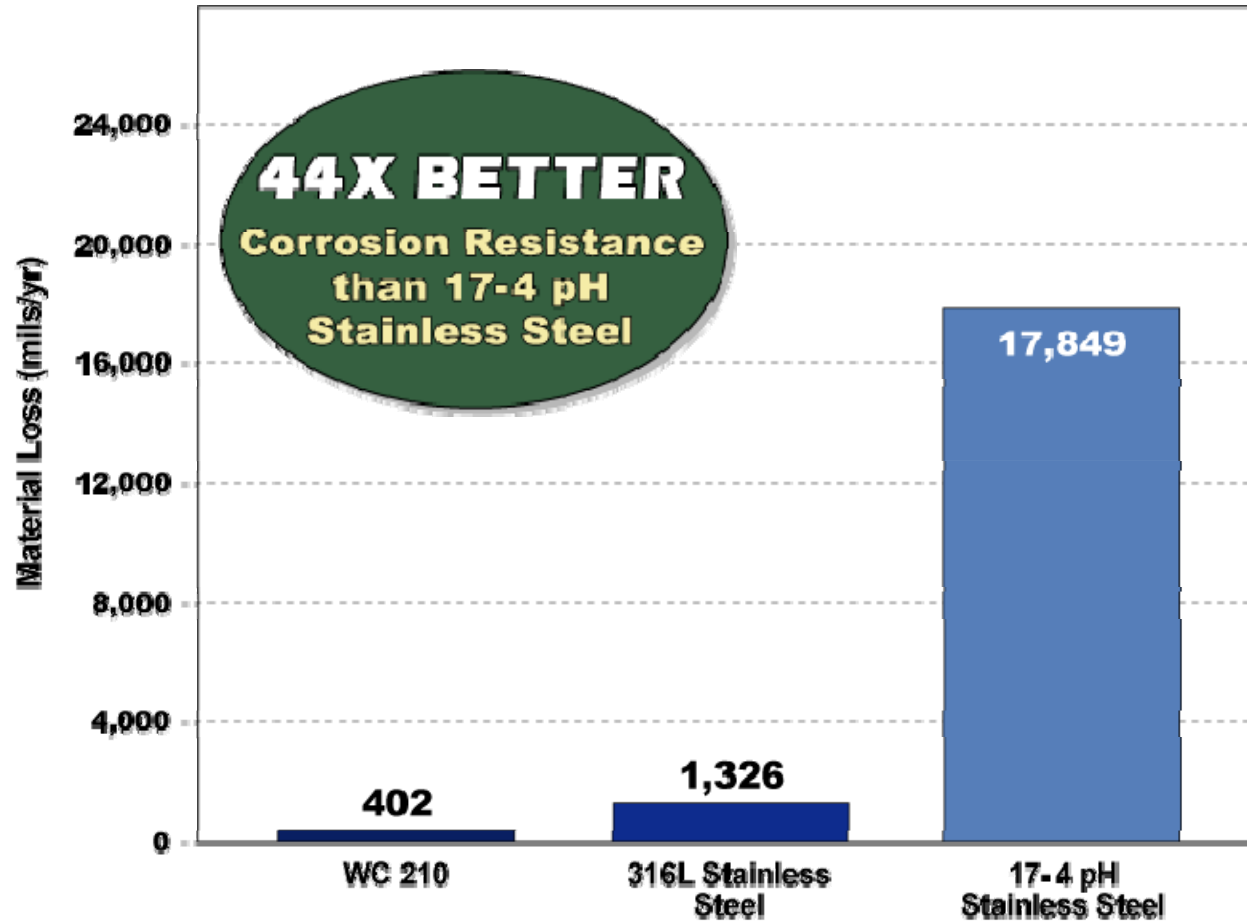
Corrosion Resistance

Laboratory Testing, ASTM G31 Standards

10% Sulfuric Acid at 212°F (100°C)

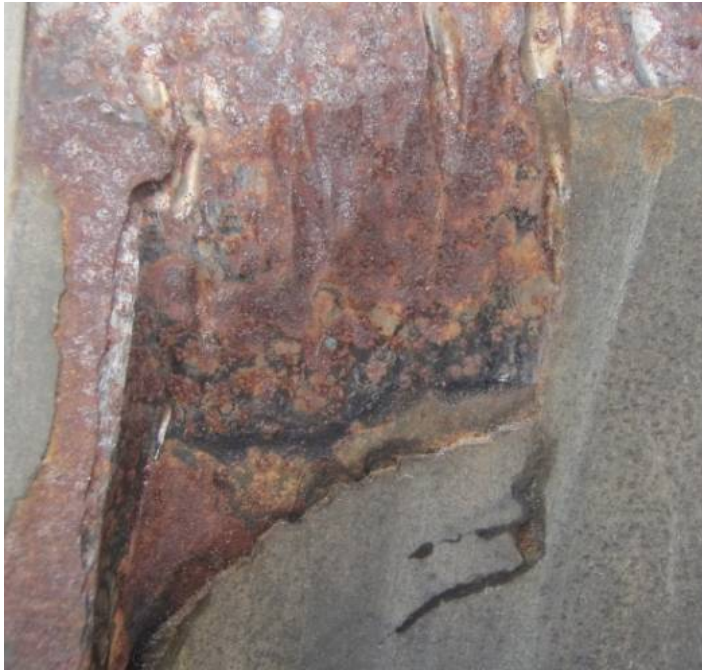
Boron Diffusion worn through
(wear plate closeup)

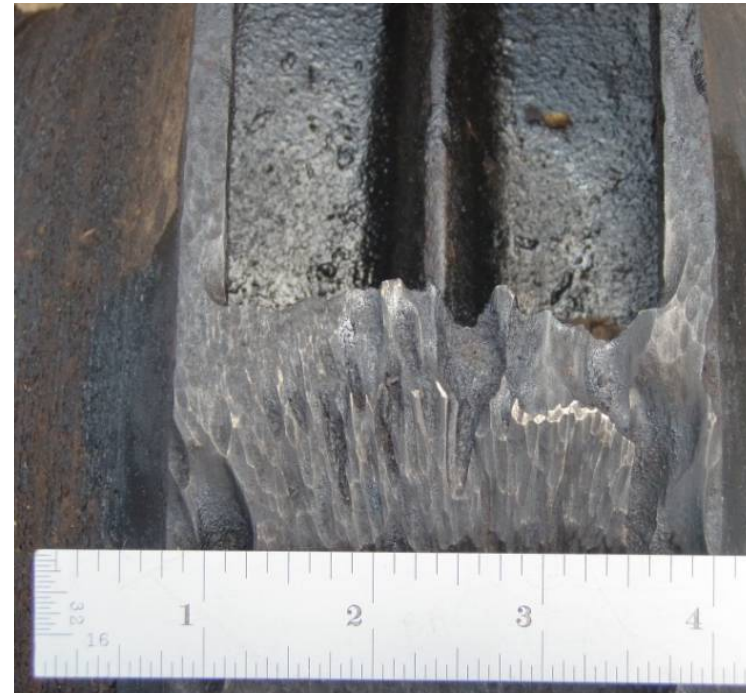
25 Chrome iron impeller
tip wear
