AN INNOVATIVE UPGRADE AND PERFORMANCE RERATE OF LARGE, HIGH SPEED, HIGH TEMPERATURE, MULTISTAGE BARREL PUMPS

Flowserve Corporation

BP Oil, Oil Technology Network

BP Oil Grangemouth Refinery Limited

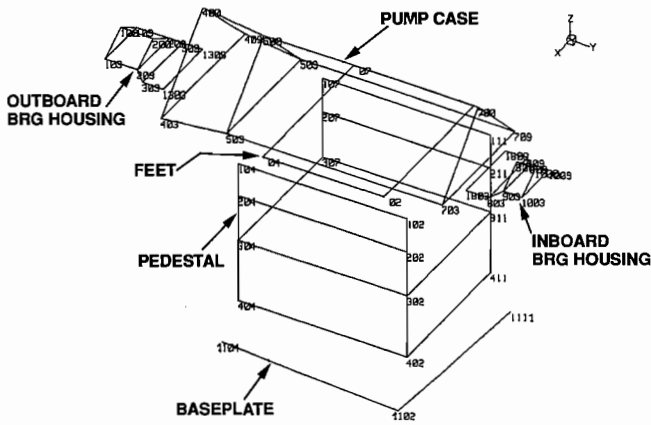
Figure 11. Geometrical Wireframe Model.

The modal analysis on unit P-302 revealed several resonance frequencies. Measurements were taken at 47 response locations in three directions, giving in total 141 DOF. Figure 11 shows the wire frame model.

Excitation with an instrumented impact hammer was done at three locations, indicated by an arrow in Figure 11, to ensure that every mode was excited. All measured FRFs are curve fitted and the modal parameters were determined and are shown in Table 6.
