BOILER FEED WATER PUMPS PERFORMANCE LOSS

AMR MOHAMED GAD- RASGAS

29TH INTERNATIONAL PUMP USERS SYMPOSIUM

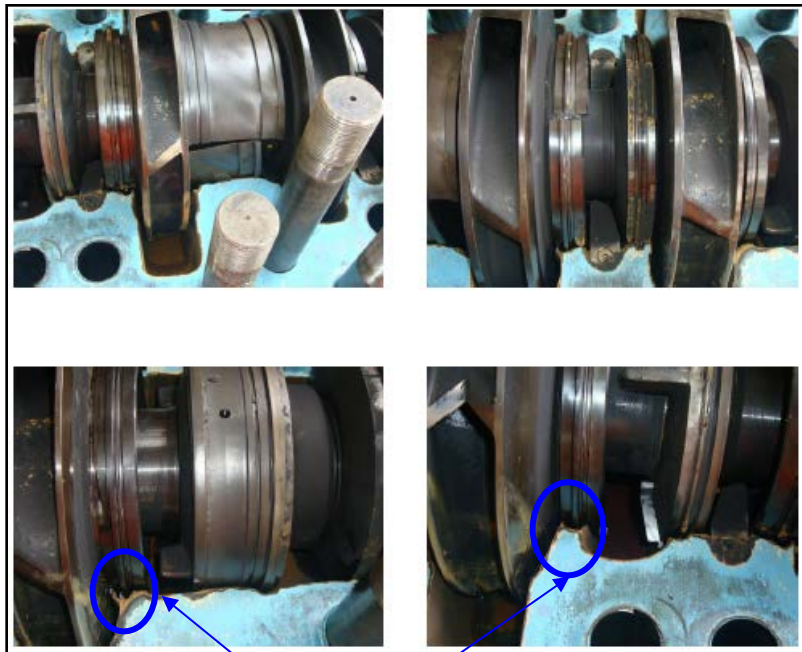
Casing erosion

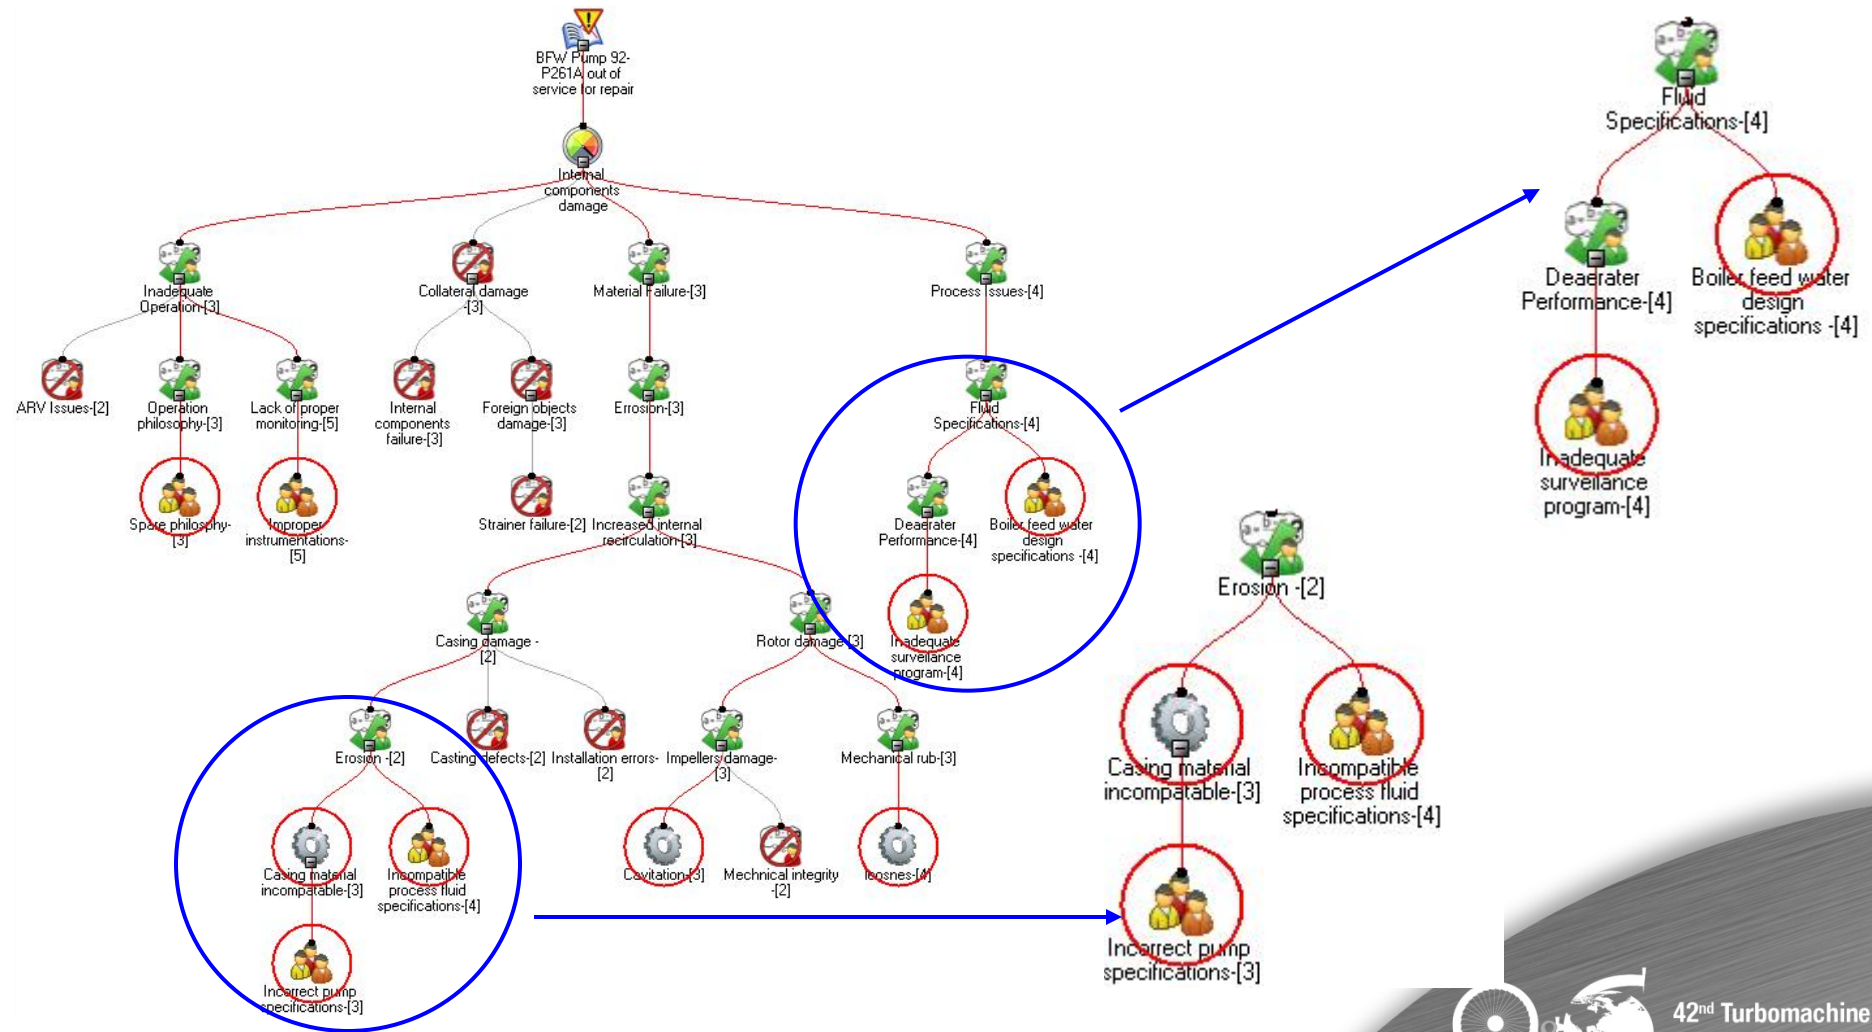
RCFA-Unit 92-P261A

- Root Cause (Human) - Incorrect material specification of the pump casing for boiler feed water service led to major damage of casing inner walls and rotor parts
- Contributing Factor 1 (Latent) – Insufficient online monitoring of pump performance due to inadequate instrumentation prevented effective pump health monitoring
- Contributing Factor 2 (Latent) – Inadequate surveillance program for boiler feed water conditions led to a possible corrosive environment within pump flow path

- Immediate action: Purchase x6 new BFWPs with 12%Cr Stainless Steel casings (A487CA6NM) and replace the existing pumps with carbon steel casing (A216 WCB)
- Medium action: Revise Equipment Strategy to perform bi-monthly online performance monitoring task including steam condensate dissolved oxygen and PH levels to ensure remaining within specification
- Long term action: Improve online monitoring:
 - Digital discharge pressure transmitter
 - Install flow measurement devices on the discharge and recirculation line
