Canned Motor Pump Failure

A Case History of Canned Motor Pump Failures – Demystifying the Thrust force

Vineet Jindal

Rotating Equipment Engineer – Shell Chemicals Seraya Pte Ltd , Singapore

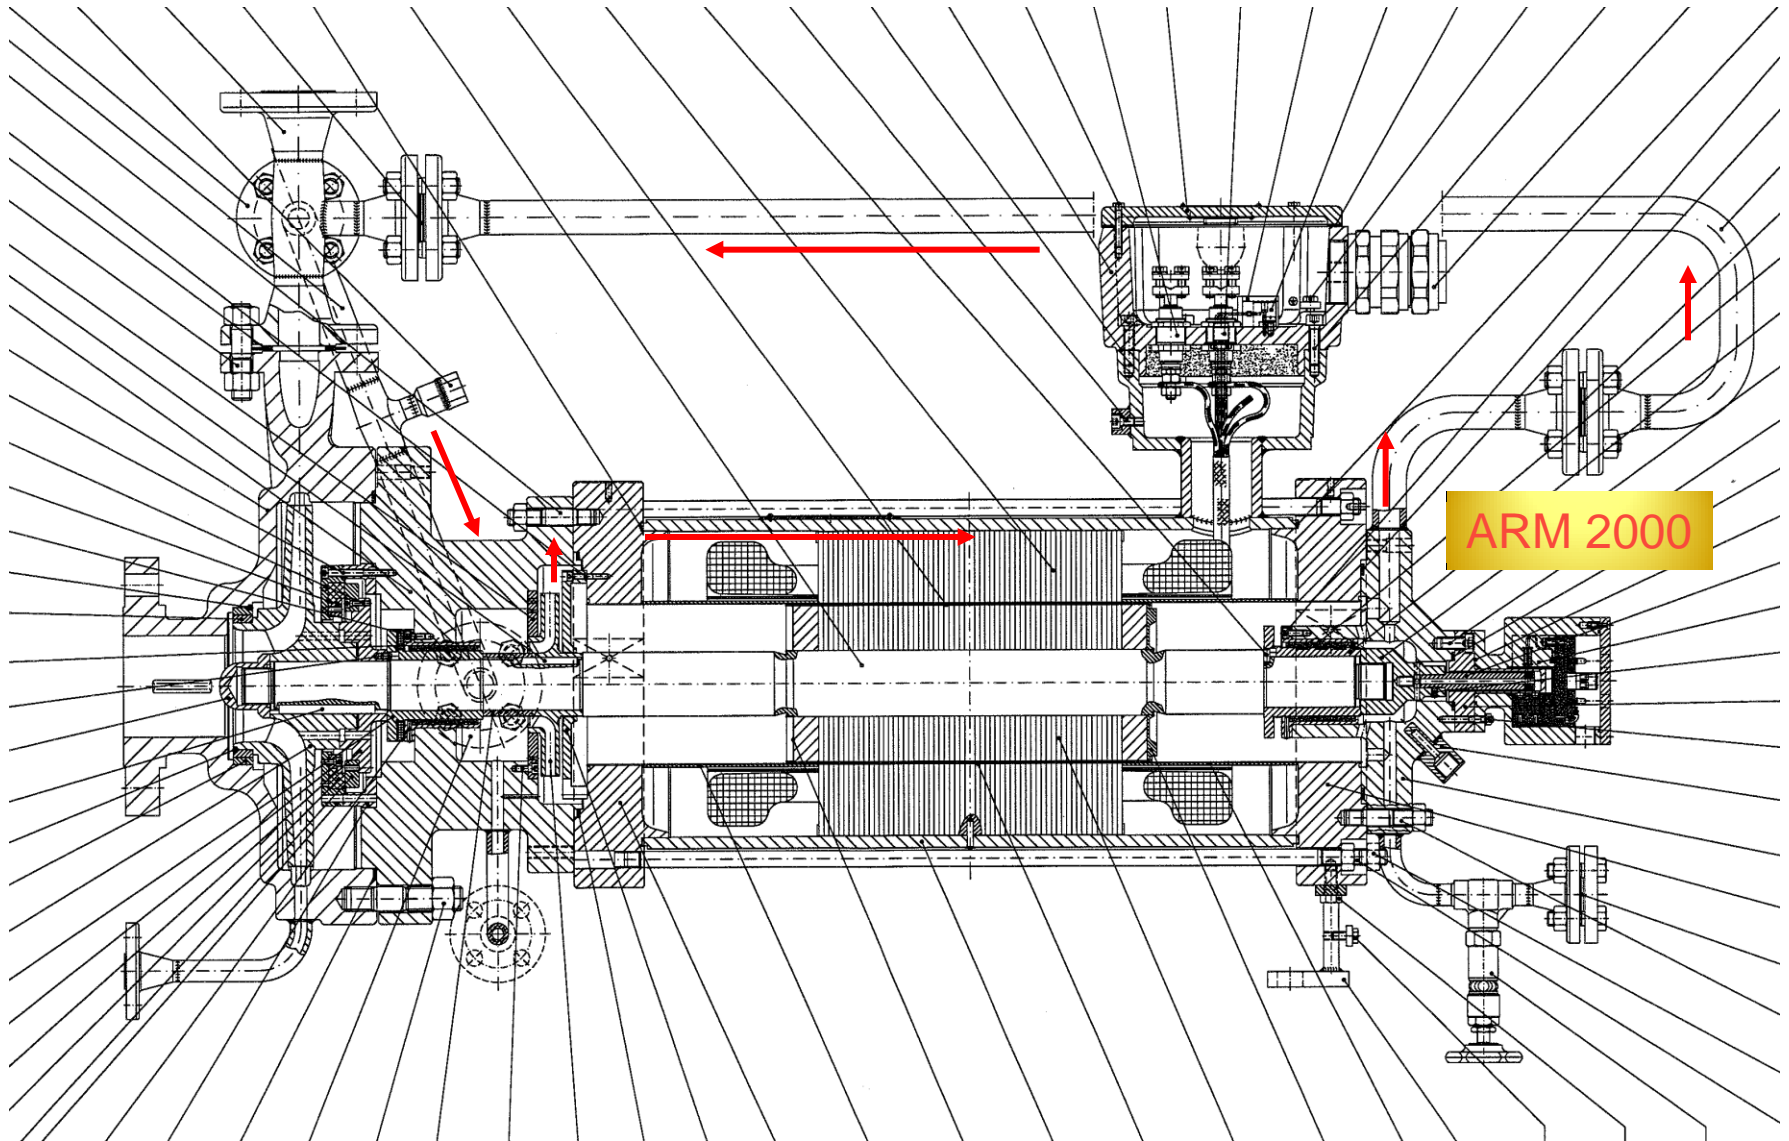
Problem Statement – The Pump Cross Sectional Drawing

- The subject pump is a Overhung Canned Motor Pump pumping Condensate with traces of Ethylene Oxide.
- The pump has a thrust balancing mechanism comprising of a rotating thrust disk and a stationary carbon ring.
- The pump has a secondary impeller which takes suction from main discharge line and circulates the cooling fluid to cool the motor windings.
- The pump is installed with a axial position measuring device called 'ARM 2000' which provides the real time position of the rotor.
- The axial position signal is monitored in DCS with an alarm and trip interlock.
- In addition to axial position , winding temperature of the motor and power output also has signals coming to DCS , though without alarms.

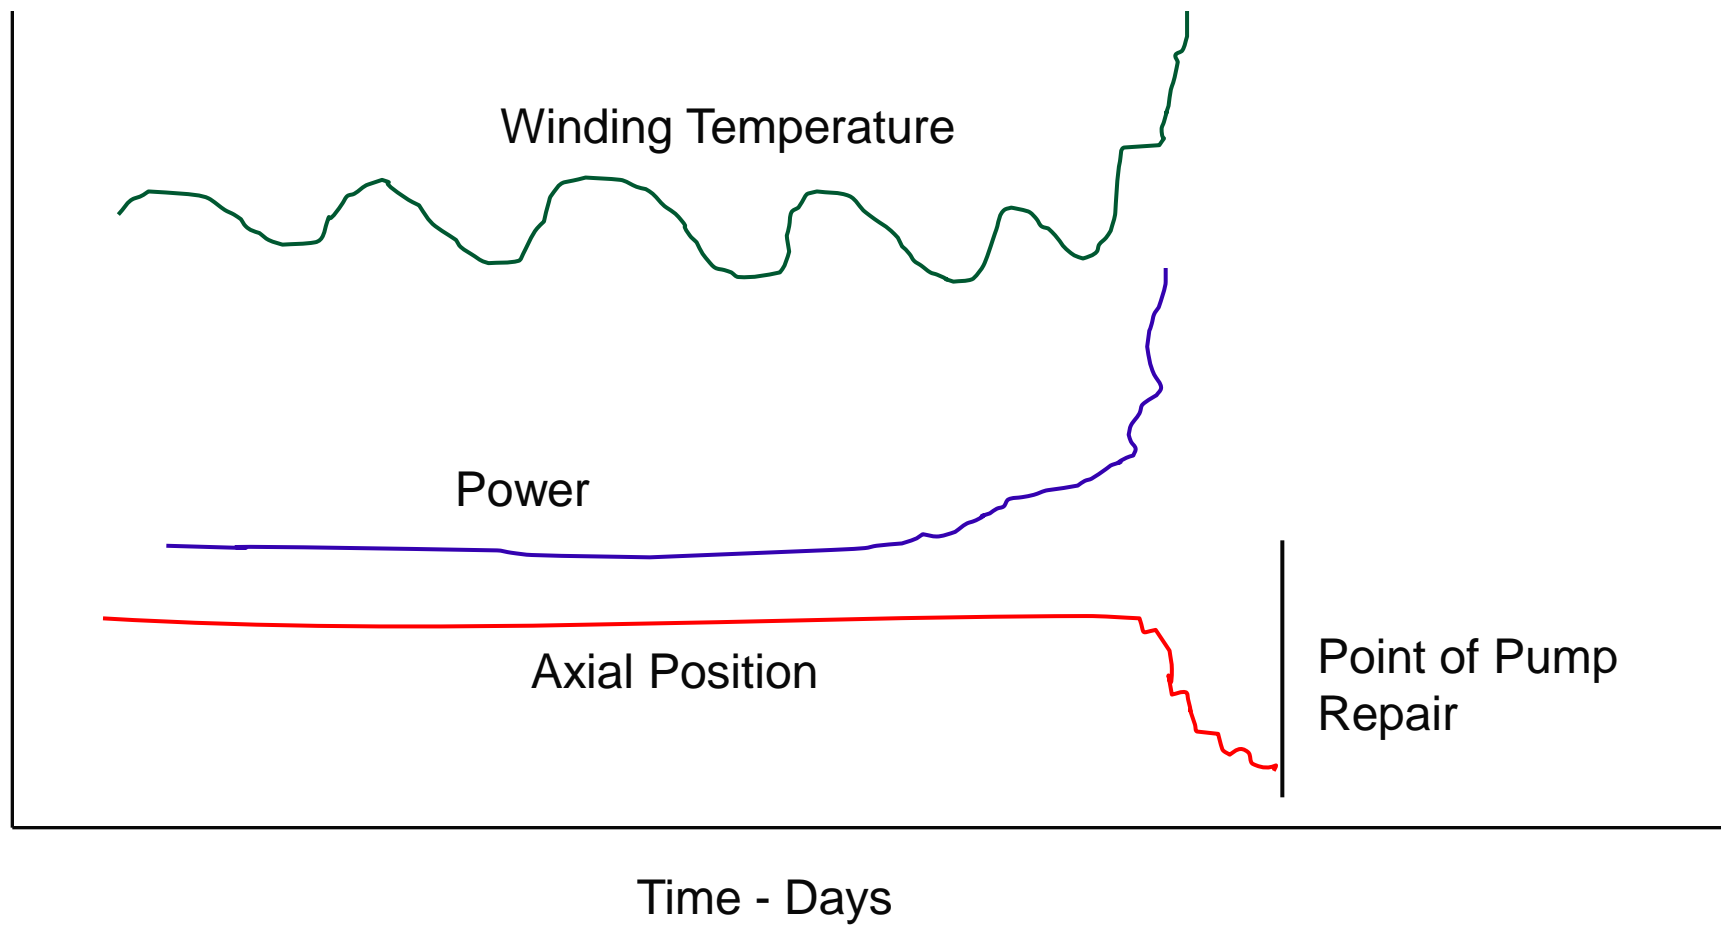
Problem Statement – How we saw it

- In a typical failure mode, axial position will change and motor current will increase.
- The carbon ring would be found heavily rubbed & damaged

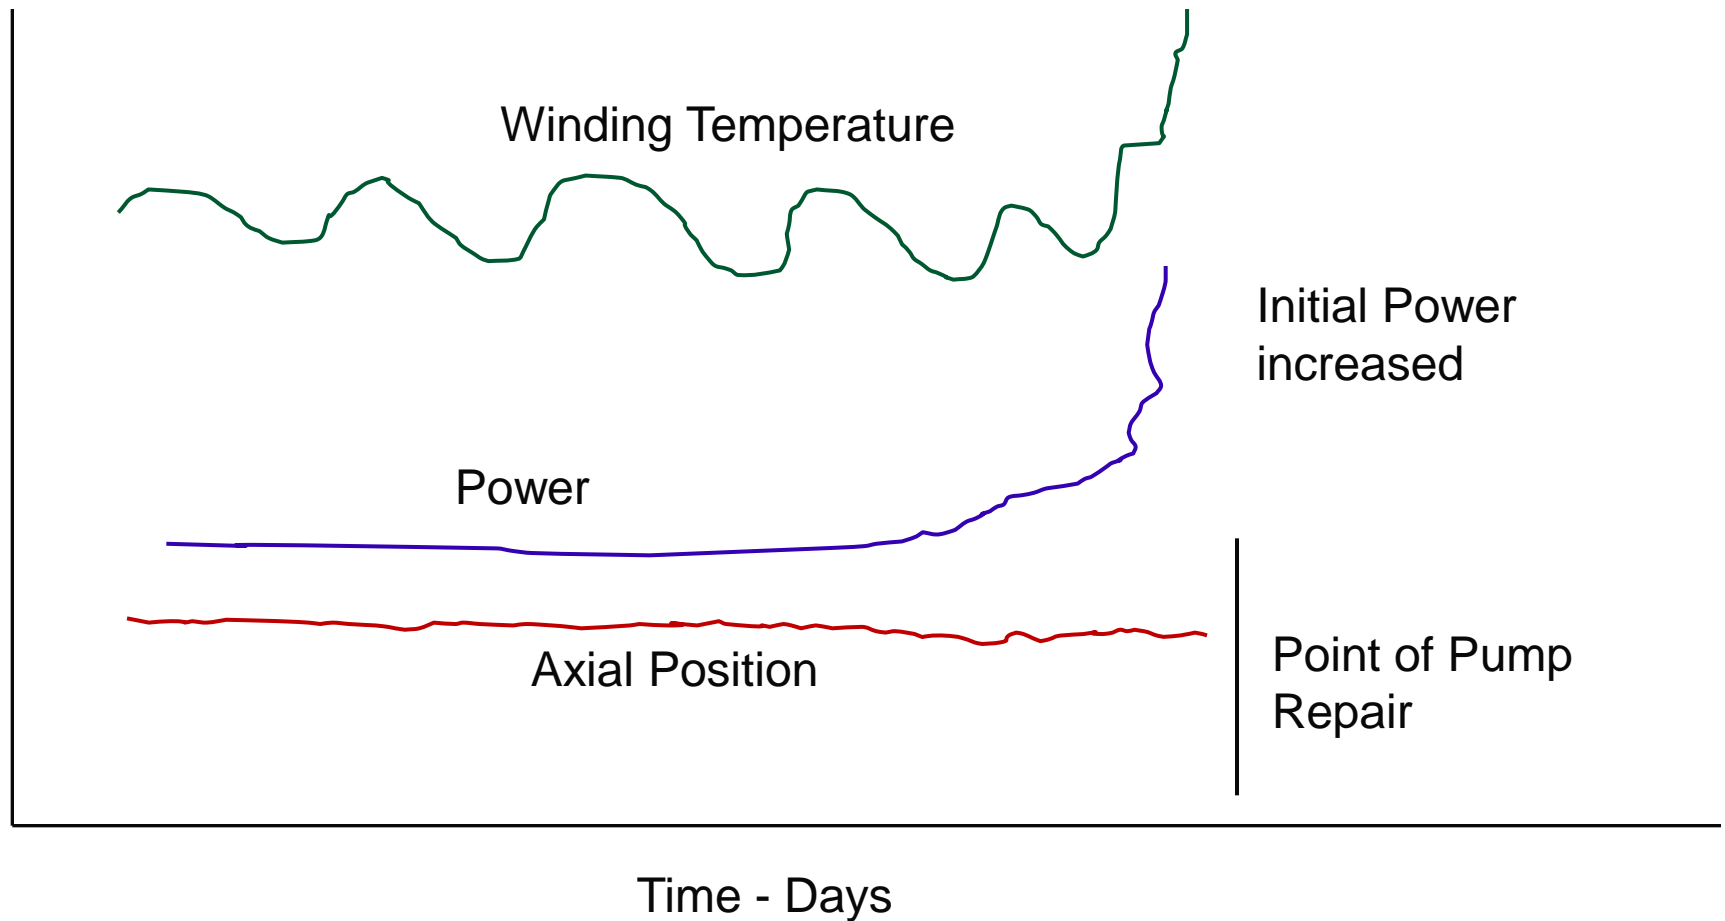
Problem Statement – Effect of First Modification

Vortex Breaker Strips created pressure on the suction end of the pump to counter thrust towards suction.
Balancing holes enlarged to facilitate balancing action.
