**43rd Turbomachinery
30th Pump SYMPOSIA**

RELIABILITY IMPROVEMENT OF MAGNETIC DRIVE PUMP FOR SPECIAL SERVICES

Presentation Overview

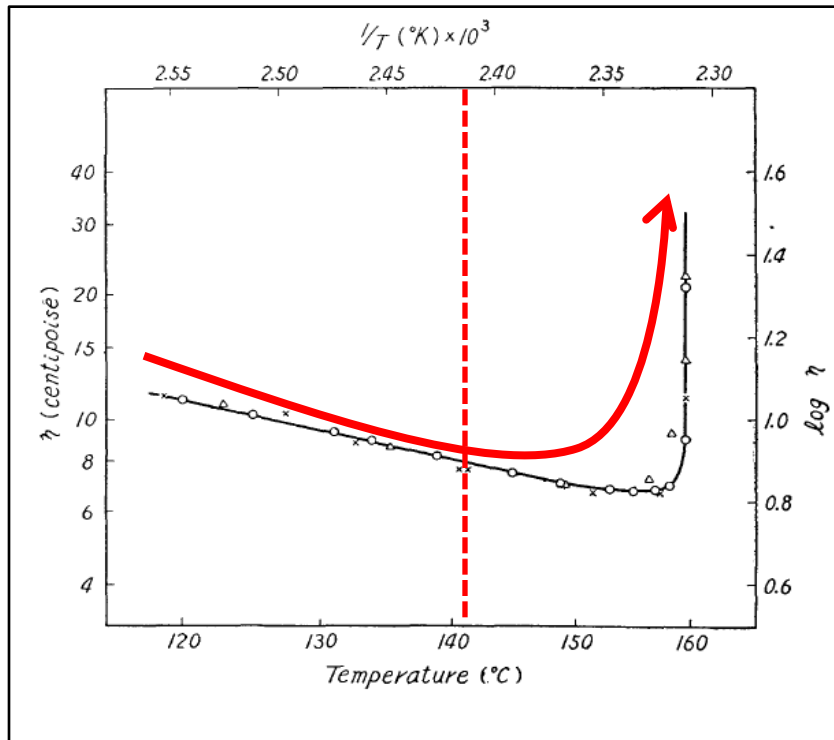
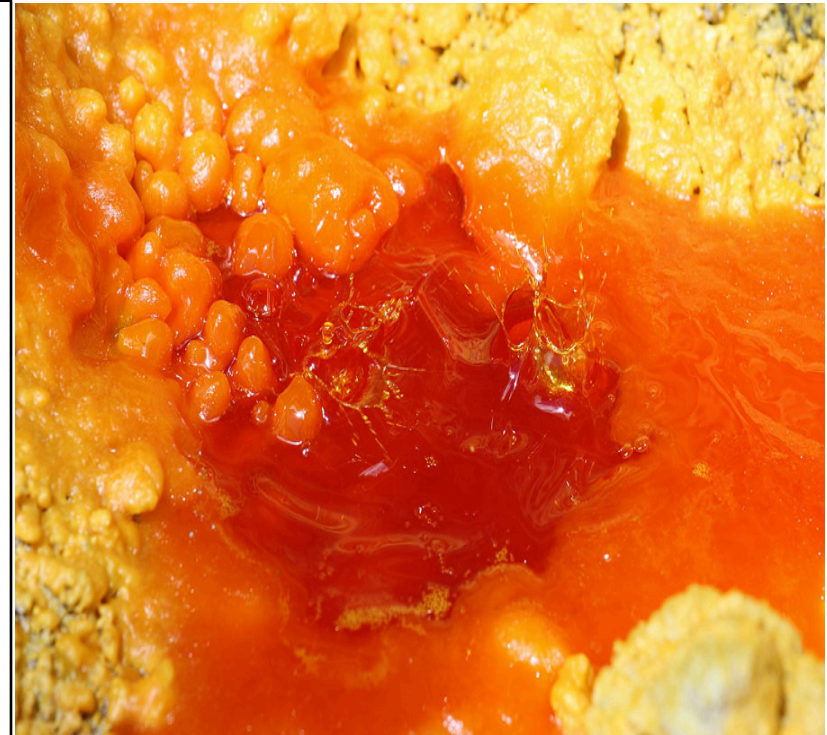
Heat generated due to operation under min. flow consequently increased viscosity of pumping fluid(molten sulfur).

Excessive Heat
Generation

Increasing
viscosity of sulfur

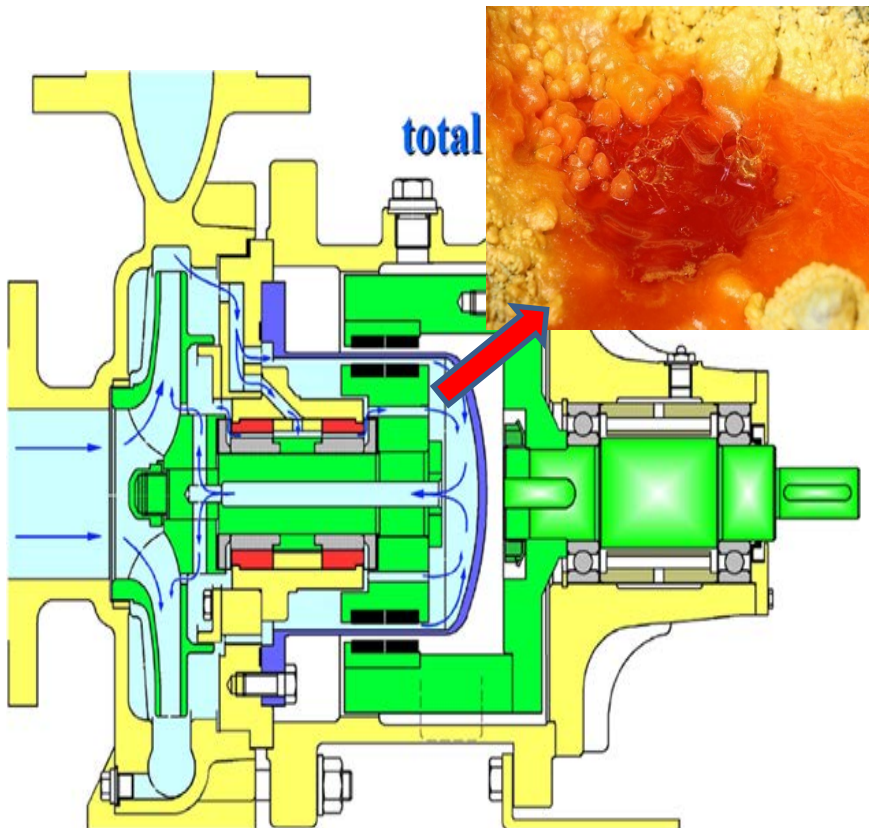
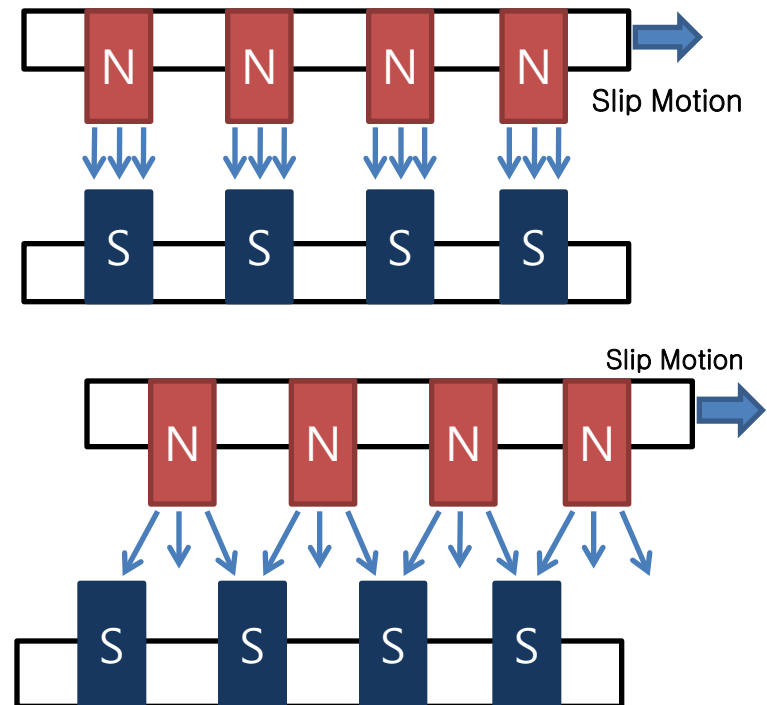
Demagnetizing
+ Heat Generation

Internal Parts Damage
(Coupling & Shell)

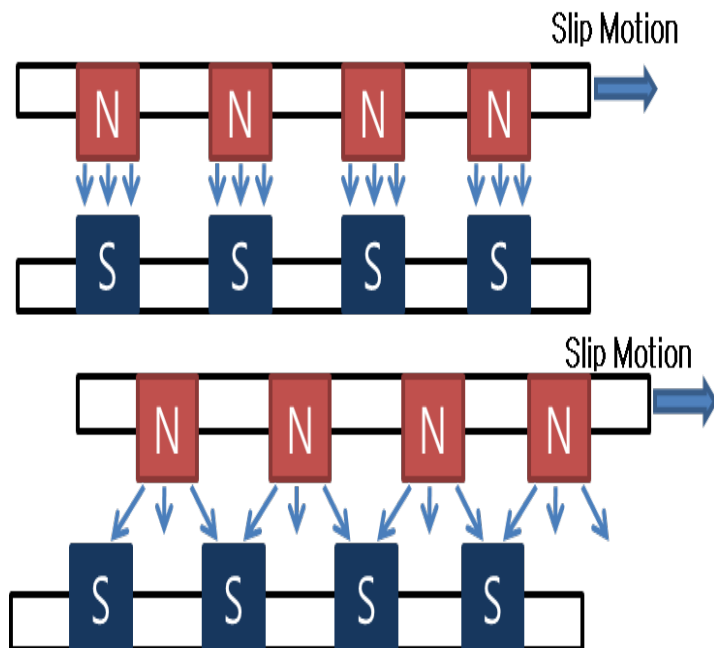
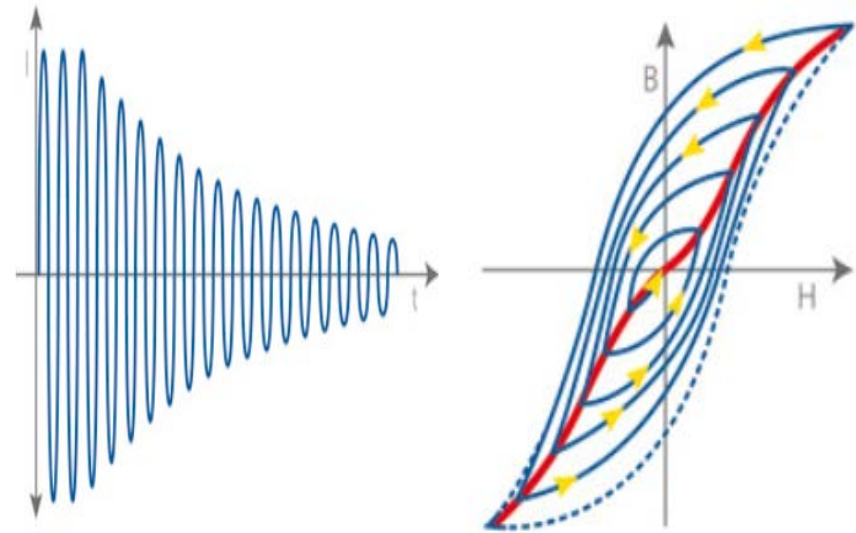
Internal Parts Damage
(Coupling & Shell)

Slip of magnetic coupling causes alternate magnetic flux with **decreasing amplitude by hysteresis loop**

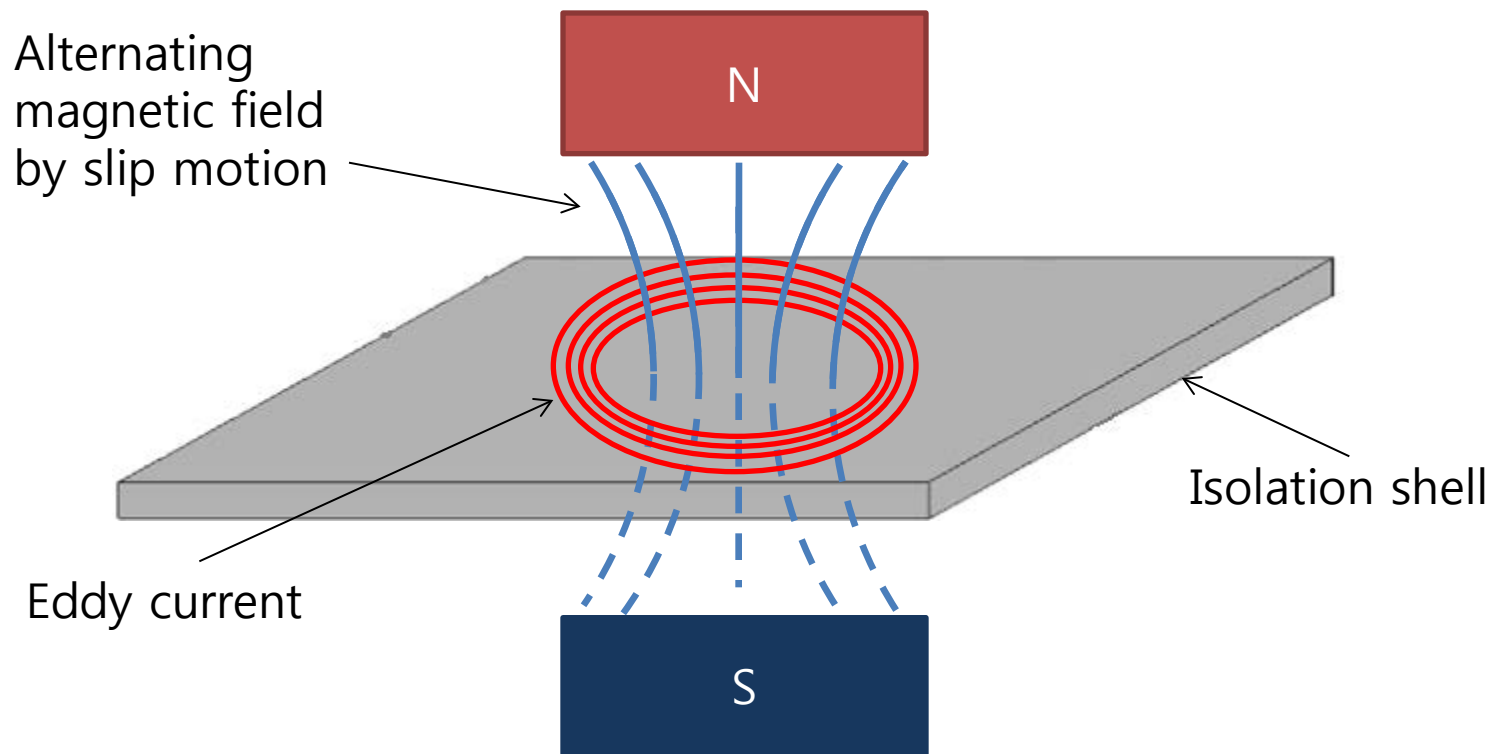
Eddy current in isolation shell inducted by alternate magnetic flux, **causes excessive heat by Ohmic loss like induction furnace**

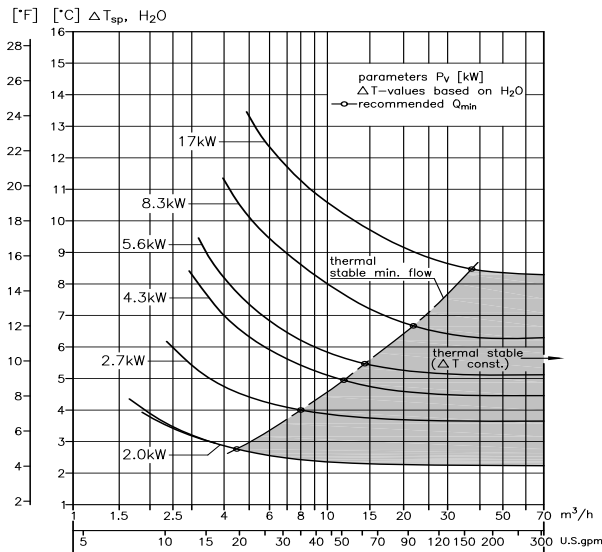
Magnetic coupling rated torque was higher than motor trip torque

▪ Expected Temperature Rise : **156.2 °C**

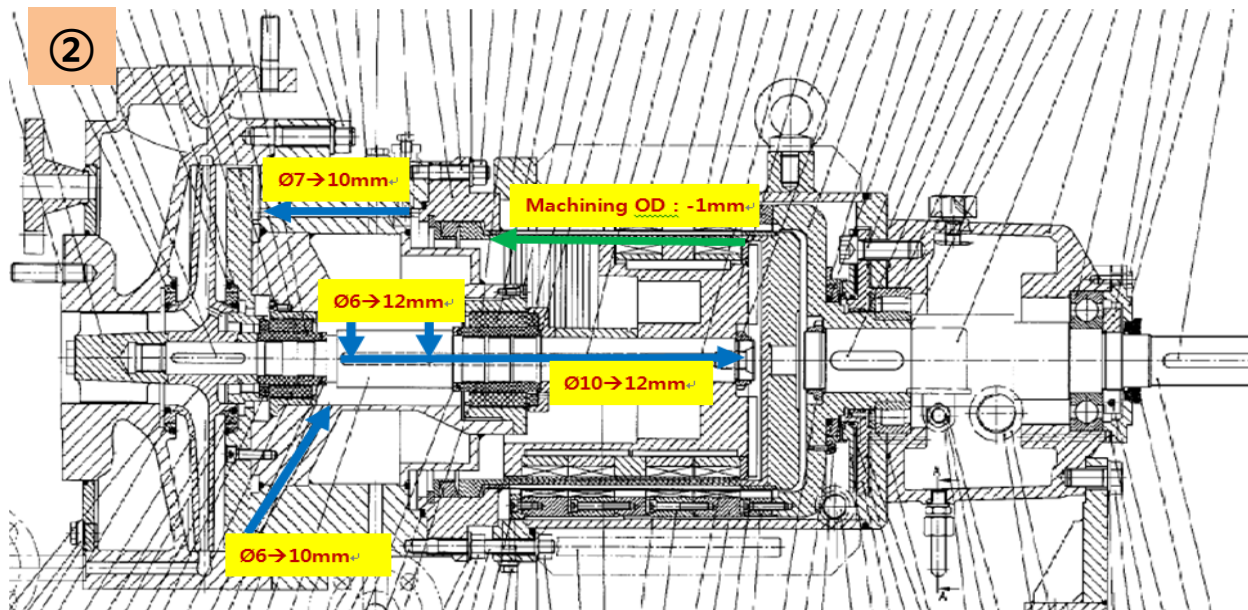
These pumps have been operated stably since 2008 without any trouble (Shell Temperature : 167 → 154 °C)

② Increase the internal cooling flow

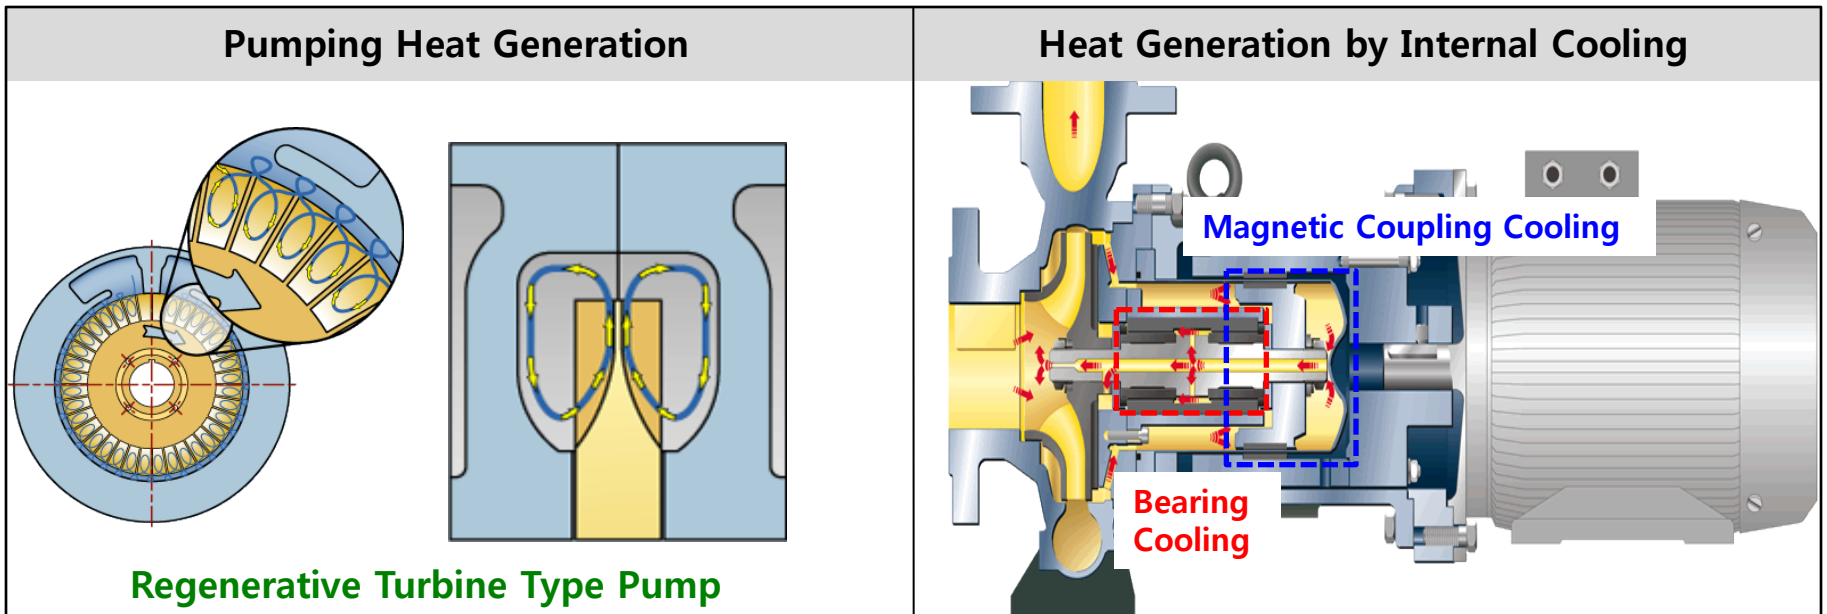
Problem	Root Causes	Aspect
① Pressure Drop due to Cavitation	a) Decreased NPSHa Suction temperature was +2.2°C higher than design	Operation
	b) Increased NSPSH3 Heat generation (+3°C) during pumping by Pumping Heat and Magnetic & Bearing Cooling Heat	Design

Root Causes	Solution Provided	Aspect
Ⓐ Decrease NPSHa	<ul style="list-style-type: none">▪ Improvement of NPSHa<ul style="list-style-type: none">- Protect pump suction line from radiation of sun- Increase Tank Level for summer	Operation
Ⓑ Increase NPSH3	<ul style="list-style-type: none">▪ Water jacketing for casing cooling	Design
Ⓒ Additional Remedy	<ul style="list-style-type: none">▪ Implement proper protection system<ul style="list-style-type: none">- Shell Temperature Monitoring & High Trip- Motor Amp. Low Trip for slip of Magnetic Coupling	Protection System
