# SEVERE SUCTION BELL DAMAGE IN LARGE, OPEN IMPELLER, VERTICAL TURBINE PUMPS

by  
**Michael D. Smith**  
Pump Consultant  
Dupont Company  
Wilmington, Delaware

## ABSTRACT

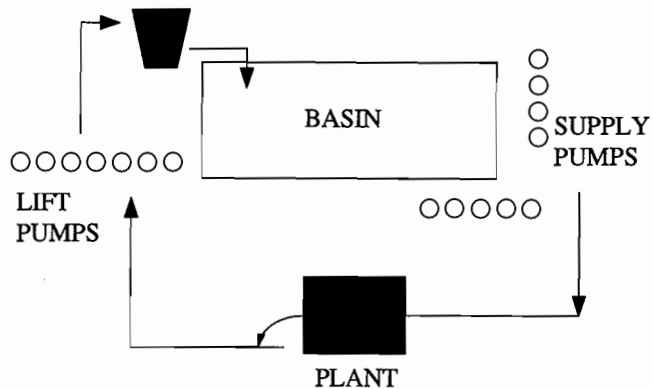
A large chemical plant has used bronze fitted, cast iron, vertical turbine pumps to circulate cooling water for over 30 years. In 1994, a new cooling water system (Figure 1), including new pumps with semiopen impellers (Figure 2), was installed and began operation. Nine 1500 hp pumps draw water from a large cooling basin. The water is supplied, under pressure, to thousands of points in the plant for process cooling. It then flows back toward the basin in an open canal. Seven 500 hp pumps then lift the water to the top of a cooling tower, where it is cooled before returning to the basin.

Figure 1. Cooling Water System.

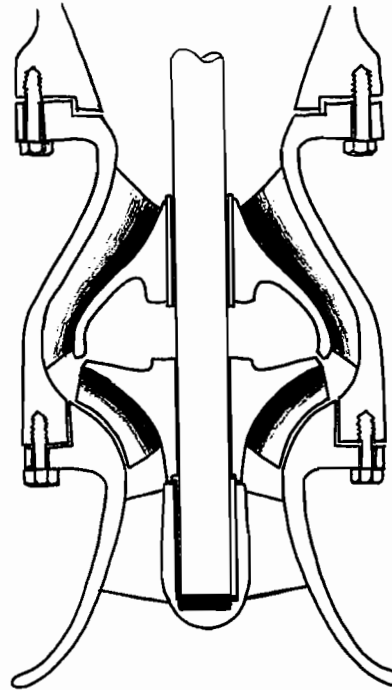
Figure 2. Vertical Turbine Pump with Semiopen Impeller.

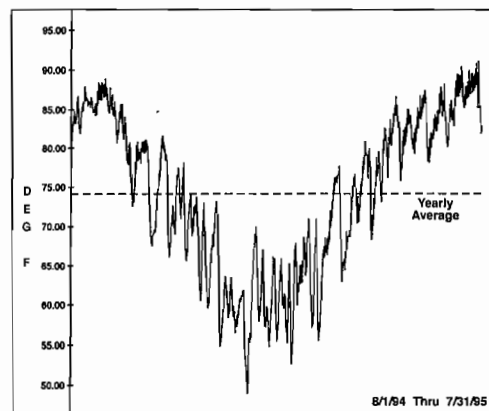
No evidence of an unusually high level of abrasives was found. Corrosion always plays a role in metal loss, whether due to erosion (oxidizing the newly exposed surface) or surface fatigue (corrosion lowers the endurance limit). There are several variables that impact how "aggressive" water is to cast iron. Temperature (Figure 8), pH (Figure 9), conductivity (Figure 10), residual chlorine (Figure 11), and total chlorides (Figure 12) were recorded throughout the life of the damaged pumps. While the two periods of low pH are suspicious, one supply and one lift pump were not in service during either period and accumulated the same damage as the other pumps. This indicates that the periods of low pH did not have a measurable impact.

Figure 8. Cooling Water Temperature During the First Year of Pump Operation.

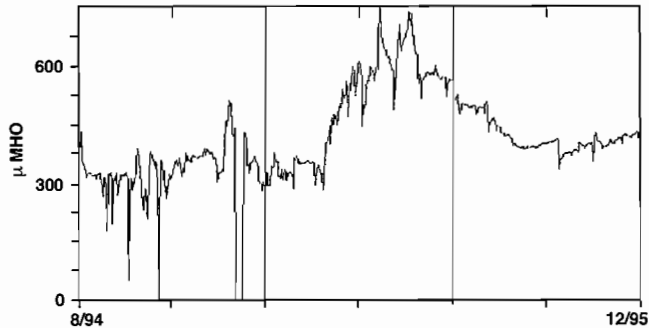
Figure 10. Cooling Water Conductivity.

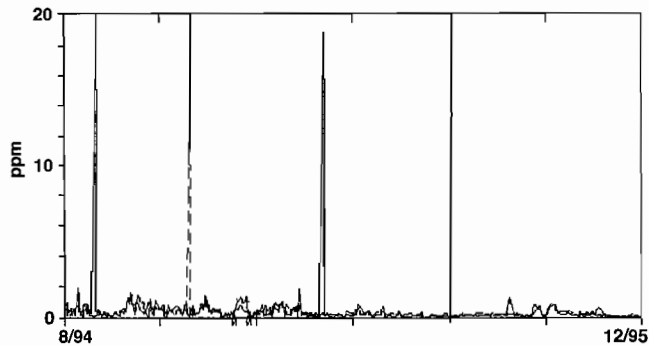
Figure 11. Cooling Water Excess Chlorine.

Additional measurements of residual chlorine near the addition points in the supply pump pits indicated some lack of mixing. This can lead to potentially damaging levels of low pH. This was also found to be insignificant since the lift pumps are not near the addition points and had similar damage.

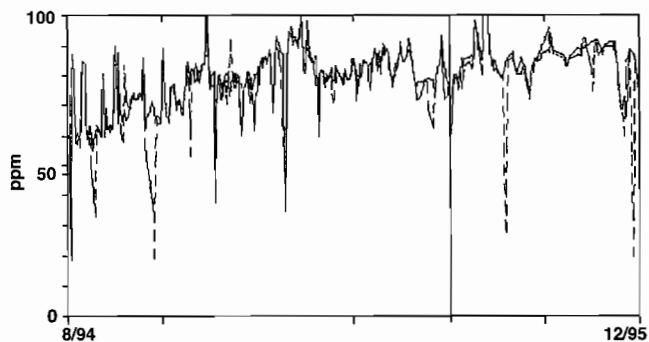
Figure 12. Cooling Water Total Chlorides.
