THE USE OF BASIC HYDRAULICS TO SOLVE FIELD PROBLEMS: THREE CASES

CASE 1: COOLING WATER PUMP CASE STUDY— CAVITATION PERFORMANCE IMPROVEMENT

CAVITATION DAMAGE AS RELATED TO OPERATING POINT

CASE 3: USE OF BASIC PUMP HYDRAULICS TO SOLVE PUMP MAINTENANCE PROBLEMS

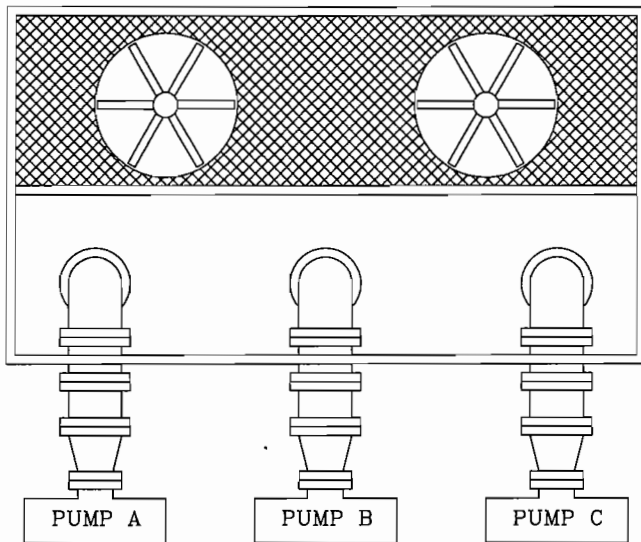
Figure 1.

The overall view of the cooling water tower is shown in Figure 1 with three pumps. Depending on load, one or two pumps are operating, with the third a spare. The total flow requirements vary between 16,000 to 25,000 gpm, based on the process heat exchangers load, ambient temperature, system minimum settling flows, and other considerations. This translates into the requirements for each individual pump to operate between 8,000 to 17,000 gpm. These double suction pumps are running at 1180 rpm, have 23.25 in impeller OD. Specific speed $N_s=2260$, and suction specific speed is $N_{ss}=10,050$ (flows used in calculation of N_s and N_{ss} are per impeller eye, i.e., half total flow).

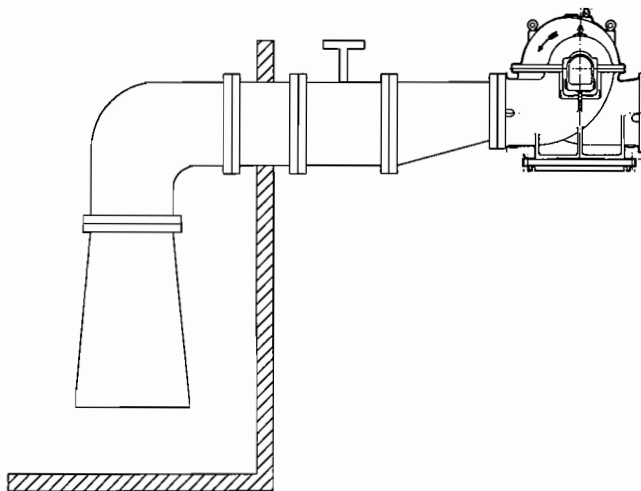
A detail of an individual pump is shown in Figure 2. The sump was designed to ensure convenient pump flooding by just opening the butterfly valve, since the water level in the sump is above the impeller centerline. At first, the pump piping was suspected as

causing a problem. The incoming sump velocities are very low (under 1.0 ft/sec), and no visual vortices were noted. The 36 in elbow and the bell were removed and the pump tested, indicating no appreciable difference in noise. The butterfly valve was installed in horizontal and then vertical stem orientation, both in the field and in the manufacturer's test facility. In the field, no noticeable change in noise was observed; in the test facility, the horizontal stem orientation was less noisy than the vertical (as expected), but the difference believed to be not significant enough to be a cause of the noise and damage. The original pump impellers were of cast iron, which is known to have poor cavitation resistance properties. From the hydraulic design standpoint, the impeller eye size was too big for the range of N_s and N_{ss} , as applied to cooling water pumps. As shown on Figure 3, and can be calculated from Fraser's data [1], the onset of the suction recirculation starts at around 13,000 gpm. At flows lower than that, the cavitation damage becomes quick, especially in light of poor metallurgy. The pump performance with operating flow range is shown on Figure 4.

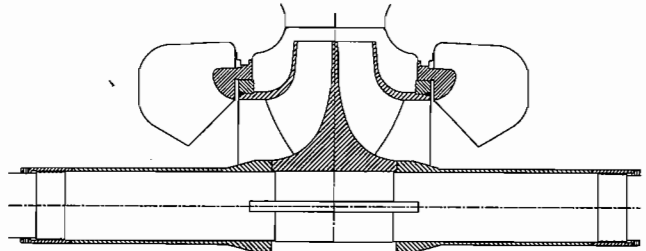
The following modification was aimed at improving flow distribution around the impeller inlet. The original suction splitter is only 15 degrees from the vertical line, and was shaped poorly, as shown on Figure 8 (left). Much better designs are given [3], and these guidelines were followed, as shown on Figure 8 (right)—much better contouring, and splitter centerline moved to 55 degrees from the vertical. In order to accommodate such modification in the field, the old suction splitter was ground off, and a new one was attached to the casing ring (Figure 9). The noise data for this modification is shown on Figure 6 (squares). Note that the whole noise curve is shifted downwards by about 3 dBA, and gets even more significantly better at the very low flow.

Figure 8. New Splitter: Repositioned, and having Better Contour Shape (Ref. Figure 7).

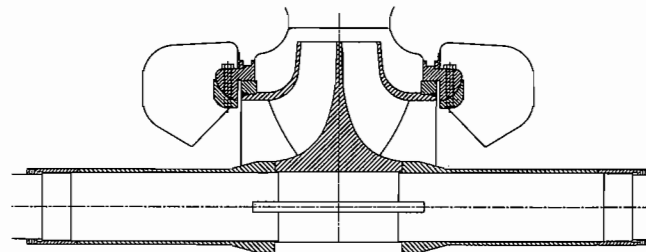
Figure 9. Bullring with Splitter Modification.

Bullring and suction splitter have little effect on cavitation damage life improvement, even though it has an effect on reducing noise and vibration level.

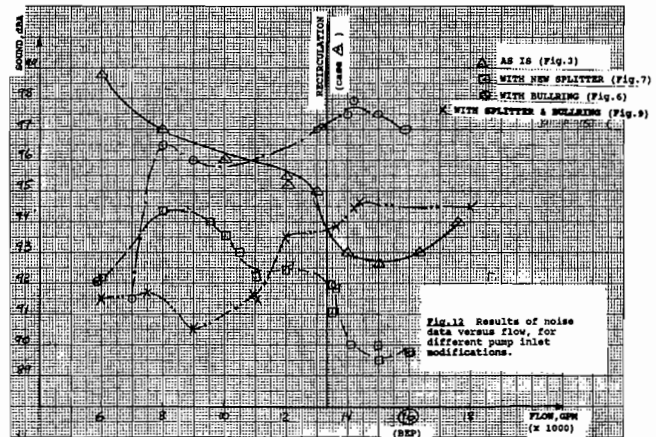
Figure 12. Results of Noise Data vs Flow, for Different Pump Inlet Modifications.

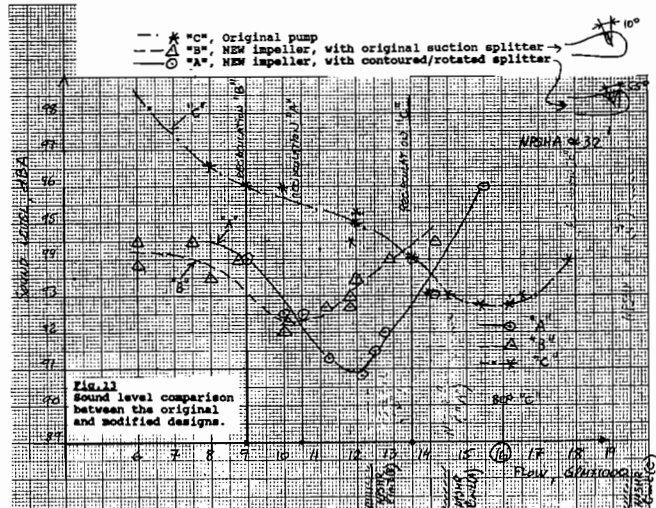
The comparison is shown in Figure 13 in noise levels between the old impeller design (pump "C") and the new one (pumps "A" and "B"). The noise was lowered for a new design - both for "A"

and "B" pumps. Pump "B" had a new impeller with smaller eye and special "P-blades" [4], but the casing still had the original blunt suction splitter (Figure 8, left), while pump "A" had also a contoured splitter (Figure 8, right). The combination of the new impeller design and contoured splitter resulted in lowest noise level. The smaller eye impeller requires higher NPSH_R though, which is the reason for the noise curve to begin to rise at the lower flow than the original impeller. This was not a problem in this case due to sufficient NPSH margin available, and the desired operating flow below 12,000 gpm. The contoured splitter offsets this disadvantage somewhat, as can be seen on Figure 13 (pump "A").

Figure 13. Sound Level Comparison between the Original and Modified Designs.

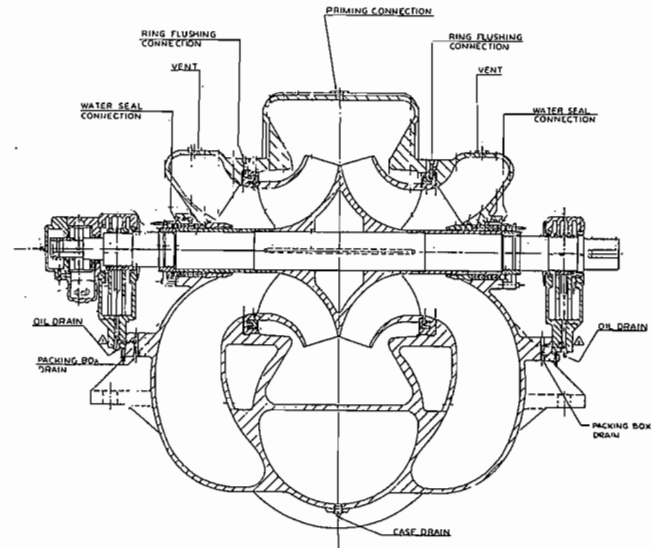
Large single stage, double suction circulating motor driven water pumps, as shown in Figure 14, were supplied to provide cooling water to power plant condensers. These pumps are relatively large motor driven pumps, having a suction flange diameter of 60 in and a discharge flange diameter of 54 in. They have horizontally split cases with a double volute discharge. The pump has two ring oil lubricated split sleeve radial bearings and a double acting tilting pad thrust bearing. The pumps were originally specified to deliver a head of 120 ft at a flow of 120,000 gpm with a required NPSH of 31 ft. The performance curve is shown in Figure 15.

Figure 14. Cross Section View of a W 60/54 (60" Inlet, 54" Discharge) Single Stage, Double Suction Circulating Water Pump.

After the pumps were installed at the power plant, the impellers were reported to have cavitation damage. Further investigation showed that the pumps were being operated at a higher flow than the design flow. This was because the head required at the field installation was less than that originally specified.

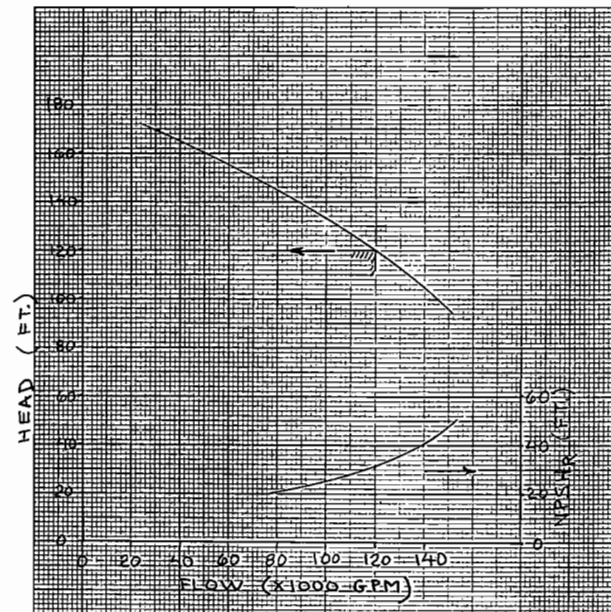
Figure 15. Performance Curve of the W 64/54 Circulating Water Pump.

The performance curve of the circulating water pump is shown in Figure 2. This figure shows that the pump has a design head of 120 ft at a design flow of 120,000 gpm. At these conditions, the available NPSH was 38 ft. The required NPSH at this design condition is 31 ft. At this operating condition, there was no indication of cavitation damage.

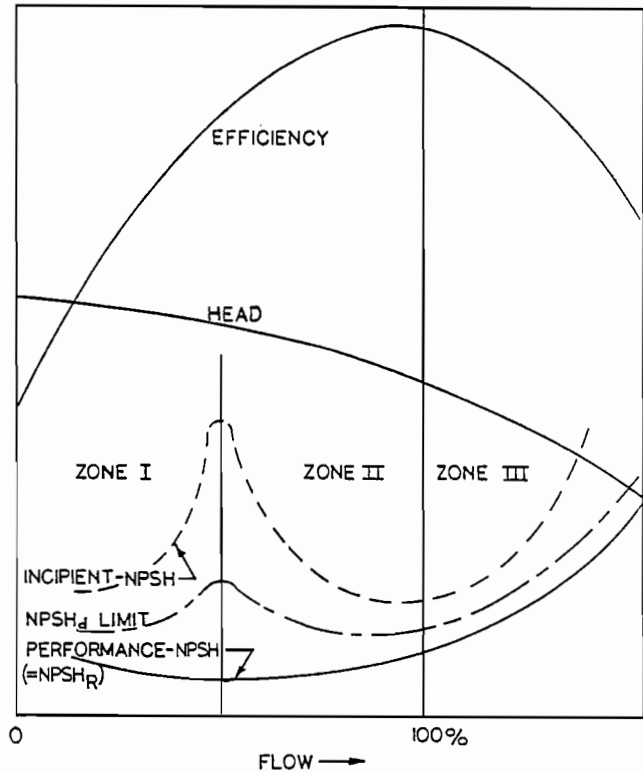
Consider a typical pump performance curve as shown in Figure 16. This figure contains five curves: a Head-Capacity curve, an Efficiency curve and three NPSH curves. The three NPSH curves are: 1) the Performance-NPSH curve, which is the amount of NPSH required to maintain hydraulic performance, 2) the NPSH curve, which is the amount of NPSH required to limit cavitation damage, and 3) the NPSH curve, which is the amount of NPSH required to prevent vapor bubble formation entirely.

Figure 16. Typical Pump Performance Curve, Showing NPSH Required, a) to Maintain Hydraulic Performance or Pump Head, b) to Limit Cavitation Damage, and c) to Prevent Vapor Bubble Formation, Incipient NPSH. (Source: Cavitation Damage In Boiler Feed Pumps by Paul Cooper and Fred Antunes, Symposium on Power Plant Feed Pumps, June 1982).

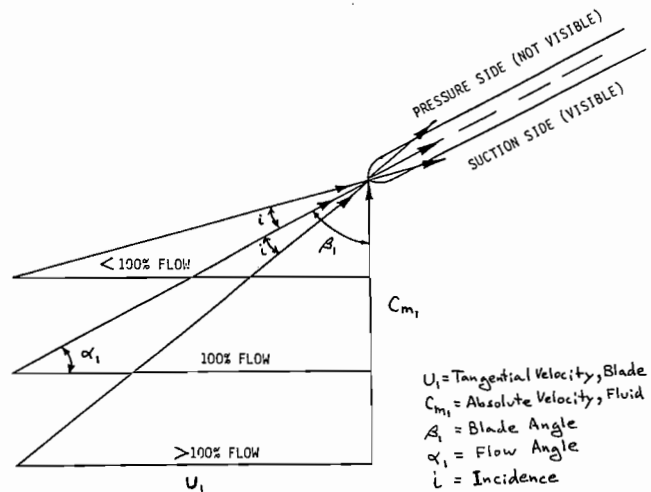
Zone III is the area that incurs runout cavitation damage that appears on the pressure side, or nonvisible side, of the blade. At higher than design flow, the angle of attack of the flow velocity vector on the blade leading edge will cause the flow to separate on the pressure side of the blade, as illustrated in Figure 17. Under

Figure 17 The Relation of Inlet Flow Velocity Vectors and Cavitation Assuming No Prerotation of the Inlet Flow.

low pressure conditions, vapor bubbles will be formed and carried downstream into higher pressure areas. When they implode on the pressure side of the blade, cavitation damage will occur. The cavitation damage will occur further downstream for higher values of incidence.
