Vertical Pump Motor Synchronous Vibration Case Study

John Bezugly

Enterprise Products, LLP

Abstract

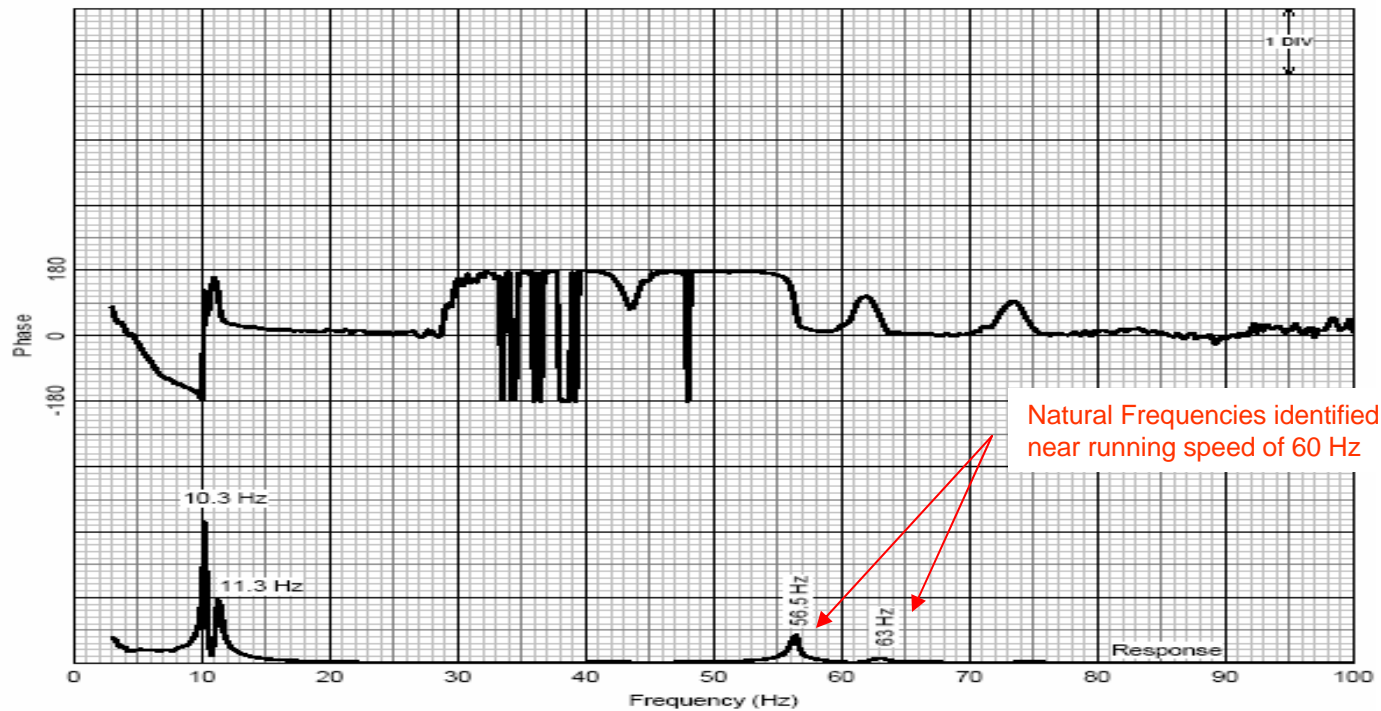
Impact Test

- Outside consultant brought in to assist with data gathering.

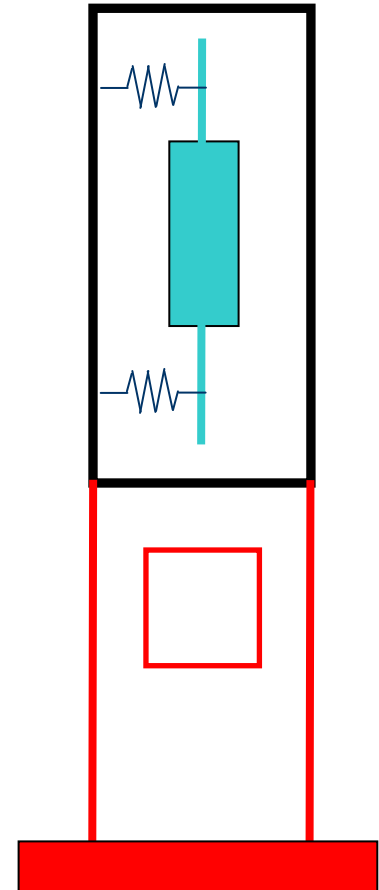
Why did Structural Modification not work?

- FEA model did not include rotor generated forces, rotor stiffness and rotor support stiffnesses.

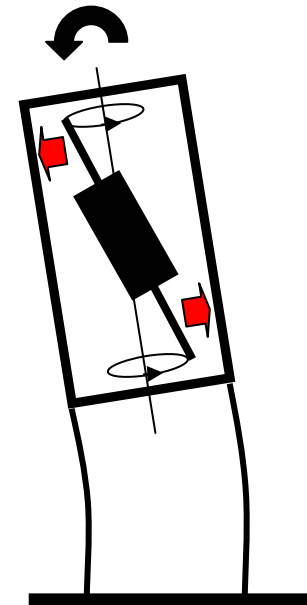
Possible Causes

- All these motor applications had high thrust bearing design consisting of 3 angular contact bearings (2 down, 1 up).
- Lack of precision of fits at upper thrust bearing could create high unbalance due to eccentricity.
- Insufficient down thrust causing improper loading of bearing and affecting stiffness.
- Other motor shop experience suggests significant attention needs to be paid to thrust bearing area during assembly with 3600 RPM high thrust motors.

- 1) Consider check balancing of 3600 RPM, 4160 V vertical high thrust motors on pumphead.
- 2) Close inspection of thrust bearing fits.
- 3) On some of the new motors that exhibited this problem it was found that installing a wavy washer above the bottom bearing stabilized the vibration.
