TROUBLESHOOTING TACTICS TO IMPROVE PUMP MEAN TIME BETWEEN REPAIRS

John P. Joseph II

Perry C. Monroe Jr.

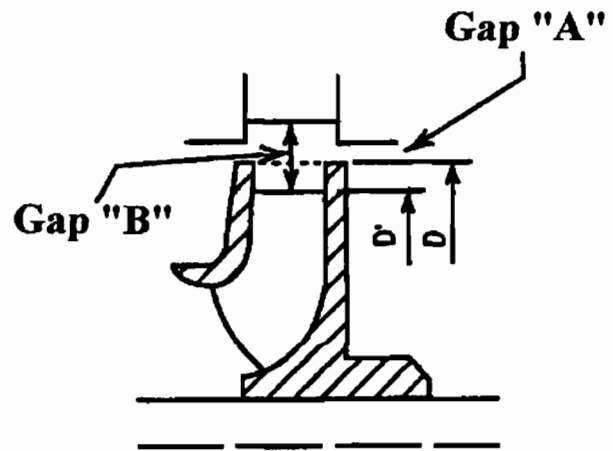
Figure 1. Impeller to Casing Gap "A," Gap "B" Relationship.

It is appropriate at this point to mention points of interest that share in the two categories of mechanical design and hydraulic fit. First, a proper "Gap B" should be established (Figure 1). This is the gap between the outermost diameter of the impeller vanes and the innermost diameter of the volute lip or diffuser tip. The Gap B should be six percent of the impeller vane radius for diffuser pumps and 10 percent of the impeller vane radius for volute pumps. The benefit of a proper Gap B dimension is a significant reduction in vane passing frequency vibration, especially at off BEP flowrates. This reduction in vane passing frequency vibration can increase seal and radial bearing life. Another related characteristic that can help if a pump must be run at less than BEP flowrates is to overfile the vane tips to reduce the dead spot in the flow field exiting the impeller OD (Figure 2).

The second point that shares both the mechanical and the hydraulic categories is a proper "Gap A" dimension. Gap A is the radial distance from the outermost diameter of the shroud of the impeller to the corresponding circumference on the case (Figure 1). This gap should be established at 0.050 in for all centrifugal pump types that have one or two shrouds. The benefit provided by a proper Gap A is a significant reduction in the eddy currents associated with discharge recirculation at less than BEP flowrates. These eddy currents shuttle forces axially across the shrouds of the impeller and can cause axial vibration and seal and thrust bearing failures. Sometimes these forces are strong enough to cause fatigue failures in the shrouds between vanes of the impeller.

When the impeller must be trimmed to better fit the process requirements, trim only the vane, not the shroud. Before rushing out to check pumps for the proper Gap A, be aware that well over 90 percent of all single stage pump cases and over 60 percent of all multistage pump cases are cast without metal in the needed area to establish a Gap A.

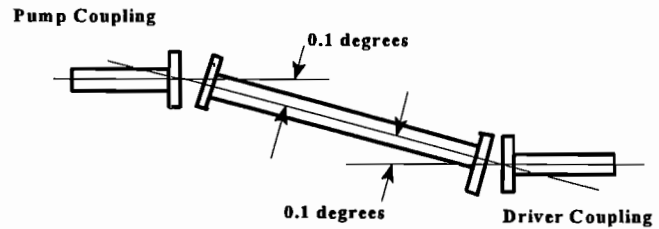
Figure 7. Alignment Tolerance Expressed in Degrees.

Proper pump to driver alignment, in the running condition, is necessary to reduce vibration and to limit forces on bearings, seals, and coupling components. Setting the cold alignment targets beforehand and aligning to those targets within a tight tolerance is required to limit alignment induced forces to an acceptably low level. Most people suggest tolerances of so many mils misalignment per inch of coupling spacer length. From the charting method, one can easily determine the angular misalignment between the pump and the coupling centerlines and between the coupling and driver centerlines after allowing for thermal growth. The misalignment in the hot, running condition should not exceed 0.1 degree between the coupling and either the pump or the driver. Transients through the warm up to reach equilibrium temperature should not exceed 0.5 degrees misalignment between the coupling and either the pump or the driver (Figure 7).

Remember that by the previously discussed piping criteria, pipe strain becomes a very low contributor to misaligning forces, especially at running temperatures. Therefore, most of the effort can be placed into determining appropriate cold targets to ideally achieve line-on-line alignment in the hot running condition. This must be done by surveying the pump and driver while in normal operation on a typical day to establish a temperature profile of the supports from the centerline of the shaft down to the top of the baseplate.

By knowing the materials of construction of the support structure and, thus, the linear coefficient of expansion, the cold alignment targets can be calculated. The alignment should be achieved by reverse indicator method as a minimum with laser alignment preferred if properly used. In the case of pumps operating above 700°F and/or having hot piping movement, the pump hot alignment should be checked while running at load and temperature using optics or the Essinger Bar.

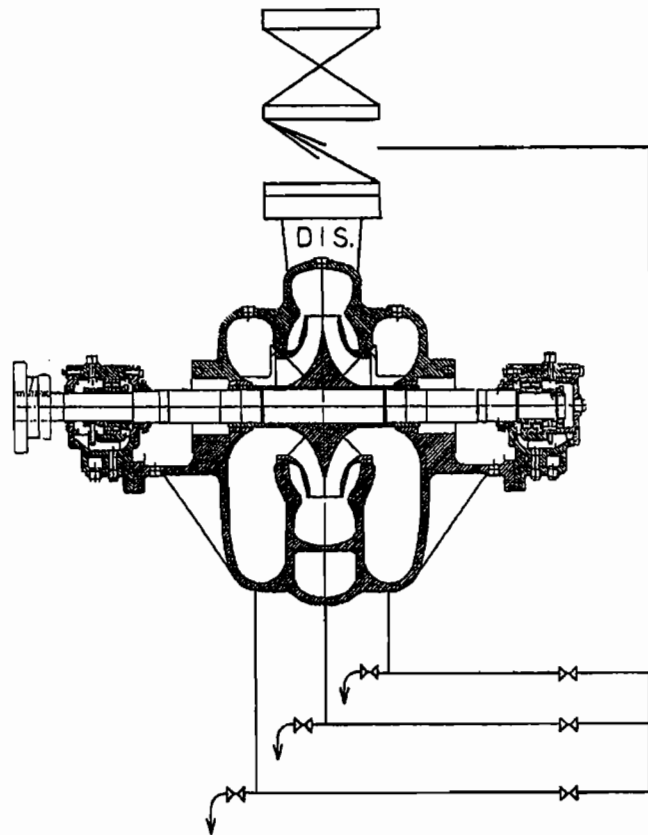
Figure 8. Warm Up Piping Arrangement for Hot Pumps.

For all hot pumps, the warm up liquids need to be piped to the bottom of each chamber in the pump case. The hot liquids can then heat soak the case and rotor from the bottom up. More uniform warm up of the pump will occur. Proper warm up piping should be included in root cause analysis of hot pumps (Figure 8).

Most hot pumps have a warm up line that bypasses the check valve and circulates hot process liquids from the pump discharge nozzle to the suction nozzle. In this arrangement, the hot liquids take the shortest path across the top of the pump case and do a very poor job of warming the bottom half of the case and rotor. Operations add to the problem by needing to start hot pumps very shortly after warm up has begun. Reasonable heat soak cannot be achieved with this arrangement. Even with extended warm up periods, most hot pumps will see significant temperature differentials from the bottom of the pump case to the top. Substantial clearances must be given to wear ring fits to allow a bowed rotor to run in a bowed pump case until temperatures equalize.
